গণপ্রজাতন্ত্রী বাংলাদেশ সরকার  
শ্রম ও কর্মসংস্থান মন্ত্রণালয়  
কলকারখানা ও প্রতিষ্ঠান পরিদর্শন অধিদপ্তর

ক্যাপ পর্যবেক্ষণের তথ্য

| কারখানার নাম | কালার স্টীচ লিঃ |

| মূল্যায়নের ধরন: বৈদ্যুতিক মূল্যায়ন | পর্যবেক্ষণের তারিখ: ০২-০৪-২০২৩ |

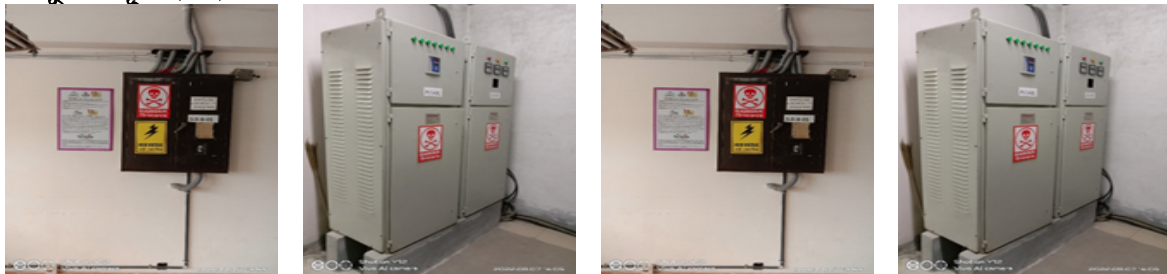
| পরিদর্শন<br>পর্যবেক্ষণ | <p>□ Ventilation and illumination of substation is poor □ Separating wall not extended up to the ceiling □ No clear identification mark on distribution panel □ No instruction for first aid to electrical shock and artificial respiration □ Non-conductor mat not provided</p> |

| মন্তব্য | <p>Previous Timeline: N/A. had no CAP Report Final Timeline: 11-Jul-17. Factory has no taken any action yet but they will have agreed to complete within timeline. 25-06-2020 visit Observation: No clear identification mark on distribution panel. Non-conductor mat not provided 08-10-2020: Ventilation and illumination of substation is poor. Separating wall not extended up to the ceiling. Clear identification mark on distribution panel was found. No instruction for first aid to electrical shock and artificial respiration. Conductor mat are provided in front of DB boards. 26-01-2021 on visit day Ventilation and illumination of substation is poor. Separating wall not extended up to the ceiling. Clear identification mark on distribution panel was found. No instruction for first aid to electrical shock and artificial respiration. Conductor mat are provided in front of DB boards. 10-06-2021: 1. Design drawings to demonstrate the incorporation of fire rated enclosure from floor to ceiling was produced and fire rated self-closing swing door for the Substation room was not approved yet. 2. Clear identification mark observed on distribution boards. 07-08-2022 Visit Observation: 1. Design drawings to demonstrate the incorporation of fire rated enclosure from floor to ceiling were produced and fire rated self-closing swing door for the Substation room were not approved yet. 2. Clear identification mark were observed on distribution boards. 02-04-2023: Same as previous visit.</p> |

| কার্যক্রম | <p>□ Produce design drawings to demonstrate the incorporation of fire rated enclosure from floor to ceiling and an approved fire rated self-closing swing door for the Substation room. □ Provide clear identification mark on distribution panel.</p> |
