গণপ্রজাতন্ত্রী বাংলাদেশ সরকার
শ্রম ও কর্মসংস্থান মন্ত্রণালয়
কলকারখানা ও প্রতিষ্ঠান পরিদর্শন অধিদপ্তর

ক্যাপ পর্যবেক্ষণের তথ্য

কারখানার নাম	মেসার্স কাট এন সিউ লিঃ
ঠিকানা	A. M. Plaza (10Th Floor), 76, DIT Road
কারখানার কোড	DHK145
কালার কোড

মূল্যায়নের ধরণ: বৈদ্যুতিক মূল্যায়ন	পর্যবেক্ষণের তারিখ: ০৫-০৪-২০২৩
১. পর্যবেক্ষণ

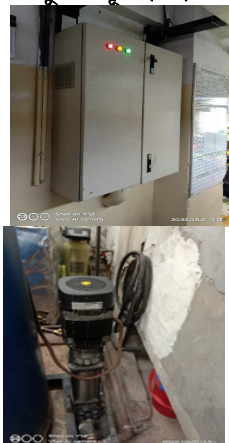
পরিদর্শন পর্যবেক্ষণ	□ No instruction for first aid to electrical shock □ Access obstructed/barred □ Connections without lug □ Body & door not earthed □ No SLD/clear identification mark for distribution board □ MDB/SDB/SB or MCB installed on the wooden board □ Live parts of machine or equipment exposed □ Motor frame not earthed
কাপ আইটেম ক্যাটাগরি

কার্যক্রম	□ Provide duplicate earth leads for MDB. □ Provide earthing to body & door. □ Consult for finding cause of burning inside distribution box and take appropriate actions □ Provide clear identification mark on distribution board and SLD □ Install MDB/SDB/SB/MCCB on nonflammable board. □ Provide earthing to motor frames.
সুপারিশের তথ্যসূত্র	
কারখানার কার্যক্রম	They have taken some action and they have agreed to complete within the timeline.
অগ্রাধিকার	৬ সপ্তাহ
চূড়ান্ত সময়সীমা	০২-১১-২০১৬
সংশোধিত সময়সীমা	০১-০১-১৯৭০
অগ্রগতির অবস্থা	চলমান
মন্তব্য	24-07-2018: 1. Duplicate Earth leads are not found in MDB. 2. Some door panels are not earthed yet. 3. No burning sign found inside distribution boards. 4. They consulted BD technology to submit SLD in DIFE. 5. Identification of distribution boards are not found in some MDB/DB/SDB. 23-10-2018: Same as above observation. 17-04-2019: Same as above observation. 18-12-2019: 1. Duplicate earth leads were not used for MDB. 2. Panel boards were earthed properly and panel door earthing were found in some distribution boards. 3 No burning sign found inside the distribution boards. 4. Clear identification of panel boards were not found in the distribution boards. 5. MDB/SDB/SB/MCCB were found to e installed on non-flammable boards. 6. Motor frames were found to be earthed. 19-08-2020: Same as above. 09-11-2020: 1. Duplicate earth leads were used for MDB. 2. Panel boards were earthed properly and panel door earthing were found in distribution boards. 3 No burning sign found inside the distribution boards. 4. Clear identification of panel boards were found in the distribution boards. 5. MDB/SDB/SB/MCCB were found to e installed on non-flammable boards. 6. Motor frames were found to be earthed. 09-02-2021 Visit Observation : 1. Duplicate earth leads were used for MDB. 2. Panel boards were earthed properly and panel door earthing were found in distribution boards. 3 No burning sign found inside the distribution boards. 4. Clear identification of panel boards were found in the distribution boards. 5. MDB/SDB/SB/MCCB were found to e installed on non-flammable boards. 6. Motor frames were found to be earthed. 09-05-2021 Visit Observation : 1. Duplicate earth leads were used for MDB. 2. Panel boards were earthed properly and panel door earthing were found in distribution boards. 3 No burning sign found inside the distribution boards. 4. Clear identification of panel boards were found in the distribution boards. 5. MDB/SDB/SB/MCCB were found to e installed on non-flammable boards. 6. Motor frames were found to be earthed. 10/08/2021: Duplicate earth leads are provided for MDB. Earthing is provided to most of the panel body and door. Thermographic scanning report doesn't show any major hot point. No burning sign has been seen inside panel boards. Clear identification mark is provided on all the distribution boards. MDB/SDB/SB/MCCB are all installed on nonflammable boards. Motors are found to be earthed. 01-08-2022 Visit Observation : 1. Duplicate earth leads were used for MDB. 2. Panel boards & panel door were earthed properly. 3 No burning sign found inside the distribution boards. 4. Clear identification of panel boards were not found. 5. MDB/SDB/SB/MCCB are all installed on non inflammable boards. 6. Motor frames were found to be earthed. 05.04.2023: 1. Duplicate earth leads were used for MDB. 2. Panel boards & panel door were earthed properly. 3 No burning sign found inside the distribution boards. 4. Clear identification of panel boards were not found. 5. MDB/SDB/SB/MCCB are all installed on non inflammable boards. 6. Motor frames were found to be earthed.

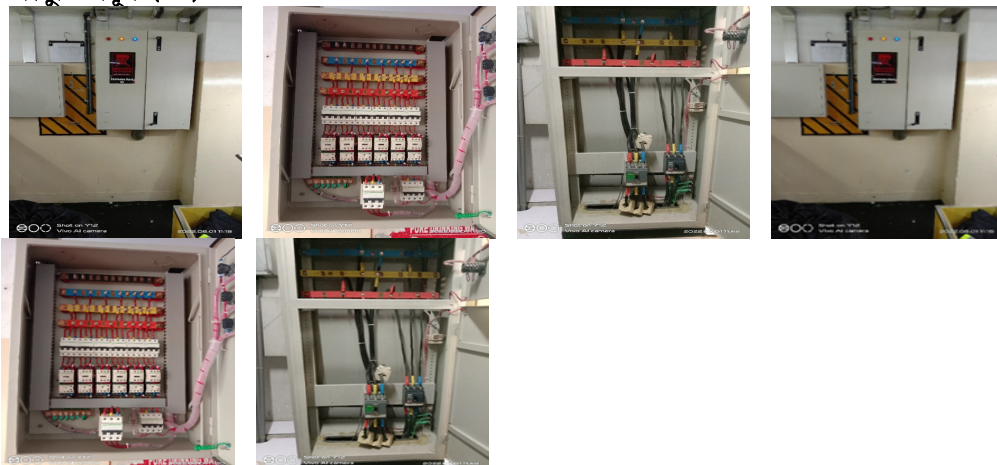
পরিদর্শন পর্যবেক্ষণ	<input type="checkbox"/> No instruction for first aid to electrical shock <input type="checkbox"/> Access obstructed/barred <input type="checkbox"/> Connections without lug <input type="checkbox"/> Body & door not earthed <input type="checkbox"/> No SLD/clear identification mark for distribution board <input type="checkbox"/> MDB/SDB/SB or MCB installed on the wooden board <input type="checkbox"/> Live parts of machine or equipment exposed <input type="checkbox"/> Motor frame not earthed
ক্যাপ আইটেম ক্যাটাগরি

কার্যক্রম	<input type="checkbox"/> Provide instructions for first aid for exposure to electrical shock <input type="checkbox"/> Remove obstruction to ensure access to MDB/MCB Box <input type="checkbox"/> Ensure well-dressed cabling with lugs <input type="checkbox"/> Cover the exposed live parts.
সুপারিশের তথ্যসূত্র	
কারখানার কার্যক্রম	It has been implemented.
অগ্রাধিকার	প্রযোজ্য নয়
চূড়ান্ত সময়সীমা	-
সংশোধিত সময়সীমা	০১-০১-১৯৭০
অগ্রগতির অবস্থা	চলমান
মন্তব্য	<p>24-07-2018: 1. First aid and electric shock recuperation instruction were not provided at required area. 2. Cables are not well dressed in some panel boards. 3. Live part are not covered properly in some machine. 4. Motor frame are earthed but dedicated earthing for each circuit breaker is required. 23-10-2018: Same as above observation. 17-04-2019: Same as above observation. 18-12-2019: 1. First aid electric shock recuperation were found near some distribution boards. 2. Clearance for distribution boards and MCB box were not found. Needs minimum 1m clearance around according to NTPA guideline. 3. Cables were not found to be well dressed in some panel boards and proper cable lugs were not used for termination in MCB. 4. MCB box were found to be without cover. 19-08-2020: 1. Same as above. 2. Clearance for distribution boards and MCB box were found. 3. Same as above. 4. MCB box were not found to be without cover. 09-11-2020: 1. First aid electric shock recuperation were found near some distribution boards. 2. Clearance for distribution boards and MCB box were found. 3. Cables were found to be well dressed in some panel boards and proper cable lugs were used for termination in MCB. 4. MCB box were not found to be without cover. 09-05-2021 Visit Observation : 1. First aid electric shock recuperation were found near some distribution boards. 2. Clearance for distribution boards and MCB box were found. 3. Cables were found to be well dressed in some panel boards and proper cable lugs were used for termination in MCB. 4. MCB box were not found to be without cover. 09-02-2021 Visit Observation : 1. First aid electric shock recuperation were found near some distribution boards. 2. Clearance for distribution boards and MCB box were found. 3. Cables were found to be well dressed in some panel boards and proper cable lugs were used for termination in MCB. 4. MCB box were not found to be without cover. 10/08/2021: Instruction for first aid to electrical shock has been provided for all the distribution boards. Access to MDB/MCB box has been ensured. Well dressed cabling with lugs has been ensured inside all the distribution boards. Exposed live parts are not covered. 01-08-2022 Visit Observation : 1. Instruction for first aid to electrical shock and artificial respiration was not found for every panel board. 2. Access to MDB/MCB box has been ensured. 3. Well dressed cabling with lugs has not been ensured inside all the distribution boards. 4. Exposed live parts are not covered. 05.04.2023: 1. Instruction for first aid to electrical shock and artificial respiration was not found for every panel board. 2. Access to MDB/MCB box has been ensured. 3. Well dressed cabling with lugs has not been ensured inside all the distribution boards. 4. Exposed live parts are not covered.</p>
