গণপ্রজাতন্ত্রী বাংলাদেশ সরকার
শ্রম ও কর্মসংস্থান মন্ত্রণালয়
কলকারখানা ও প্রতিষ্ঠান পরিদর্শন অধিদপ্তর

ক্যাপ পর্যবেক্ষণের তথ্য

কারখানার নাম	মেসার্স কাট এন সিউ লিঃ
ঠিকানা	A. M. Plaza (10Th Floor), 76, DIT Road
কারখানার কোড	DHK145
কালার কোড	
মূল্যায়নের ধরণ: বৈদ্যুতিক মূল্যায়ন	পর্যবেক্ষণের তারিখ: ০৫-০৪-২০২৩
১. পর্যবেক্ষণ

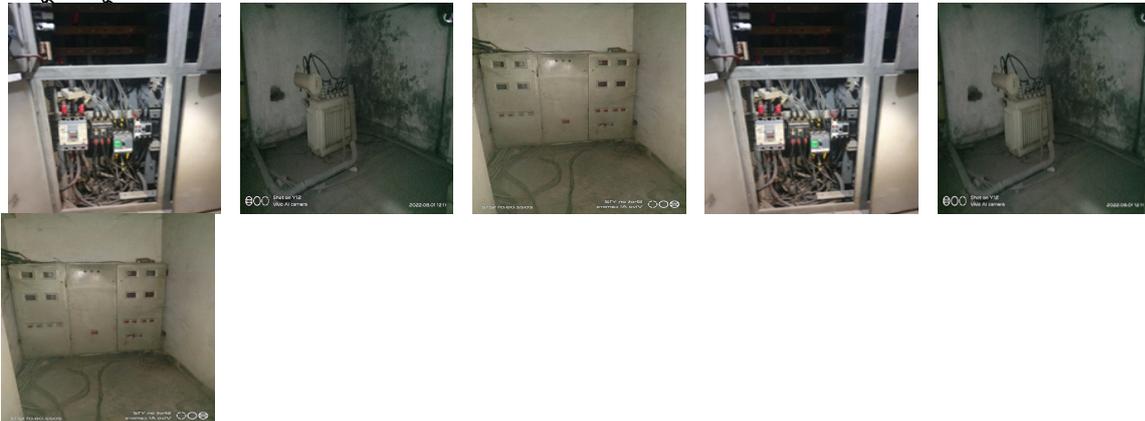
সংযুক্তিসমূহ (৬)

পরিদর্শন পর্যবেক্ষণ	Access to substation not easy Ventilation and illumination of substation is poor Separating wall not extended up to the ceiling No SLD/clear identification mark on distribution panel No instruction for first aid to electrical shock and artificial respiration Non-conductor mat not provided/ insufficient Improper earthing Loose or temporary cabling/connection without lug/uncovered cable trench lint/dirt in substation
ক্যাম আইটেম কাটাগরি

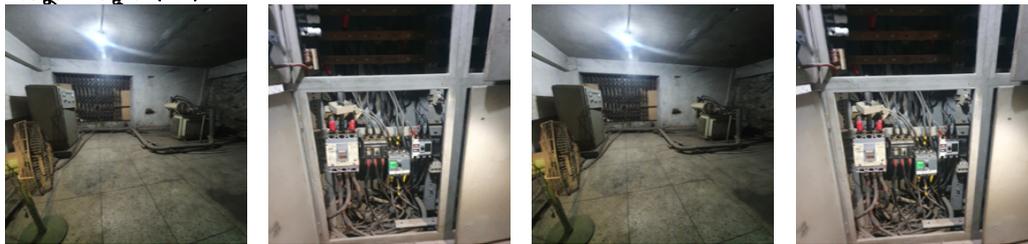
সংযুক্তিসমূহ (৪)

পরিদর্শন পর্যবেক্ষণ	<input type="checkbox"/> Access to substation not easy <input type="checkbox"/> Ventilation and illumination of substation is poor <input type="checkbox"/> Separating wall not extended up to the ceiling <input type="checkbox"/> No SLD/clear identification mark on distribution panel <input type="checkbox"/> No instruction for first aid to electrical shock and artificial respiration <input type="checkbox"/> Non-conductor mat not provided/ insufficient <input type="checkbox"/> Improper earthing <input type="checkbox"/> Loose or temporary cabling/connection without lug/uncovered cable trench <input type="checkbox"/> lint/dirt in substation
ক্যাপ আইটেম ক্যাটাগরি

কার্যক্রম	<input type="checkbox"/> Keep the substation clean <input type="checkbox"/> Provide instructions for first aid and artificial respiration from exposure to electrical shock. <input type="checkbox"/> Provide cover on the cable trench and rubber mat in front of the panel <input type="checkbox"/> Ensure well-dressed cabling with lugs
সুপারিশের ভিত্তিসূত্র	
কার্যখালার কার্যক্রম	They have taken some action and they have agreed to complete within the timeline.
অগ্রাধিকার	প্রয়োজ্য নশ
চূড়ান্ত সময়সীমা	০৫-১০-২০১৬
সংশোধিত সময়সীমা	০১-০১-১৯৭০
অগ্রগতির অবস্থা	চলমান
মন্তব্য	<p>24-07-2018: 1. Substation have been found clean. 2. First aid and electric shock recuperation instruction were not provided at required areas. 3. Cable trenches were not covered properly in substation room. 4. Rubber mat needs to be provided in required places. 23-10-2018: Same as above observation. 17-04-2019: Same as above observation. 18-12-2019: 1. Substation was found clean. 2. First aid and electric shock recuperation instruction were not provided near some distribution boards. 3. Cable trenches were found to be covered and proper rubber mats were found in front of the panel boards. 4. Cables were not found to be well dressed in some panel boards and proper cable lugs were not used for termination in MCB. 19-08-2020: Same as above. 09-11-2020 1. Substation was found clean. 2. First aid and electric shock recuperation instruction were provided near some distribution boards. 3. Cable trenches were found to be covered and proper rubber mats were found in front of the panel boards. 4. Cables were found to be well dressed in some panel boards and proper cable lugs were used for termination in MCB. 09-02-2021 Visit Observation : 1. Substation was found clean. 2. First aid and electric shock recuperation instruction were provided near some distribution boards. 3. Cable trenches were found to be covered and proper rubber mats were found in front of the panel boards. 4. Cables were found to be well dressed in panel boards and proper cable lugs were used for termination in MCB. 09-05-2021 Visit Observation : 1. Substation was found clean. 2. First aid and electric shock recuperation instruction were provided near some distribution boards. 3. Cable trenches were found to be covered and proper rubber mats were found in front of the panel boards. 4. Cables were found to be well dressed in panel boards and proper cable lugs were used for termination in MCB. 10/08/2021: Substation room is found to be clean. Instruction for first aid and artificial respiration from exposure is provided. Rubber mat is not provided in front of the LT panel. Well dressed cabling with lugs is ensured. 01-08-2022 Visit Observation : 1. Substation room was not found clean during inspection period. 2. Instruction for first aid and artificial respiration was not found for every panel board. 3. Rubber mat is not provided in front of the LT panel. 4. Well dressed cabling with lugs is not ensured. 05.04.2023: 1. Substation room was not found clean during inspection period. 2. Instruction for first aid and artificial respiration was not found for every panel board. 3. Rubber mat is not provided in front of the LT panel. 4. Well dressed cabling with lugs is not ensured.</p>

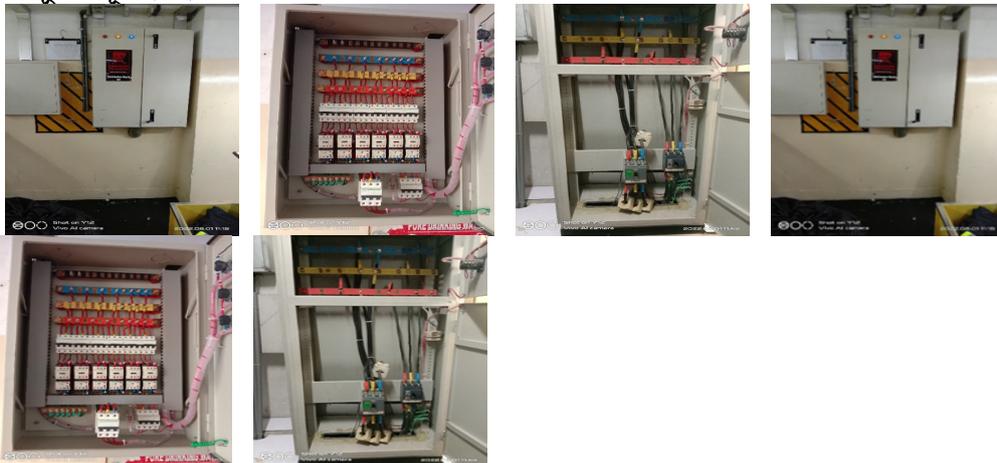
সংযুক্তিসমূহ (৬)

পরিদর্শন পর্যবেক্ষণ	<input type="checkbox"/> No instruction for first aid to electrical shock <input type="checkbox"/> Access obstructed/barred <input type="checkbox"/> Connections without lug <input type="checkbox"/> Body & door not earthed <input type="checkbox"/> No SLD/clear identification mark for distribution board <input type="checkbox"/> MDB/SDB/SB or MCB installed on the wooden board <input type="checkbox"/> Live parts of machine or equipment exposed <input type="checkbox"/> Motor frame not earthed
ক্যাপ আইটেম ক্যাটাগরি

কার্যক্রম	<input type="checkbox"/> Provide instructions for first aid for exposure to electrical shock <input type="checkbox"/> Remove obstruction to ensure access to MDB/ MCB Box <input type="checkbox"/> Ensure well-dressed cabling with lugs <input type="checkbox"/> Cover the exposed live parts.
সুপারিশের ভিত্তিসূত্র	
কারখানার কার্যক্রম	It has been implemented.
অগ্রাধিকার	প্রশাস্য নয়
চূড়ান্ত সময়সীমা	-
সংশোধিত সময়সীমা	০১-০১-১৯৭০
অগ্রগতির অবস্থা	চলমান
মন্তব্য	<p>24-07-2018: 1. First aid and electric shock recuperation instruction were not provided at required area. 2. Cables are not well dressed in some panel boards. 3. Live part are not covered properly in some machine. 4. Motor frame are earthed but dedicated earthing for each circuit breaker is required. 23-10-2018: Same as above observation. 17-04-2019: Same as above observation. 18-12-2019: 1. First aid electric shock recuperation were found near some distribution boards. 2. Clearance for distribution boards and MCB box were not found. Needs minimum 1m clearance around according to NTPA guideline. 3. Cables were not found to be well dressed in some panel boards and proper cable lugs were not used for termination in MCB. 4. MCB box were found to be without cover. 19-08-2020: 1. Same as above. 2. Clearance for distribution boards and MCB box were found. 3. Same as above. 4. MCB box were not found to be without cover. 09-11-2020: 1. First aid electric shock recuperation were found near some distribution boards. 2. Clearance for distribution boards and MCB box were found. 3. Cables were found to be well dressed in some panel boards and proper cable lugs were used for termination in MCB. 4. MCB box were not found to be without cover. 09-05-2021 Visit Observation : 1. First aid electric shock recuperation were found near some distribution boards. 2. Clearance for distribution boards and MCB box were found. 3. Cables were found to be well dressed in some panel boards and proper cable lugs were used for termination in MCB. 4. MCB box were not found to be without cover. 09-02-2021 Visit Observation : 1. First aid electric shock recuperation were found near some distribution boards. 2. Clearance for distribution boards and MCB box were found. 3. Cables were found to be well dressed in some panel boards and proper cable lugs were used for termination in MCB. 4. MCB box were not found to be without cover. 10/08/2021: Instruction for first aid to electrical shock has been provided for all the distribution boards. Access to MDB/MCB box has been ensured. Well dressed cabling with lugs has been ensured inside all the distribution boards. Exposed live parts are not covered. 01-08-2022 Visit Observation : 1. Instruction for first aid to electrical shock and artificial respiration was not found for every panel board. 2. Access to MDB/MCB box has been ensured. 3. Well dressed cabling with lugs has not been ensured inside all the distribution boards. 4. Exposed live parts are not covered. 05.04.2023: 1. Instruction for first aid to electrical shock and artificial respiration was not found for every panel board. 2. Access to MDB/MCB box has been ensured. 3. Well dressed cabling with lugs has not been ensured inside all the distribution boards. 4. Exposed live parts are not covered.</p>
