গণপ্রজাতন্ত্রী বাংলাদেশ সরকার
শ্রম ও কর্মসংস্থান মন্ত্রণালয়
কলকারখানা ও প্রতিষ্ঠান পরিদর্শন অধিদপ্তর

ক্যাপ পর্যবেক্ষণের তথ্য

কারখানার নাম	মেসার্স কাট এন সিউ লিঃ
ঠিকানা	A. M. Plaza (10Th Floor), 76, DIT Road
কারখানার কোড	DHK145
কালার কোড	
মূল্যায়নের ধরণ: কাঠামোগত মূল্যায়ন	পর্যবেক্ষণের তারিখ: ০৫-০৪-২০২৩
১. পর্যবেক্ষণ

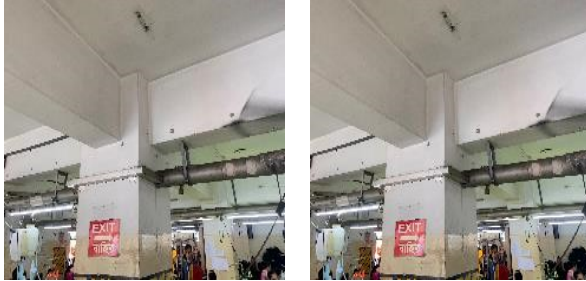
পরিদর্শন পর্যবেক্ষণ	Distress in Primary Structural Element
কাপ আইটেম ক্যাটাগরি

কার্যক্রম	The owner or user of the building should be vigilant about development of any distress, particularly in primary structural elements such as columns, beams and slabs. If crack appear, propagate and widen, detail assessment and adoption of the remedial measures may become necessary.
সুপারিশের তথ্যসূত্র	
কারখানার কার্যক্রম	No distress in Primary Structural Element has been found until today since the day of assessment
অগ্রাধিকার	অবিলম্বে
চূড়ান্ত সময়সীমা	-
সংশোধিত সময়সীমা	০১-০১-১৯৭০
অগ্রগতির অবস্থা	সংশোধিত
মন্তব্য	19/08/2020: No distress was found in any structural element during the inspection day. 09.11.2020: No distress or crack was found during inspection day. 09/02/2021: No distress found in any primary structural elements on the visiting date. 10/08/2021: There was no major distress found in any structural primary elements on the date of inspection. 01/08/2022: No distress were found in any primary structural elements during the inspection date. 05-04-2023: Completed.
