গণপ্রজাতন্ত্রী বাংলাদেশ সরকার
শ্রম ও কর্মসংস্থান মন্ত্রণালয়
কলকারখানা ও প্রতিষ্ঠান পরিদর্শন অধিদপ্তর

ক্যাপ পর্যবেক্ষণের তথ্য

কারখানার নাম	কতুল্লা, এয়াপবেলস
ঠিকানা	B-68/1 Wapda Road, Jalkuri, Siddirganj, Narayanganj
কারখানার কোড	NRY087
কালার কোড	
মূল্যায়নের ধরণ: কাঠামোগত মূল্যায়ন	পর্যবেক্ষণের তারিখ: ০১-০২-২০২৩
১. পর্যবেক্ষণ

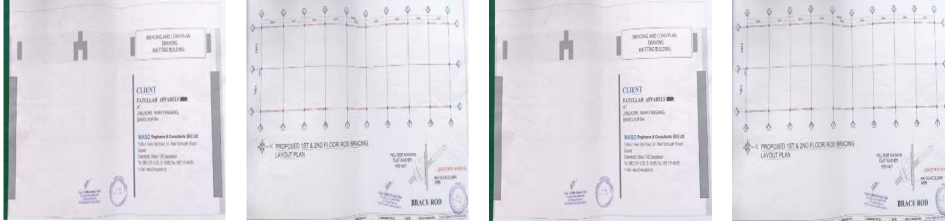
সংযুক্তিসমূহ (৪)

পরিদর্শন পর্ববেষ্টিত	During inspection, bracing for lateral stability in 1st and GF was not found.
ক্যাপ আইটেম ক্যাটাগরি

কার্যক্রম	Verify the lateral stability of the structure and confirm the requirement of any bracing of the structure.
সুপারিশের তথ্যসূত্র	
কারখানার কার্যক্রম	We have already engaged consultant to verify lateral stability of the structure to confirm the requirement of any bracing of the structure.
অগ্রাধিকার	৬ সপ্তাহ
চূড়ান্ত সময়সীমা	১৫-০৯-২০১৬
সংশোধিত সময়সীমা	০১-০১-১৯৭০
অগ্রগতির অবস্থা	চলমান
মন্তব্য	27-10-2020, They have already talk to their consultant engineer to verify lateral stability of the structure. 13.01.2021-During inspection, bracing for lateral stability in 1st and GF was not found. But they have already talk to their consultant engineer to verify lateral stability of the structure. 03-06-2021 (CVV4) : During inspection, bracing for lateral stability in 1st and GF was not found. But they have already talk to their consultant engineer to verify lateral stability of the structure but not yet. 24-Aug-2021 (CVV5) : As-built architectural drawing, structural drawing & DEA report have been prepared and submitted to DIFE for approval ,only submission letter of that is available. 28-Aug-2022: After Submission of DEA report DIFE have some correction. Factory management says that, they has been start to work this correction & Corrected DEA report will submit to DIFE as soon as possible. Proposed Bracing layout plan & sectional drawing found on site during visit. 01-Feb-2023: After Submission of DEA report DIFE have some correction. Factory management says that, they has been start to work this correction & Corrected DEA report will submit to DIFE as soon as possible.

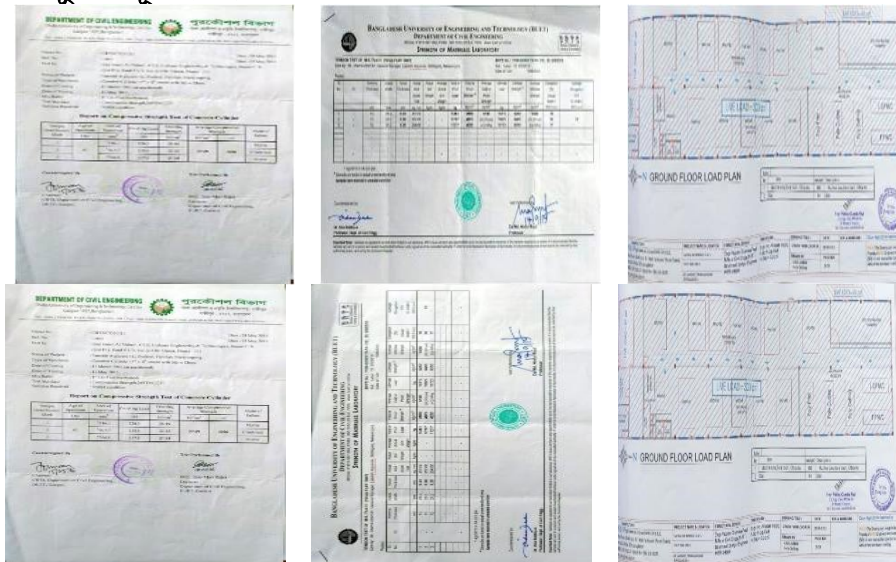
সংযুক্তিসমূহ (৬)

পরিদর্শন পর্যবেক্ষণ	During document review floor load plan and material test report were not found.
ক্যাপ আইটেম ক্যাটাগরি

কার্যক্রম	Develop full set of floor load plan showing loading details, and conduct materials test.
সুপারিশের তথ্যসূত্র	
কারখানার কার্যক্রম	We have already developed floor load plan by DEA and done material test report from BUET
অগ্রাধিকার	৬ মাস
চূড়ান্ত সমন্বয়সীমা	-
সংশোধিত সমন্বয়সীমা	০১-০১-১৯৭০
অগ্রগতির অবস্থা	চলমান
মন্তব্য	27-10-2020, They have all kind test reports & we found all kinds report at factory. 13.01.2021: No floor load plan has been found during inspection but as built drawing material test report was found. 03-06-2021 (CVV4): No floor load plan has been found during inspection but as built drawing material test report was found. 24-Aug-2021 (CVV5): Floor load plan has not found during inspection , materials test report is available at factory. 28-Aug-2022: Materials test report & floor load plan drawing is available at factory during visit. but floor load plan are not posted on floor because they are waiting for approved floor load plan. 01.Feb.2023: Materials test report & floor load plan drawing is available at factory during visit. but floor load plan are not posted on floor because they are waiting for approved floor load plan.
