গণপ্রজাতন্ত্রী বাংলাদেশ সরকার  
শ্রম ও কর্মসংস্থান মন্ত্রণালয়  
কলকারখানা ও প্রতিষ্ঠান পরিদর্শন অধিদপ্তর

ক্যাপ পর্যবেক্ষণের তথ্য

কারখানার নাম	কতুল্লা, এয়াপারেলস		
ঠিকানা	B-68/1 Wapda Road, Jalkuri, Siddirganj, Narayanganj		
কারখানার কোড	NRY087		
কালার কোড			
মূল্যায়নের ধরণ: <a href="#">কঠামোগত মূল্যায়ন</a>		পর্যবেক্ষণের তারিখ: ০১-০২-২০২৩	
১. পর্যবেক্ষণ

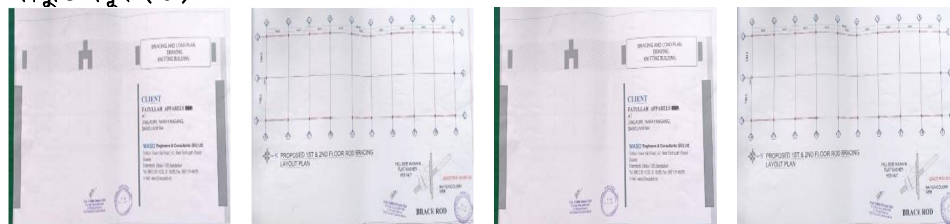
#### সংযুক্তিসমূহ (৪)

পরিদর্শন পর্ববেক্ষণ	During inspection, bracing for lateral stability in 1st and GF was not found.
ক্যাপ আইটেম ক্যাটাগরি

কার্যক্রম	Verify the lateral stability of the structure and confirm the requirement of any bracing of the structure.
সুপারিশের তথ্যসূত্র	
কারখানার কার্যক্রম	We have already engaged consultant to verify lateral stability of the structure to confirm the requirement of any bracing of the structure.
অগ্রাধিকার	৬ সপ্তাহ
চূড়ান্ত সময়সীমা	১৫-০৯-২০১৬
সংশোধিত সময়সীমা	০১-০১-১৯৭০
অগ্রগতির অবস্থা	চলমান
মন্তব্য	27-10-2020, They have already talk to their consultant engineer to verify lateral stability of the structure. 13.01.2021-During inspection, bracing for lateral stability in 1st and GF was not found. But they have already talk to their consultant engineer to verify lateral stability of the structure. 03-06-2021 (CVV4): During inspection, bracing for lateral stability in 1st and GF was not found. But they have already talk to their consultant engineer to verify lateral stability of the structure but not yet. 24-Aug-2021 (CVV5): As-built architectural drawing, structural drawing & DEA report have been prepared and submitted to DIFE for approval, only submission letter of that is available. 28-Aug-2022: After Submission of DEA report DIFE have some correction. Factory management says that, they has been start to work this correction & Corrected DEA report will submit to DIFE as soon as possible. Proposed Bracing layout plan & sectional drawing found on site during visit. 01-Feb-2023: After Submission of DEA report DIFE have some correction. Factory management says that, they has been start to work this correction & Corrected DEA report will submit to DIFE as soon as possible.

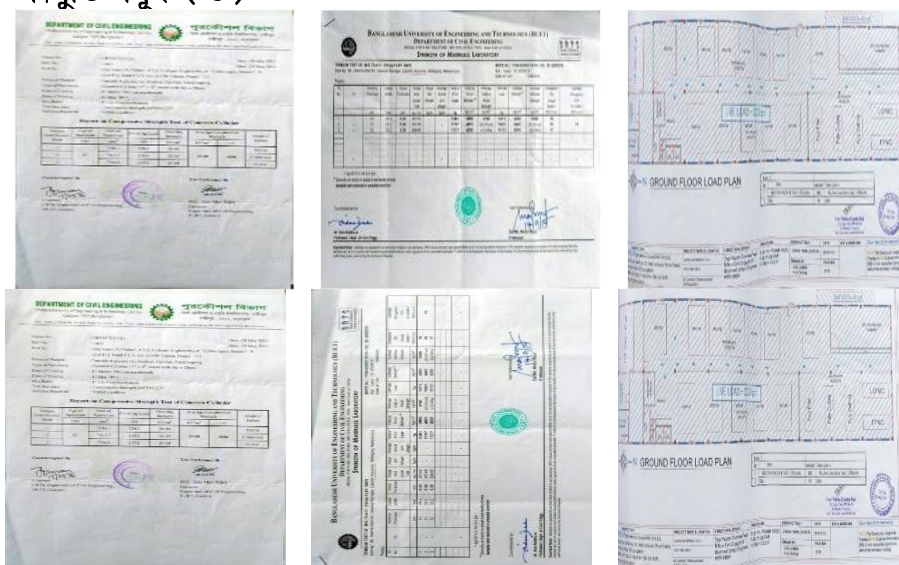
### সংযুক্তিসমূহ ( ৬ )

পরিদর্শন পর্যবেক্ষণ	During document review floor load plan and material test report were not found.
ক্যাপ আইটেম ক্যাটাগরি

কার্যক্রম	Develop full set of floor load plan showing loading details, and conduct materials test.
সুপারিশের তথ্যসূত্র	
কারখানার কার্যক্রম	We have already developed floor load plan by DEA and done material test report from BUET
অগ্রাধিকার	৬ মাস
চূড়ান্ত সময়সীমা	-
সংশোধিত সময়সীমা	০১-০১-১৯৭০
অগ্রগতির অবস্থা	চলমান
মন্তব্য	27-10-2020, They have all kind test reports & we found all kinds report at factory. 13.01.2021: No floor load plan has been found during inspection but as built drawing material test report was found. 03-06-2021 ( CVV4 ): No floor load plan has been found during inspection but as built drawing material test report was found. 24-Aug-2021 ( CVV5 ): Floor load plan has not found during inspection , materials test report is available at factory. 28-Aug-2022: Materials test report & floor load plan drawing is available at factory during visit. but floor load plan are not posted on floor because they are waiting for approved floor load plan. 01.Feb.2023: Materials test report & floor load plan drawing is available at factory during visit. but floor load plan are not posted on floor because they are waiting for approved floor load plan.
