গণপ্রজাতন্ত্রী বাংলাদেশ সরকার
শ্রম ও কর্মসংস্থান মন্ত্রণালয়
কলকারখানা ও প্রতিষ্ঠান পরিদর্শন অধিদপ্তর

ক্যাপ পর্যবেক্ষণের তথ্য

কারখানার নাম	কনভিন্স এম্পায়ারেলস লিঃ
ঠিকানা	Plot # 68-71, Block-Section # 2, Rupnagar, Mirpur, Dhaka .
কারখানার কোড	DHK136
কালার কোড	
মূল্যায়নের ধরণ: কাঠামোগত মূল্যায়ন	পর্যবেক্ষণের তারিখ: ৩০-০১-২০২৩
১. পর্যবেক্ষণ

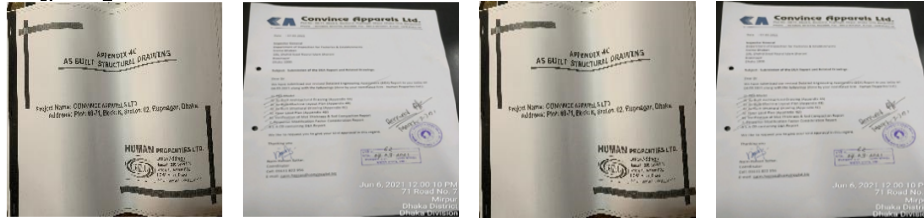
সংযুক্তিসমূহ (৪)

পরিদর্শন পর্যবেক্ষণ	Cursory calculations indicate high punching shear stress in the flat plate slabs of 1st, 2nd and 5th floor. Flat plate thickness is 6.5".
ক্যাপ আইটেম ক্যাটাগরি

কার্যক্রম	Verify in-situ concrete stresses either by 100mm dia. cores or existing cylinder strength data. Cores to be taken from 4 different areas of slab at different level.
সুপারিশের তথ্যসূত্র	
কারখানার কার্যক্রম	We have engaged a consulting firm .
অগ্রাধিকার	প্রশোচনা নয়
চূড়ান্ত সময়সীমা	০১-০৯-২০১৬
সংশোধিত সময়সীমা	০১-০১-১৯৭০
অগ্রগতির অবস্থা	সংশোধিত
মন্তব্য	01.10.2020: They have got the approval of DEA report from DIFE, but they did not able to show any approved copy during inspection time. One follow up visit was held on the factory and they got some mismatch. The management suggested by engineering team to do the rest of the work but the factory didn't do any work due to corona. 13.01.2021: This issue covered by DEA. They have got the approval of DEA report from DIFE, but they did not able to show any approved copy during inspection time. 06/06/2021: All revised documents including DEA report with core test result is re-submitted to DIFE on 07-03-21. Now they are waiting for approval. 29.08.2021: All revised documents including DEA report with core test result is re-submitted to DIFE on 07-03-21. They got the approval for the Business Certificate from the task Force Number of 157 on May-30-2021. 10/08/2022: The DEA report has received approval from DIFE and also received 'Certificate of Business as Usual'. 30-01-2023: Completed.

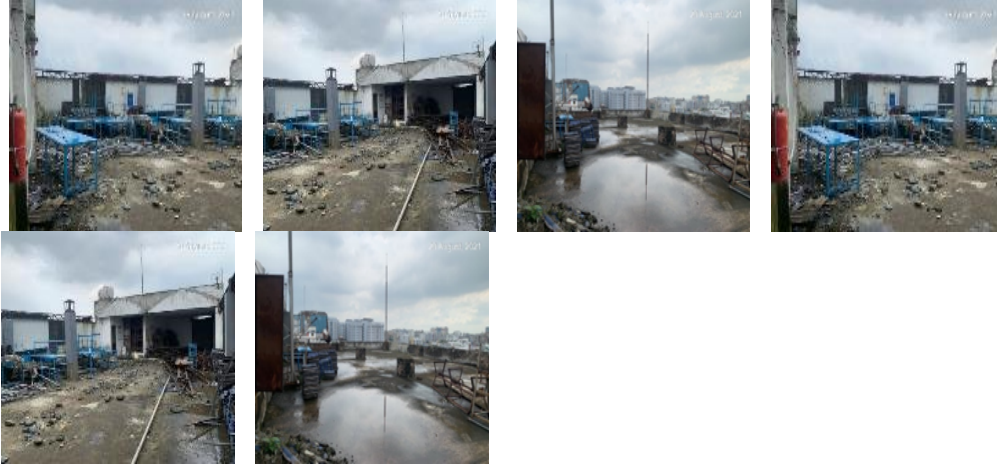
সংযুক্তিসমূহ (৬)

পরিদর্শন পর্যবেক্ষণ	There is an additional roof truss steel shed on roof which covers 40% of the roof top. No design documents of the shed have been found.
ক্যাপ আইটেম ক্যাটাগরি

কার্যক্রম	Building engineer to check the capacity and stability of the lightweight roofs and make any necessary alterations.
সুপারিশের তথ্যসূত্র	
কারখানার কার্যক্রম	Do
অগ্রাধিকার	প্রয়োজ্য নয়
চূড়ান্ত সময়সীমা	০১-০৯-২০১৬
সংশোধিত সময়সীমা	০১-০১-১৯৭০
অগ্রগতির অবস্থা	সংশোধিত
মন্তব্য	01.10.2020: There is an additional roof truss steel shed on roof but the assigned consultant firm didn't show this structure in architectural drawing. 13.01.2021: No drawing found for roof shed. 06/06/2021: According to the Taskforce review the factory is advised to demolish the shed building of roof. Now the factory has been continuing its demolition work. 29.08.2021: According to the Taskforce review the factory is advised to demolish the shed building of roof. Now the factory has been continuing its demolition work. 10/08/2022: Roof steel shed has found demolish during inspection date. 30-01-2023: Completed.

কার্যক্রম	Carry out upgrade measures required as part of the design checks. Prepare as built structural drawings for additional structure
সুপারিশের তথ্যসূত্র	
কারখানার কার্যক্রম	Do
অগ্রাধিকার	
চূড়ান্ত সময়সীমা	২১-০১-২০১৭
সংশোধিত সময়সীমা	০১-০১-১৯৭০
অগ্রগতির অবস্থা	সংশোধিত
মন্তব্য	01.10.2020 visit observation: No upgrade measure showing the Structural design drawing. 13.01.2021: No structural drawing found for roof shed. 06/06/2021: According to the Taskforce review the factory is advised to demolish the shed building of roof. Now the factory has been continuing its demolition work. 29.08.2021: According to the Taskforce review the factory is advised to demolish the shed building of roof. Now the factory has been continuing its demolition work. 10/08/2022: Roof steel shed has found demolish during inspection date. 30-01-2023: Completed.

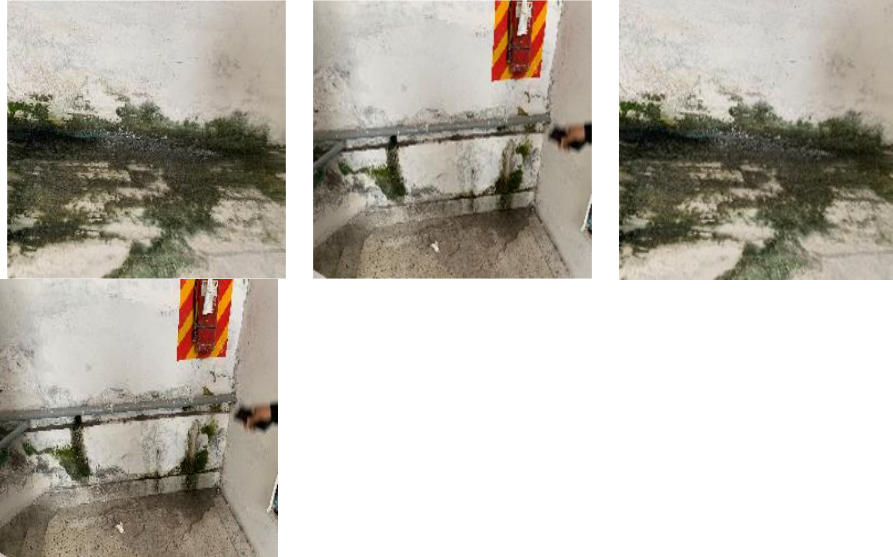
সংযুক্তিসমূহ (৪)

পরিদর্শন পর্যবেক্ষণ	Dampness was observed on the walls and ceiling of basement, 1st, 5th and 6th floor. The possible cause of dampness is leakage of pipes.
ক্যাপ আইটেম ক্যাটাগরি

কার্যক্রম	Building Engineer should find out the causes of dampness and carry out repair remedial works as required.
সুপারিশের তথ্যসূত্র	
কারখানার কার্যক্রম	We will repair immediately
অগ্রাধিকার	প্রয়োজ্য নয়
চূড়ান্ত সময়সীমা	২১-০১-২০১৭
সংশোধিত সময়সীমা	০১-০১-১৯৭০
অগ্রগতির অবস্থা	চলমান
মন্তব্য	01.10.2020: Dampness has been found on 4th,5th, 8th,9th and roof ceiling. Ultimately Dampness is visible in all the floor at different intensity. 13.01.2021: Dampness has been found on different periphery wall. & 8th floor ceiling. 06/06/2021: There is no remedial action has been taken dampness of the factory building still now. Dampness found in B/floor, G/floor, 8th floor, roof floor and stair areas of every floor. 29.08.2021 Visit observation: There is no remedial action has been taken dampness of the factory building still now. Dampness found in B/floor, G/floor, 8th floor, roof floor and stair areas of every floor. 10/08/2022: Dampness were found during inspection date. 30-01-2023: Dampness were found during inspection date.
