গণপ্রজাতন্ত্রী বাংলাদেশ সরকার
শ্রম ও কর্মসংস্থান মন্ত্রণালয়
কলকারখানা ও প্রতিষ্ঠান পরিদর্শন অধিদপ্তর

ক্যাপ পর্যবেক্ষণের তথ্য

কারখানার নাম	কনভিন্স এ্যাপারেলস লিঃ
ঠিকানা	Plot # 68-71, Block-Section # 2, Rupnagar, Mirpur, Dhaka .
কারখানার কোড	DHK136
কালার কোড	
মূল্যায়নের ধরণ: কাঠামোগত মূল্যায়ন	পর্যবেক্ষণের তারিখ: ৩০-০১-২০২৩
১. পর্যবেক্ষণ

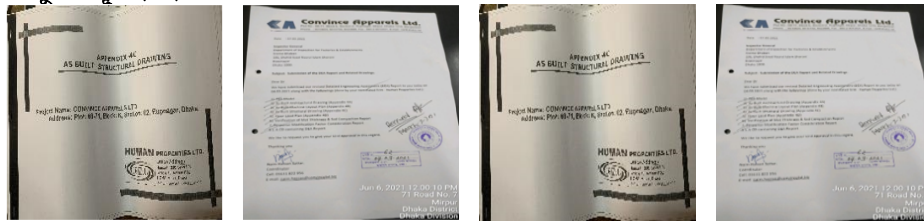
সংযুক্তিসমূহ (৪)

পরিদর্শন পর্যবেক্ষণ	Cursory calculations indicate high punching shear stress in the flat plate slabs of 1st, 2nd and 5th floor. Flat plate thickness is 6.5".
ক্যাপ আইটেম ক্যাটাগরি

কার্যক্রম	Verify in-situ concrete stresses either by 100mm dia. cores or existing cylinder strength data. Cores to be taken from 4 different areas of slab at different level.
সুপারিশের তথ্যসূত্র	
কারখানার কার্যক্রম	We have engaged a consulting firm .
অগ্রাধিকার	প্রশোচনা নয়
চূড়ান্ত সময়সীমা	০১-০৯-২০১৬
সংশোধিত সময়সীমা	০১-০১-১৯৭০
অগ্রগতির অবস্থা	সংশোধিত
মন্তব্য	01.10.2020: They have got the approval of DEA report from DIFE, but they did not able to show any approved copy during inspection time. One follow up visit was held on the factory and they got some mismatch. The management suggested by engineering team to do the rest of the work but the factory didn't do any work due to corona. 13.01.2021: This issue covered by DEA. They have got the approval of DEA report from DIFE, but they did not able to show any approved copy during inspection time. 06/06/2021: All revised documents including DEA report with core test result is re-submitted to DIFE on 07-03-21. Now they are waiting for approval. 29.08.2021: All revised documents including DEA report with core test result is re-submitted to DIFE on 07-03-21. They got the approval for the Business Certificate from the task Force Number of 157 on May-30-2021. 10/08/2022: The DEA report has received approval from DIFE and also received 'Certificate of Business as Usual'. 30-01-2023: Completed.

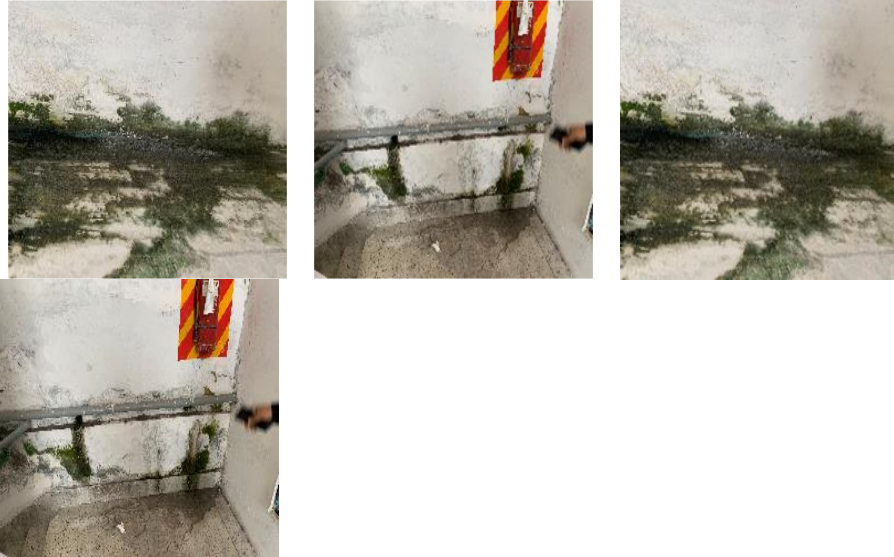
সংযুক্তিসমূহ (৪)

পরিদর্শন পর্যবেক্ষণ	Dampness was observed on the walls and ceiling of basement, 1st, 5th and 6th floor. The possible cause of dampness is leakage of pipes.
ক্যাপ আইটেম ক্যাটাগরি

কার্যক্রম	Building Engineer should find out the causes of dampness and carry out repair remedial works as required.
সুপারিশের তথ্যসূত্র	
কারখানার কার্যক্রম	We will repair immediately
অগ্রাধিকার	প্রয়োজ্য নয়
চূড়ান্ত সময়সীমা	২১-০১-২০১৭
সংশোধিত সময়সীমা	০১-০১-১৯৭০
অগ্রগতির অবস্থা	চলমান
মন্তব্য	01.10.2020: Dampness has been found on 4th,5th, 8th,9th and roof ceiling. Ultimately Dampness is visible in all the floor at different intensity. 13.01.2021: Dampness has been found on different periphery wall. & 8th floor ceiling. 06/06/2021: There is no remedial action has been taken dampness of the factory building still now. Dampness found in B/floor, G/floor, 8th floor, roof floor and stair areas of every floor. 29.08.2021 Visit observation: There is no remedial action has been taken dampness of the factory building still now. Dampness found in B/floor, G/floor, 8th floor, roof floor and stair areas of every floor. 10/08/2022: Dampness were found during inspection date. 30-01-2023: Dampness were found during inspection date.
