গণপ্রজাতন্ত্রী বাংলাদেশ সরকার  
শ্রম ও কর্মসংস্থান মন্ত্রণালয়  
কলকারখানা ও প্রতিষ্ঠান পরিদর্শন অধিদপ্তর

ক্যাপ পর্যবেক্ষণের তথ্য

কারখানার নাম	কনভিন্স এ্যাপারেলস লিঃ
ঠিকানা	Plot # 68-71, Block-Section # 2, Rupnagar, Mirpur, Dhaka .
কারখানার কোড	DHK136
কালার কোড

মূল্যায়নের ধরণ: <a href="#">কঠামোগত মূল্যায়ন</a>	পর্যবেক্ষণের তারিখ: <a href="#">৩০-০১-২০২৩</a>
১. পর্যবেক্ষণ

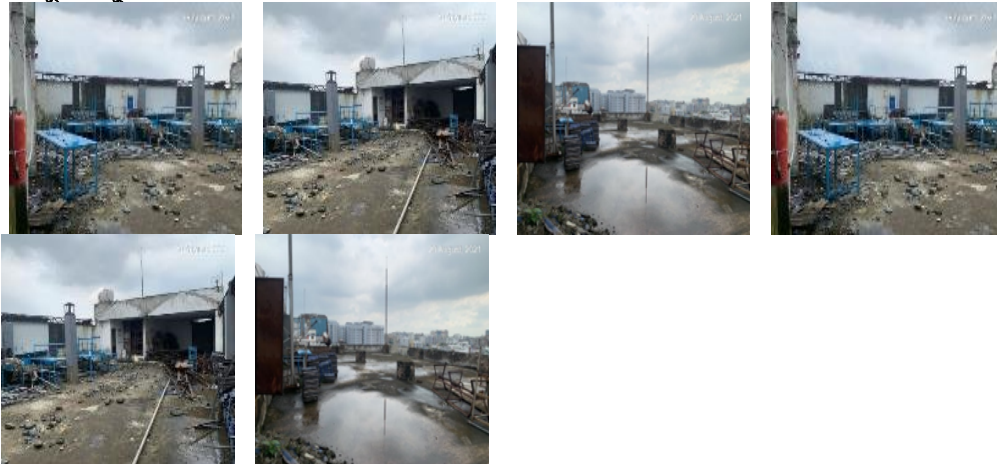
## সংযুক্তিসমূহ (৬)

পরিদর্শন পর্যবেক্ষণ	There is an additional roof truss steel shed on roof which covers 40% of the roof top. No design documents of the shed have been found.
ক্যাপ আইটেম ক্যাটাগরি

কার্যক্রম	Building engineer to check the capacity and stability of the lightweight roofs and make any necessary alterations.
সুপারিশের তথ্যসূত্র	
কারখানার কার্যক্রম	Do
অগ্রাধিকার	প্রয়োজ্য নয়
চূড়ান্ত সময়সীমা	০১-০৯-২০১৬
সংশোধিত সময়সীমা	০১-০১-১৯৭০
অগ্রগতির অবস্থা	সংশোধিত
মন্তব্য	01.10.2020: There is an additional roof truss steel shed on roof but the assigned consultant firm didn't show this structure in architectural drawing. 13.01.2021: No drawing found for roof shed. 06/06/2021: According to the Taskforce review the factory is advised to demolish the shed building of roof. Now the factory has been continuing its demolition work. 29.08.2021: According to the Taskforce review the factory is advised to demolish the shed building of roof. Now the factory has been continuing its demolition work. 10/08/2022: Roof steel shed has found demolish during inspection date. 30-01-2023: Completed.

কার্যক্রম	Carry out upgrade measures required as part of the design checks. Prepare as built structural drawings for additional structure
সুপারিশের তথ্যসূত্র	
কারখানার কার্যক্রম	Do
অগ্রাধিকার	
চূড়ান্ত সময়সীমা	২১-০১-২০১৭
সংশোধিত সময়সীমা	০১-০১-১৯৭০
অগ্রগতির অবস্থা	সংশোধিত
মন্তব্য	01.10.2020 visit observation: No upgrade measure showing the Structural design drawing. 13.01.2021: No structural drawing found for roof shed. 06/06/2021: According to the Taskforce review the factory is advised to demolish the shed building of roof. Now the factory has been continuing its demolition work. 29.08.2021: According to the Taskforce review the factory is advised to demolish the shed building of roof. Now the factory has been continuing its demolition work. 10/08/2022: Roof steel shed has found demolish during inspection date. 30-01-2023: Completed.
