গণপ্রজাতন্ত্রী বাংলাদেশ সরকার  
শ্রম ও কর্মসংস্থান মন্ত্রণালয়  
কলকারখানা ও প্রতিষ্ঠান পরিদর্শন অধিদপ্তর

ক্যাপ পর্যবেক্ষণের তথ্য

কারখানার নাম	টিবিএইচ ক্যাশন টেক্স		
ঠিকানা	Kha-10/A, Bepari Para,		
কারখানার কোড	DHK581		
কালার কোড

মূল্যায়নের ধরণ: বৈদ্যুতিক মূল্যায়ন	পর্যবেক্ষণের তারিখ: ০২-০২-২০২৩
১. পর্যবেক্ষণ

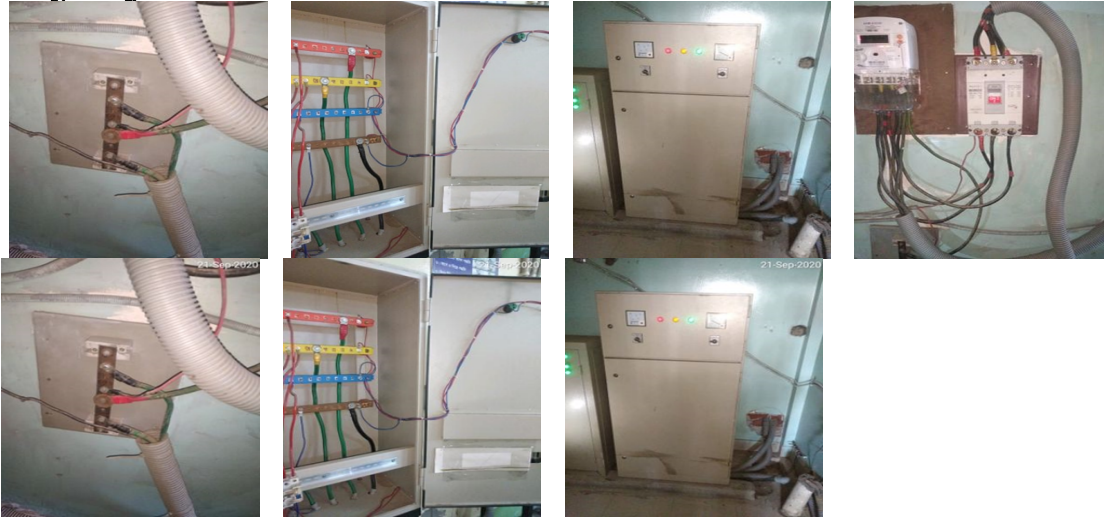
#### সংযুক্তিসমূহ (৭)

কার্যক্রম	CCV Date: 21-09-2020 1. Single earth lead observed at earth bus bar 2. Distribution boards were earthed but door were not grounded. 3. Clear identification mark were not found in some distribution boards for e.g LT Panel. 4. MDB/SDB/SB or MCCB or MCB were installed on a non combustible material 01-09-2021 1. Single earth lead observed at earth bus bar 2. Distribution boards were earthed but door were not grounded. 3. Clear identification mark were not found in some distribution boards for e.g LT Panel. 4. MDB/SDB/SB or MCCB or MCB were installed on a non combustible material
সুপারিশের তথ্যসূত্র	
কার্যখানার কার্যক্রম	6 weeks
অগ্রাধিকার	প্রয়োজ্য নহ
চূড়ান্ত সময়সীমা	০১-০১-১৯৭০
সংশোধিত সময়সীমা	০১-০১-১৯৭০
অগ্রগতির অবস্থা	চলমান
মন্তব্য	21-09-2020: 1. Single earth lead observed at earth bus bar. 2. Distribution boards were earthed but door were not grounded. 3. Clear identification mark were not found in some distribution boards for e.g. LT Panel. 4. MDB/SDB/SB or MCCB or MCB were installed on a non combustible material. 01-09-2021: 1. Single earth lead observed at earth bus bar. 2. Distribution boards were earthed but door were not grounded. 3. Clear identification mark were not found in some distribution boards for e.g. LT Panel. 4. MDB/SDB/SB or MCCB or MCB were installed on a non combustible material. 03-08-2022 visit observation: 1. Single earth lead observed at earth bus bar. 2. Distribution board & door were not earthed. 3. Clear identification mark were not found on distribution board. 4. MDB/SDB/SB or MCCB/MCB were installed on wooden board. 02-02-2023 visit observation: 1. Single earth lead observed at earth bus bar. 2. Distribution board & door were not earthed. 3. Clear identification mark were not found on distribution board. 4. MDB/SDB/SB or MCCB/MCB were installed on wooden board.

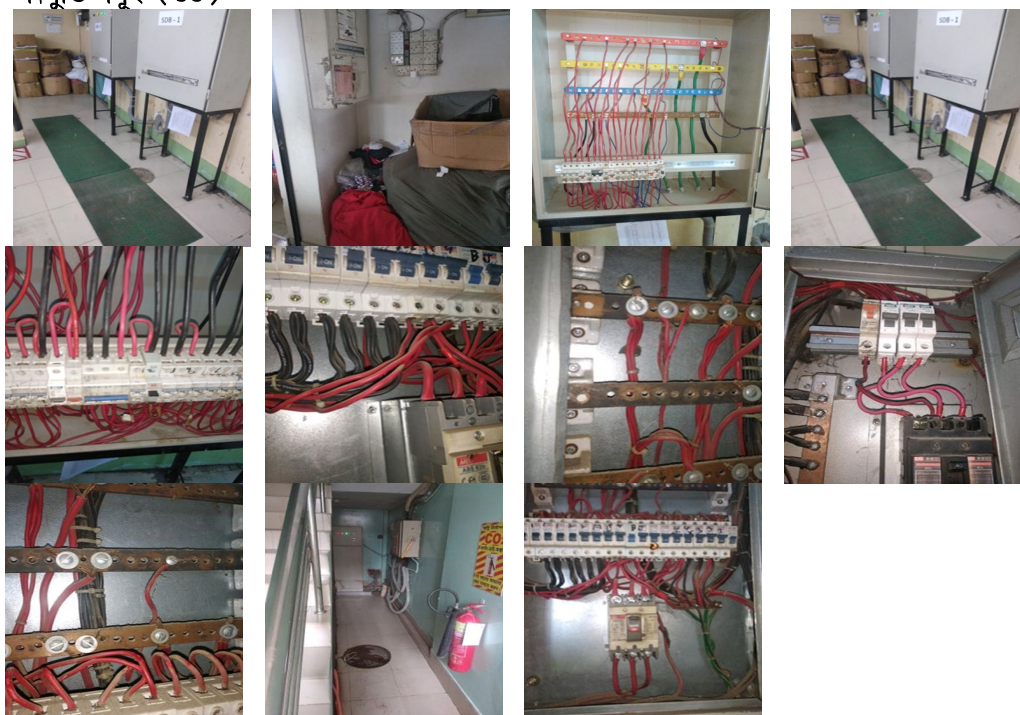
#### সংযুক্তিসমূহ (১১)

কার্যক্রম	CCV Date: 21-09-2020 1. Instruction board for first aid and respiratory system exposure to electrical shock were not provided at required places for e.g near distribution boards and generator room. 2. Obstruction observed in front of the distribution board. 3. Cables were found to be well dressed inside the distribution boards 01-09-2021 1. Instruction board for first aid and respiratory system exposure to electrical shock were not provided at required places for e.g near distribution boards and generator room. 2. Obstruction observed in front of the distribution board. 3. Cables were found to be well dressed inside the distribution boards
সুপারিশের তথ্যসূত্র	
কালখানার কার্যক্রম	On-going
অগ্রাধিকার	প্রয়োজ্য নয়
চূড়ান্ত সময়সীমা	০১-০১-১৯৭০
সংশোধিত সময়সীমা	০১-০১-১৯৭০
অগ্রগতির অবস্থা	চলমান
মন্তব্য	21-09-2020: 1. Instruction board for first aid and respiratory system exposure to electrical shock were not provided at required places for e.g. near distribution boards and generator room. 2. Obstruction observed in front of the distribution board. 3. Cables were found to be well dressed inside the distribution boards. 01-09-2021: 1. Instruction board for first aid and respiratory system exposure to electrical shock were not provided at required places for e.g. near distribution boards and generator room. 2. Obstruction observed in front of the distribution board. 3. Cables were found to be well dressed inside the distribution boards. 03-08-2022 visit observation: 1. No instruction board for first aid to electrical shock respiration found near panel boards. 2. Obstruction were found in front of the distribution board. 3. Undressed messy wire/cable were found inside panel boards. 4. Cable termination without proper cable lugs/sleeve/socket or ferrule were found. 02-02-2023 visit observation: 1. No instruction board for first aid to electrical shock respiration found near panel boards. 2. Obstruction were found in front of the distribution board. 3. Undressed messy wire/cable were found inside panel boards. 4. Cable termination without proper cable lugs/sleeve/socket or ferrule were found.
