গণপ্রজাতন্ত্রী বাংলাদেশ সরকার
শ্রম ও কর্মসংস্থান মন্ত্রণালয়
কলকারখানা ও প্রতিষ্ঠান পরিদর্শন অধিদপ্তর

ক্যাপ পর্যবেক্ষণের তথ্য

কারখানার নাম	টিবিএইচ ক্যাশন টেক্স
ঠিকানা	Kha-10/A, Bepari Para,
কারখানার কোড	DHK581
কালার কোড	
মূল্যায়নের ধরণ: বৈদ্যুতিক মূল্যায়ন	পর্যবেক্ষণের তারিখ: ০২-০২-২০২৩
১. পর্যবেক্ষণ

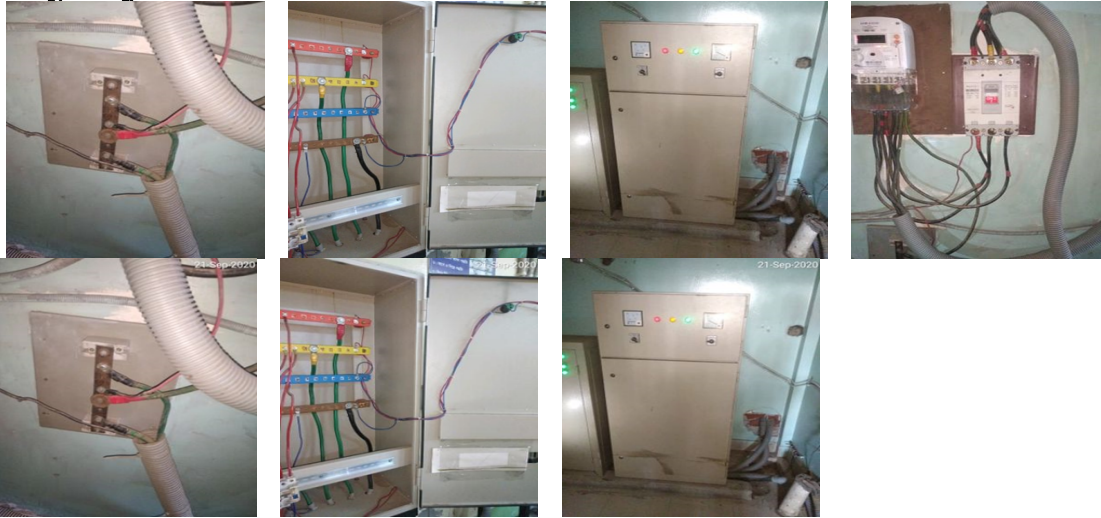
কার্যক্রম	CCV Date: 21-09-2020 1. Single earth lead observed at earth bus bar 2. Distribution boards were earthed but door were not grounded. 3. Clear identification mark were not found in some distribution boards for e.g LT Panel. 4. MDB/SDB/SB or MCCB or MCB were installed on a non combustibile material 01-09-2021 1. Single earth lead observed at earth bus bar 2. Distribution boards were earthed but door were not grounded. 3. Clear identification mark were not found in some distribution boards for e.g LT Panel. 4. MDB/SDB/SB or MCCB or MCB were installed on a non combustibile material
সুপারিশের তথ্যসূত্র	
কারখানার কার্যক্রম	6 weeks
অগ্রাধিকার	প্রশোজা নস
চূড়ান্ত সময়সীমা	০১-০১-১৯৭০
সংশোধিত সময়সীমা	০১-০১-১৯৭০
অগ্রগতির অবস্থা	চলমান
মন্তব্য	21-09-2020: 1. Single earth lead observed at earth bus bar. 2. Distribution boards were earthed but door were not grounded. 3. Clear identification mark were not found in some distribution boards for e.g. LT Panel. 4. MDB/SDB/SB or MCCB or MCB were installed on a non combustibile material. 01-09-2021: 1. Single earth lead observed at earth bus bar. 2. Distribution boards were earthed but door were not grounded. 3. Clear identification mark were not found in some distribution boards for e.g. LT Panel. 4. MDB/SDB/SB or MCCB or MCB were installed on a non combustibile material. 03-08-2022 visit observation: 1. Single earth lead observed at earth bus bar. 2. Distribution board & door were not earthed. 3. Clear identification mark were not found on distribution board. 4. MDB/SDB/SB or MCCB/MCB were installed on wooden board. 02-02-2023 visit observation: 1. Single earth lead observed at earth bus bar. 2. Distribution board & door were not earthed. 3. Clear identification mark were not found on distribution board. 4. MDB/SDB/SB or MCCB/MCB were installed on wooden board.

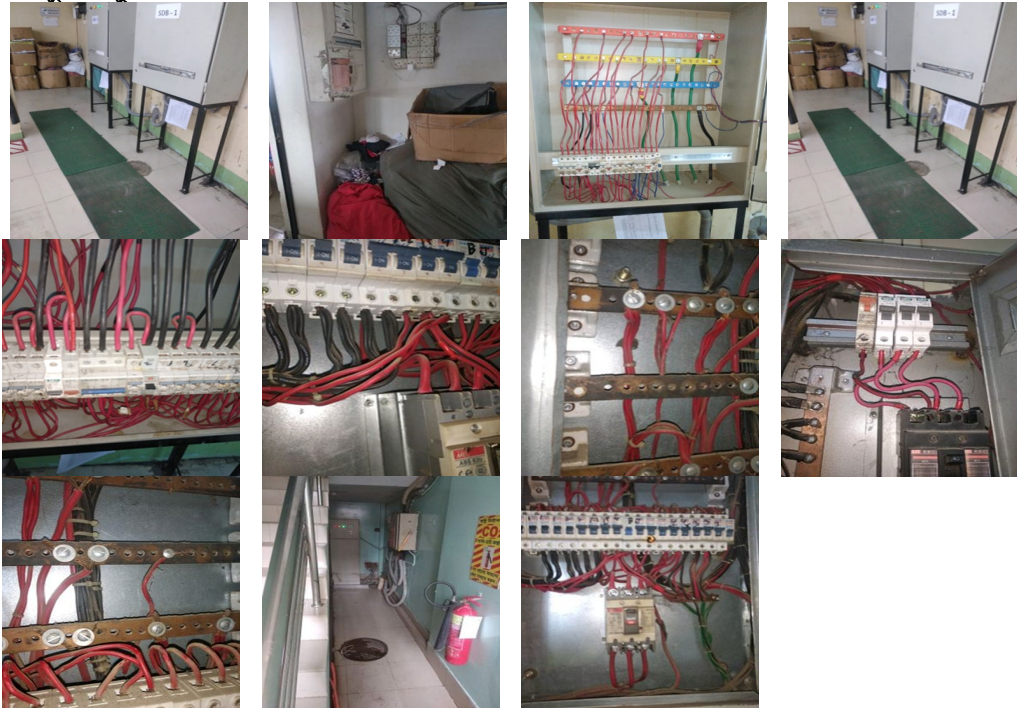
কার্যক্রম	CCV Date: 21-09-2020 1. Instruction board for first aid and respiratory system exposure to electrical shock were not provided at required places for e.g near distribution boards and generator room. 2. Obstruction observed in front of the distribution board. 3. Cables were found to be well dressed inside the distribution boards 01-09-2021 1. Instruction board for first aid and respiratory system exposure to electrical shock were not provided at required places for e.g near distribution boards and generator room. 2. Obstruction observed in front of the distribution board. 3. Cables were found to be well dressed inside the distribution boards
সুপারিশের ভিত্তিসূত্র	
কালখালার কার্যক্রম	On-going
অগ্রাধিকার	প্রায়োজ্য নয়
চূড়ান্ত সময়সীমা	০১-০১-১৯৭০
সংশোধিত সময়সীমা	০১-০১-১৯৭০
অগ্রগতির অবস্থা	চলমান
মন্তব্য	21-09-2020: 1. Instruction board for first aid and respiratory system exposure to electrical shock were not provided at required places for e.g. near distribution boards and generator room. 2. Obstruction observed in front of the distribution board. 3. Cables were found to be well dressed inside the distribution boards. 01-09-2021: 1. Instruction board for first aid and respiratory system exposure to electrical shock were not provided at required places for e.g. near distribution boards and generator room. 2. Obstruction observed in front of the distribution board. 3. Cables were found to be well dressed inside the distribution boards. 03-08-2022 visit observation: 1. No instruction board for first aid to electrical shock respiration found near panel boards. 2. Obstruction were found in front of the distribution board. 3. Undressed messy wire/cable were found inside panel boards. 4. Cable termination without proper cable lugs/sleeve/socket or ferrule were found. 02-02-2023 visit observation: 1. No instruction board for first aid to electrical shock respiration found near panel boards. 2. Obstruction were found in front of the distribution board. 3. Undressed messy wire/cable were found inside panel boards. 4. Cable termination without proper cable lugs/sleeve/socket or ferrule were found.
