গণপ্রজাতন্ত্রী বাংলাদেশ সরকার
শ্রম ও কর্মসংস্থান মন্ত্রণালয়
কলকারখানা ও প্রতিষ্ঠান পরিদর্শন অধিদপ্তর

ক্যাপ পর্যবেক্ষণের তথ্য

কারখানার নাম	আর টেক্স কাশন লিঃ		
ঠিকানা	146, Satarkul Road, North Badda		
কারখানার কোড	DHK476		
কালার কোড

মূল্যায়নের ধরণ: বৈদ্যুতিক মূল্যায়ন	পর্যবেক্ষণের তারিখ: ০৩-০৪-২০২৩
১. পর্যবেক্ষণ

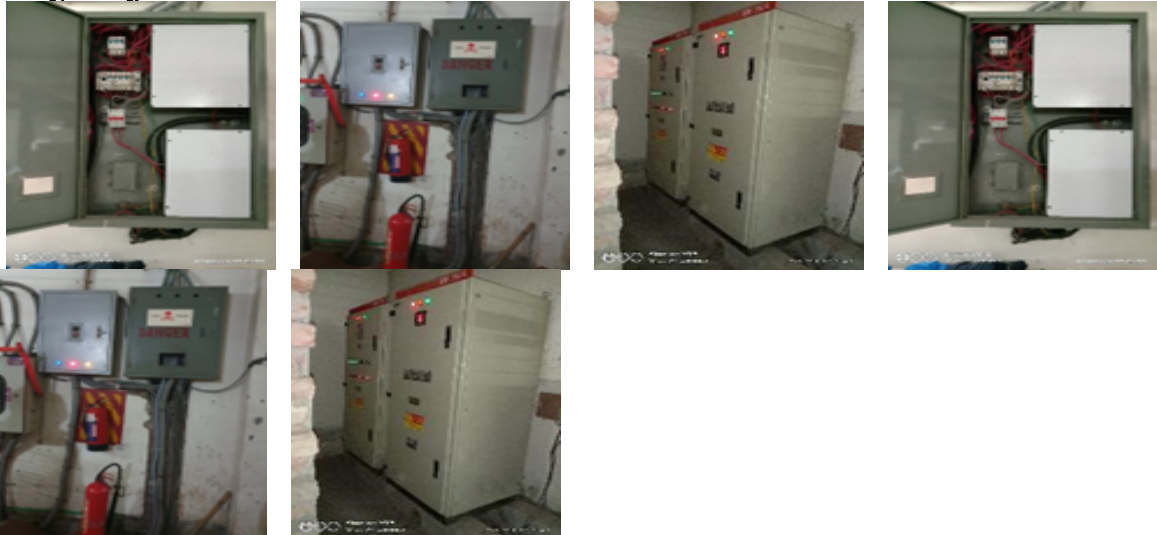
পরিদর্শন পর্যবেক্ষণ	□ No instruction for first aid to electrical shock □ Cable ends not properly soldered or crimped □ Connection without lug □ Undressed messy wire inside □ Body & door not earthed □ No clear identification mark on distribution board □ MDB/SDB/SB or MCB installed on the wooden board
ক্যাপ আইটেম ক্যাটাগরি

কার্যক্রম	□ Provide earthing to body & door. □ Provide clear identification mark on distribution board. □ Install MDB/SDB/SB or MCB on metal board.
সুপারিশের তথ্যসূত্র	
কারখানার কার্যক্রম	
অগ্রাধিকার	৬ সপ্তাহ
চূড়ান্ত সময়সীমা	-
সংশোধিত সময়সীমা	০১-০১-১৯৭০
অগ্রগতির অবস্থা	চলমান
মন্তব্য	19/10/2020: 1. Door earthing was not found in any of the boards. Body earthing was present in some of the boards. 2. Clear identification marks were not provided on any of the boards. 3. Some of the switchboards were installed on wooden boards. All the other boards were installed on metal boards. 04/01/2021: 1. Door earthing was not found in most of the boards. Only one board has door earthing. Body earthing was present in some of the boards. 2. Clear identification marks were not provided on any of the boards. 3. Some of the switchboards were installed on wooden boards. All the other boards were installed on metal boards. 07-09-2021: Door earthing was not found in most of the boards. Only one board has door earthing. Body earthing was present in some of the boards. Clear identification marks were not provided on any of the boards. Some of the switchboards were installed on wooden boards. All the other boards were installed on metal boards. 03-08-2022 visit observation: 1. Panel board & door earthing were not found properly in distribution board. 2. Clear identification marks were not found on distribution board. 3. Some of the switchboards were installed on wooden boards. All the other boards were installed on metal boards. 03.04.2023: 1. Panel board & door earthing were not found properly in distribution board. 2. Clear identification marks were not found on distribution board. 3. Some of the switchboards were installed on wooden boards. All the other boards were installed on metal boards.

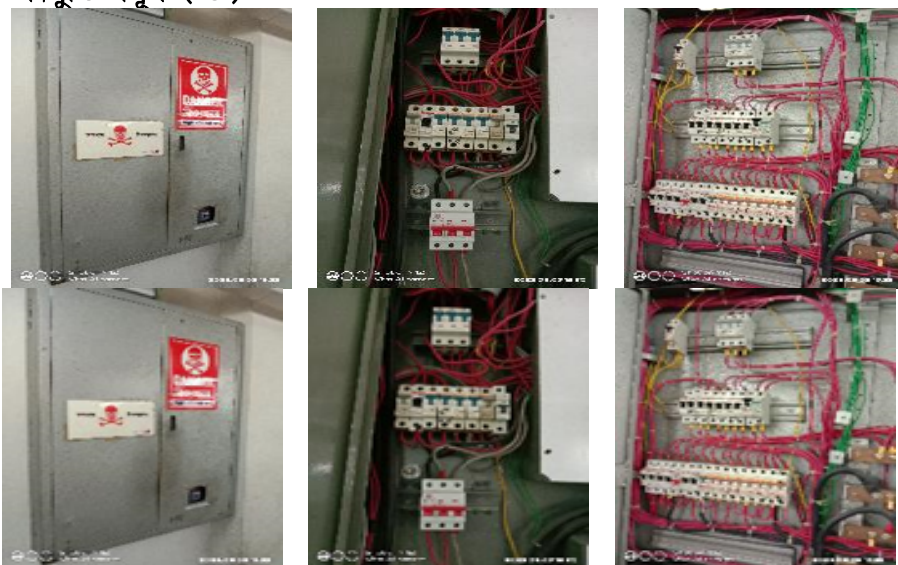
পরিদর্শন পর্যবেক্ষণ	<p>□ No instruction for first aid to electrical shock □ Cable ends not properly soldered or crimped □ Connection without lug □ Undressed messy wire inside □ Body & door not earthed □ No clear identification mark on distribution board □ MDB/SDB/SB or MCB installed on the wooden board</p>
ক্যাপ আইটেম ক্যাটাগরি

কার্যক্রম	<p>□ Provide instructions for first aid from exposure to electrical shock □ Ensure well-dressed cabling with lugs</p>
সুপারিশের তথ্যসূত্র	
কারখানার কার্যক্রম	
অগ্রাধিকার	প্রযোজ্য নয়
চূড়ান্ত সময়সীমা	-
সংশোধিত সময়সীমা	০১-০১-১৯৭০
অগ্রগতির অবস্থা	শুরু হয়নি
মন্তব্য	<p>19/10/2020: 1. Instructions for first aid from exposure to electrical shock were not provided. 2. Cables were not well dressed. Cable looping was present in all the boards. 04/01/2021: 1. Instructions for first aid from exposure to electrical shock were not provided. 2. Cables were not well dressed. Cable looping was present in all the boards. 07-09-2021: Instructions for first aid from exposure to electrical shock were not provided. Cables were not well dressed. Cable looping was present in all the boards. 03-08-2022 visit observation: 1. Instructions for first aid from exposure to electrical shock were not found. 2. Cables were not well dressed. 3. Cable looping were found. 03.04.2023: 1. Instructions for first aid from exposure to electrical shock were not found. 2. Cables were not well dressed. 3. Cable looping were found.</p>
