গণপ্রজাতন্ত্রী বাংলাদেশ সরকার
শ্রম ও কর্মসংস্থান মন্ত্রণালয়
কলকারখানা ও প্রতিষ্ঠান পরিদর্শন অধিদপ্তর

ক্যাপ পর্যবেক্ষণের তথ্য

কারখানার নাম	টপস এন্ড বটম লি.
ঠিকানা	Mill Gate, Tongi, Gazipur
কারখানার কোড	GZP342
কালার কোড	
মূল্যায়নের ধরণ: বৈদ্যুতিক মূল্যায়ন	পর্যবেক্ষণের তারিখ: ২৪-০১-২০২৩
১. পর্যবেক্ষণ

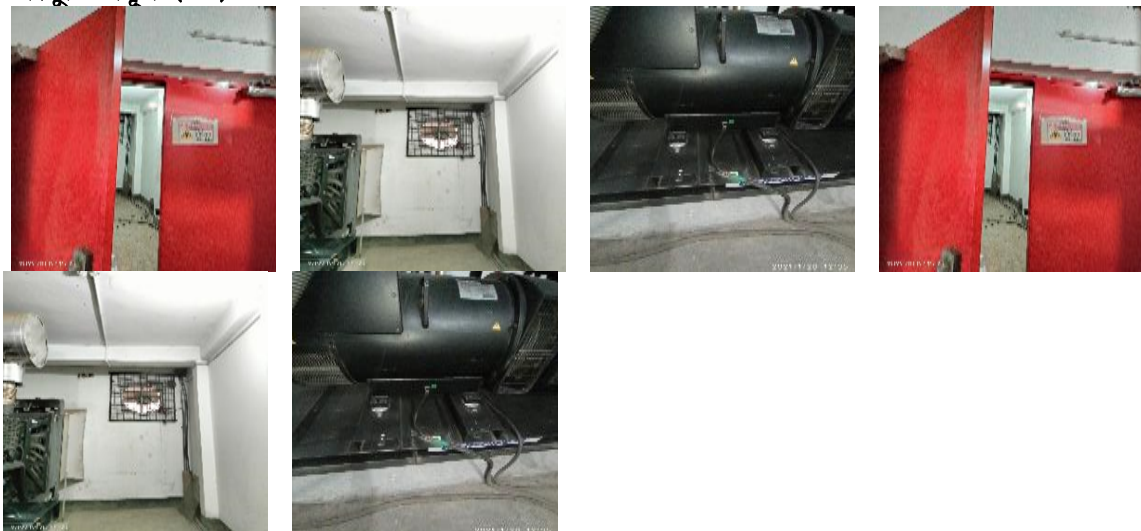
পরিদর্শন পর্যবেক্ষণ	<p>□ The generator room smaller than the required size □ Inadequate ventilation of the generator room □ The generator room is not properly segregated from the rest of the occupancy due to presence of non Fire-rated Door □ No appropriate detector in generator room □ One point frame earthing of generator instead of two</p>
ক্যাপ আইটেম ক্যাটাগরি

কার্যক্রম	<p>□ Produce design drawings to demonstrate the incorporation of fire rated enclosure from floor to ceiling and an approved fire rated self-closing swing door for the Generator room. □ Provide firefighting equipment as required by the Guidelines.</p>
সুপারিশের তথ্যসূত্র	
কারখানার কার্যক্রম	Initiative has not been taken but they have agreed to complete by their consultant
অগ্রাধিকার	৬ সপ্তাহ
চূড়ান্ত সময়সীমা	১০-১১-২০১৬
সংশোধিত সময়সীমা	০১-০১-১৯৭০
অগ্রগতির অবস্থা	সংশোধিত
মন্তব্য	<p>01-10-2020 (CVV-2): Generator room is slightly smaller than the required size but properly segregated by fire door and two point frame earthing found at generator . 28-01-2021 (CVV-3): # The generator room smaller than the required size. # Inadequate ventilation of the generator room and suggested one more ventilator in the generator room. # The generator room is properly segregated from the rest of the occupancy due to presence of non Fire-rated Door. # Appropriate detector was found inside generator room. # Two point frame earthing of generator was observed. 10.06.2021 (CVV 4: Generator room is slightly smaller than the required size but properly segregated by fire door and two point frame earthing found at generator .Appropriate detector was found inside generator room. 18.08.2021 (CVV5): Generator room is slightly smaller than the required size but properly segregated by fire door and two point frame earthing found at generator .Appropriate detector was found inside generator room. 07-08-2022: Generator room is slightly smaller than the required size but properly segregated by fire door and two point frame earthing found at generator . Appropriate detector was found inside generator room. 24-01-2023: Generator room is slightly smaller than the required size but properly segregated by fire door and two point frame earthing found at generator . Appropriate detector was found inside generator room.</p>
