গণপ্রজাতন্ত্রী বাংলাদেশ সরকার
শ্রম ও কর্মসংস্থান মন্ত্রণালয়
কলকারখানা ও প্রতিষ্ঠান পরিদর্শন অধিদপ্তর

ক্যাপ পর্যবেক্ষণের তথ্য

কারখানার নাম	টপস এন্ড বটম লি.
ঠিকানা	Mill Gate, Tongi, Gazipur
কারখানার কোড	GZP342
কালার কোড

মূল্যায়নের ধরন: বৈদ্যুতিক মূল্যায়ন	পর্যবেক্ষণের তারিখ: ২৪-০১-২০২৩
১. পর্যবেক্ষণ

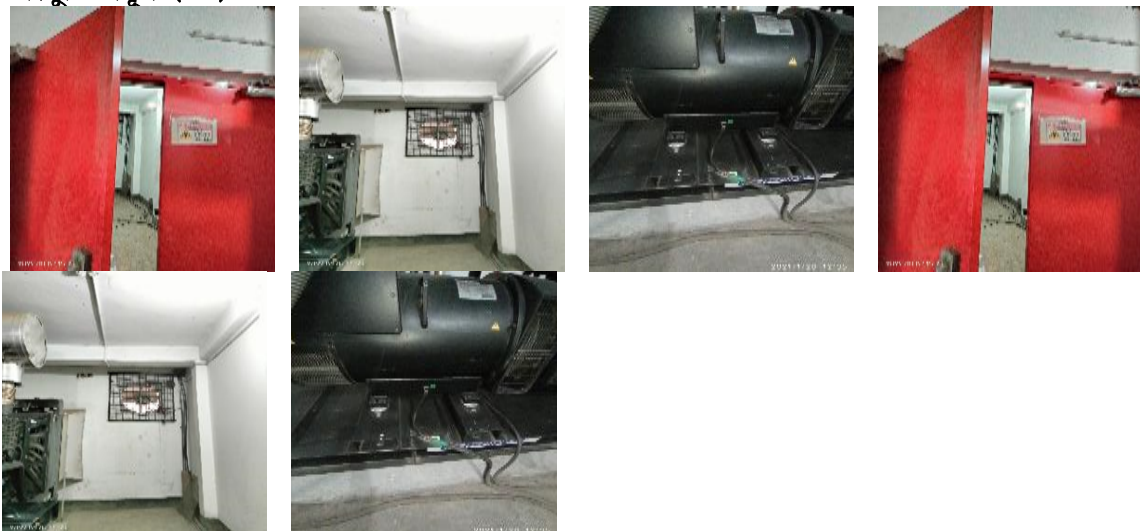
পরিদর্শন পর্যবেক্ষণ	<p>□ The generator room smaller than the required size □ Inadequate ventilation of the generator room □ The generator room is not properly segregated from the rest of the occupancy due to presence of non Fire-rated Door □ No appropriate detector in generator room □ One point frame earthing of generator instead of two</p>
ক্যাপ আইটেম ক্যাটাগরি

কার্যক্রম	<p>□ Produce design drawings to demonstrate the incorporation of fire rated enclosure from floor to ceiling and an approved fire rated self-closing swing door for the Generator room. □ Provide firefighting equipment as required by the Guidelines.</p>
সুপারিশের তথ্যসূত্র	
কারখানার কার্যক্রম	Initiative has not been taken but they have agreed to complete by their consultant
অগ্রাধিকার	৬ সপ্তাহ
চূড়ান্ত সময়সীমা	১০-১১-২০১৬
সংশোধিত সময়সীমা	০১-০১-১৯৭০
অগ্রগতির অবস্থা	সংশোধিত
মন্তব্য	<p>01-10-2020 (CVV-2): Generator room is slightly smaller than the required size but properly segregated by fire door and two point frame earthing found at generator . 28-01-2021 (CVV-3): # The generator room smaller than the required size. # Inadequate ventilation of the generator room and suggested one more ventilator in the generator room. # The generator room is properly segregated from the rest of the occupancy due to presence of non Fire-rated Door. # Appropriate detector was found inside generator room. # Two point frame earthing of generator was observed. 10.06.2021 (CVV 4: Generator room is slightly smaller than the required size but properly segregated by fire door and two point frame earthing found at generator .Appropriate detector was found inside generator room. 18.08.2021 (CVV5): Generator room is slightly smaller than the required size but properly segregated by fire door and two point frame earthing found at generator .Appropriate detector was found inside generator room. 07-08-2022: Generator room is slightly smaller than the required size but properly segregated by fire door and two point frame earthing found at generator . Appropriate detector was found inside generator room. 24-01-2023: Generator room is slightly smaller than the required size but properly segregated by fire door and two point frame earthing found at generator . Appropriate detector was found inside generator room.</p>

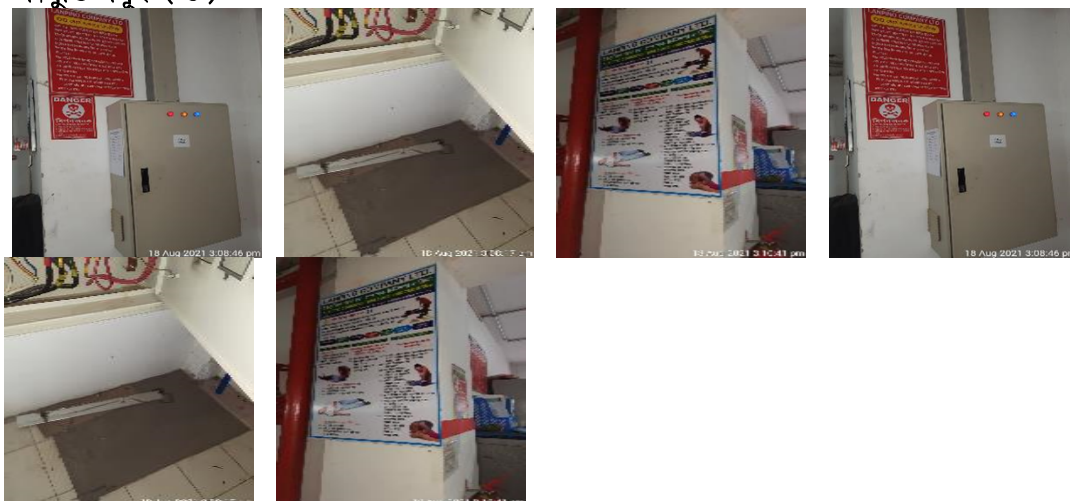
পরিদর্শন পর্যবেক্ষণ	□ No SLD/clear identification mark on distribution panel □ No instruction for first aid to electrical shock and artificial respiration □ No indicating lamps on the panel □ Uncovered cable trench □ Non-conductive mat insufficient □ No earthing at all required electrical points □ No detector in substation * Lint/dirt in substation
ক্যাপ আইটেম ক্যাটাগরি

কার্যক্রম	□ Provide clear identification mark on MDB/DB/SDB and provide SLD □ Install MDB/DB/SDB/SB/MCCB on nonflammable board. □ Provide earthing to body and door of MDB/DB/SDB. □ Provide earth bar and neutral bar in MDB/DB/SDB □ Provide duplicate earth leads for MDB.
সুপারিশের তথ্যসূত্র	
কার্যখানার কার্যক্রম	Initiative has been taken and work is ongoing.
অগ্রাধিকার	প্রয়োজ্য নয়
চূড়ান্ত সময়সীমা	১০-১১-২০১৬
সংশোধিত সময়সীমা	-
অগ্রগতির অবস্থা	সংশোধিত
মন্তব্য	01-10-2020 (CVV-2): □ No SLD/clear identification mark on distribution panel. □ Instruction for first aid to electrical shock and artificial respiration is available. □ Found indicating lamps on the panel. □ Found some Uncovered cable trench. □ Rubber matt is there under each panel. □ Earthing are required at all electrical points. 28-01-2021 (CVV-3): # No SLD/clear identification mark on distribution panel. # No instruction for first aid to electrical shock and artificial respiration was found. # Indicating lamps were found on the panel. # Maximum was covered cable trench few of them were uncovered. # Non-conductive mat and was sufficient. # No earthing at all required electrical points. # Detector was found inside substation. # Lint/dirt was not observed in substation. 10.06.2021 (CVV4): □ No SLD/clear identification mark on distribution panel. □ Instruction for first aid to electrical shock and artificial respiration is available. □ Found indicating lamps on the panel. □ Found some Uncovered cable trench. □ Rubber matt is there under each panel. □ Earthing are required at all electrical points. 18.08.2021 CVV5: □ No SLD/clear identification mark on distribution panel. □ Instruction for first aid to electrical shock and artificial respiration is available. □ Found indicating lamps on the panel. □ Found some Uncovered cable trench. □ Rubber matt is there under each panel. □ Earthlings are required at all electrical points. 07-08-2022: □ No SLD/clear identification mark on distribution panel. □ instruction for first aid to electrical shock and artificial respiration is available. □ Found indicating lamps on the panel. □ Rubber matt is there under each panel. 24-01-2023: □ No SLD/clear identification mark on distribution panel. □ instruction for first aid to electrical shock and artificial respiration is available. □ Found indicating lamps on the panel. □ Rubber matt is there under each panel.
