গণপ্রজাতন্ত্রী বাংলাদেশ সরকার  
শ্রম ও কর্মসংস্থান মন্ত্রণালয়  
কলকারখানা ও প্রতিষ্ঠান পরিদর্শন অধিদপ্তর

ক্যাপ পর্যবেক্ষণের তথ্য

| কারখানার নাম | স্কাইলার্ক নীট কম্পোজিট লি: |
| মূল্যায়নের ধরন: <b>বৈদ্যুতিক মূল্যায়ন</b> | পর্যবেক্ষণের তারিখ: <b>০৯-০৪-২০২৩</b> |

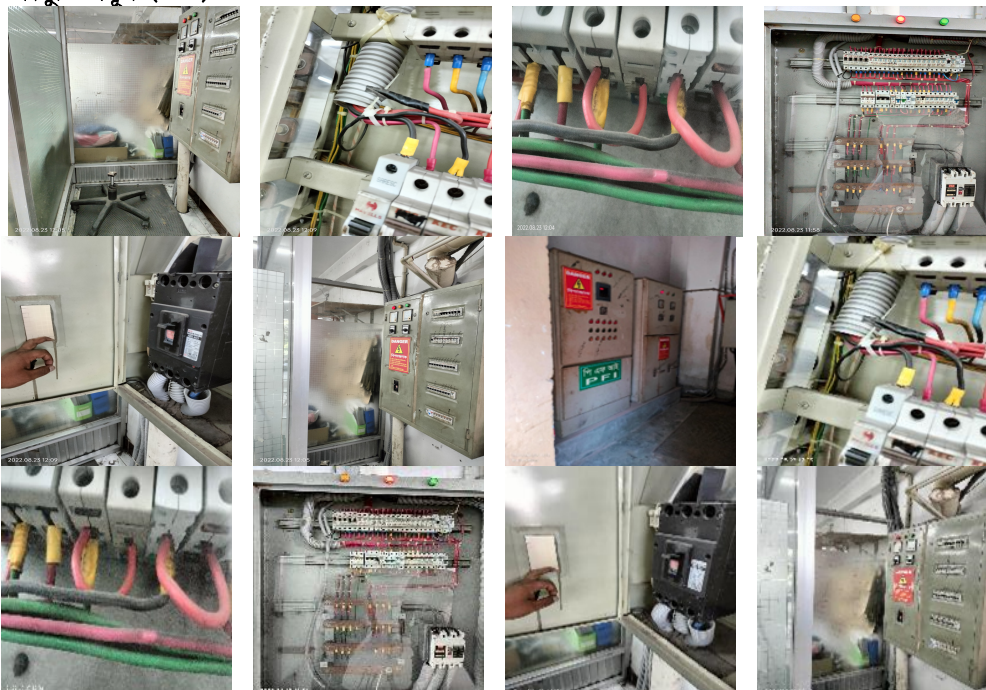
### সংযুক্তিসমূহ (১২)

| পরিদর্শন<br>পর্যবেক্ষণ | Access obstructed/barred Cable ends not properly soldered or crimped Connection without lug Undressed messy wire inside Body & door not earthed No instruction for first aid to electrical shock No clear identification mark on distribution board |

| মন্তব্য | 05-05-2021 (CVV) : Electrical single line diagram and layout drawings are not available at site. But the factory has submitted the as built and proposed SLD to DIFE for approval. 1. No instruction board for first aid to electrical shock in front of DB. 2. Proper size lugs are not present in DB. 3. Undressed messy wires are not present in DB. 4. Body & Door of DB is not properly earthed. Total system earthing is not properly done as per NTPA. Need to submit earthing system design for review. 5. No identification marking on DB. 6. MDB/DB/SDB cable ends properly sealed. 31-08-2021 : Electrical single line diagram and layout drawings are not available at site. But the factory has submitted the as built and proposed SLD to DIFE for approval. 1. No instruction board for first aid to electrical shock in front of DB. 2. Proper size lugs are not present in DB. 3. Undressed messy wires are not present in DB. 4. Body & Door of DB is not properly earthed. Total system earthing is not properly done as per NTPA. Need to submit earthing system design for review. 5. No identification marking on DB. 6. MDB/DB/SDB cable ends properly sealed. 23-08-2022 : 1. Access obstructed/barred 2. Cable ends not properly soldered or crimped 3. Connection without lugs 4. Undressed messy wire are not found in DB. 5. Body & door not earthed 6. No instruction for first aid to electrical shock 7. No clear identification mark on distribution board 09-04-2023: 1. Access obstructed/barred was not found. 2. Cable ends not properly soldered or crimped. 3. Connection without lugs was found. 4. Undressed messy wire were not found in DB. 5. Body & door was not earthed. 6. No instruction for first aid to electrical shock was found as required places. 7. No clear identification mark on distribution board. |

| কার্যক্রম | Repair broken/loose MCCB/MCB box. Provide duplicate earth leads. Provide earthing to body & door. Provide earth bar/neutral bar Identify cause of burning inside distribution box and take remedial measures Provide clear identification mark on distribution board. Install MDB/SDB/SB or MCB on metal board. |
| কার্যখালার<br>কার্যক্রম | Initiative has been taken for clear identification mark on distribution board & committed to complete within timeline. Rest of the non-conformities has been resolved. |

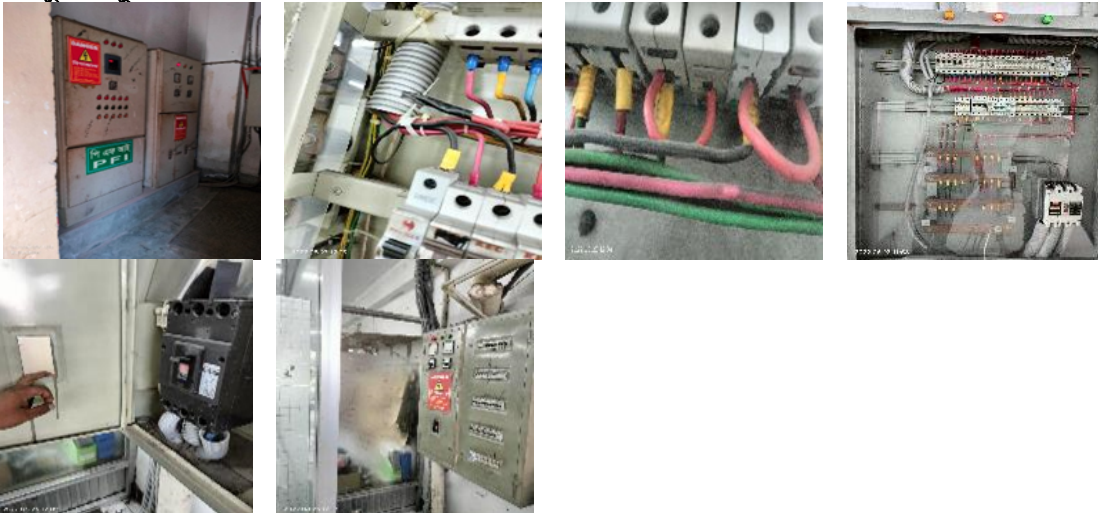
### সংযুক্তিসমূহ (৬)

| পরিদর্শন<br>পর্যবেক্ষণ | Access obstructed/barred Cable ends not properly soldered or crimped Connection without lug Undressed messy wire inside Body & door not earthed No instruction for first aid to electrical shock No clear identification mark on distribution board |

| মন্তব্য | 05-05-2021 (CVV) : Electrical single line diagram and layout drawings are not available at site. But the factory has submitted the as built and proposed SLD to DIFE for approval. 1. No instruction board for first aid to electrical shock in front of DB. 2. Proper size lugs are not present in DB. 3. Undressed messy wires are not present in DB. 4. Body & Door of DB is not properly earthed. Total system earthing is not properly done as per NTPA. Need to submit earthing system design for review. 5. No identification marking on DB. 6. MDB/DB/SDB cable ends properly sealed. 31-08-2021 : Electrical single line diagram and layout drawings are not available at site. But the factory has submitted the as built and proposed SLD to DIFE for approval. 1. No instruction board for first aid to electrical shock in front of DB. 2. Proper size lugs are not present in DB. 3. Undressed messy wires are not present in DB. 4. Body & Door of DB is not properly earthed. Total system earthing is not properly done as per NTPA. Need to submit earthing system design for review. 5. No identification marking on DB. 6. MDB/DB/SDB cable ends properly sealed. 23-08-2022 : 1. Access obstructed/barred. 2. Cable ends not properly soldered or crimped. 3. Connection without lug. 4. Undressed messy wire are not found in DB. 5. Body & door not earthed. 6. No instruction for first aid to electrical shock. 7. No clear identification mark on distribution board. 09-04-2023: 1. Access obstructed/barred was not found. 2. Cable ends not properly soldered or crimped. 3. Connection without lugs was found. 4. Undressed messy wire were not found in DB. 5. Body & door was not earthed. 6. No instruction for first aid to electrical shock was found as required places. 7. No clear identification mark on distribution board. |

| কার্যক্রম | Provide instructions for first aid from exposure to electrical shock Remove obstruction to ensure access to MDB/MCB Box Ensure well-dressed cabling with lugs Encase live machine and/or equipment parts |
| কারখানার<br>কার্যক্রম | Initiative has been taken & agreed to complete within timeline. |

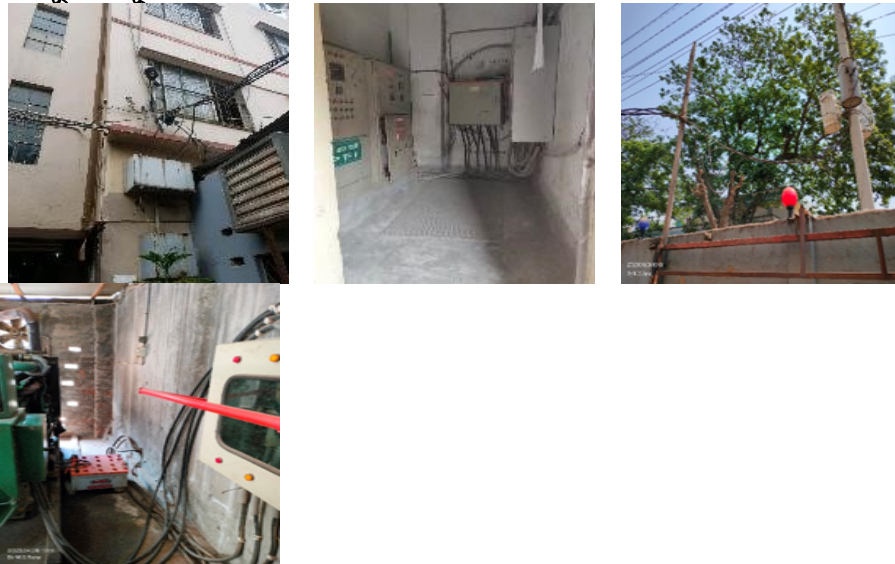
#### সংযুক্তিসমূহ ( ৪ )

| পরিদর্শন<br>পর্যবেক্ষণ | Electric cables do not pass through service shaft or insulated conduits Undressed messy wiring/cables |

| মন্তব্য | 05-05-2021 (CVV): 1. Electric cables do not pass through service shaft or insulated conduits. 2. Proper size lugs are not present in DB. 31-08-2021: 1. Electric cables do not pass through service shaft or insulated conduits. 2. Proper size lugs are not present in DB. 23-08-2022 : 1. Electric cables do not pass through service shaft or insulated conduits. 2. Undressed messy wiring/cables found. 09-04-2023: 1. Electric cables do not pass through service shaft or insulated conduits. 2. Undressed messy wiring/cables was found. |

| কার্যক্রম | Provide service ducts or insulated conduits Ensure secured connections with lug Replace undressed messy wiring/cables Properly solder cable ends |
| কারখানার<br>কার্যক্রম | Initiative has been taken & agreed to complete within timeline. |
