গণপ্রজাতন্ত্রী বাংলাদেশ সরকার
শ্রম ও কর্মসংস্থান মন্ত্রণালয়
কলকারখানা ও প্রতিষ্ঠান পরিদর্শন অধিদপ্তর

ক্যাপ পর্যবেক্ষণের তথ্য

কারখানার নাম	এস আর বি ক্যাশনস লিঃ
ঠিকানা	13448, Satarkul Bazar,
কারখানার কোড	DHK562
কালার কোড	
মূল্যায়নের ধরণ: বৈদ্যুতিক মূল্যায়ন	পর্যবেক্ষণের তারিখ: ২৩-০১-২০২৩
১. পর্যবেক্ষণ

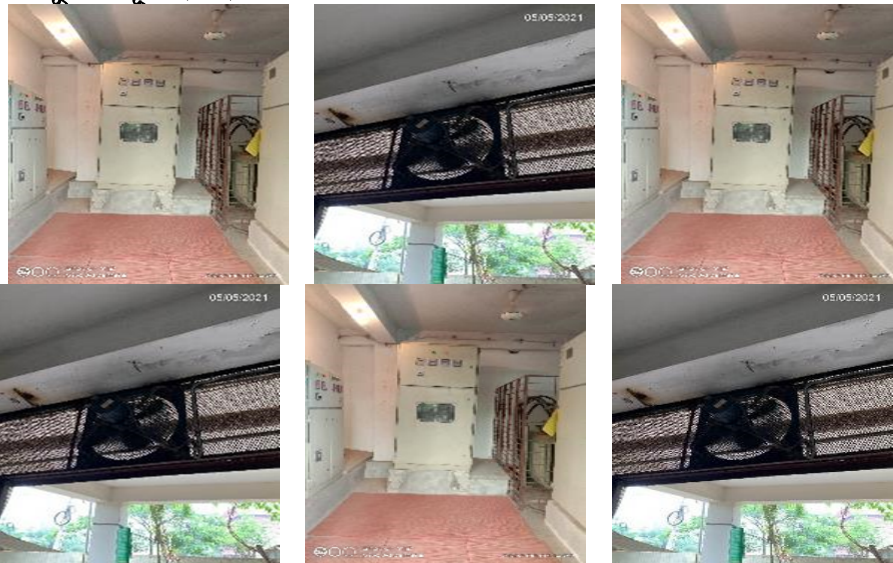
পরিদর্শন পর্যবেক্ষণ	No instruction for first aid to electrical shock Access obstructed/barred No clear identification mark on distribution board
কাপ আইটেম ক্যাটাগরি

কার্যক্রম	Provide clear identification mark on distribution board.
সুপারিশের তথ্যসূত্র	
কারখানার কার্যক্রম	2016-07-11 00:00:00
অগ্রাধিকার	প্রযোজ্য নয়
চূড়ান্ত সময়সীমা	১৫-০৮-২০২২
সংশোধিত সময়সীমা	১৫-০৮-২০২২
অগ্রগতির অবস্থা	চলমান
মন্তব্য	20-09-2020: Found clear identification mark on distribution board. 10-12-2020: Found clear identification mark on distribution board. 03-03-2021: Found clear identification mark on distribution board. 05-05-2021: Clear identification mark for some distribution boards were missing. 03-08-2022 visit observation: Clear identification mark for some distribution boards were found missing. 23-01-2023 visit observation: Clear identification mark for some distribution boards were found missing.

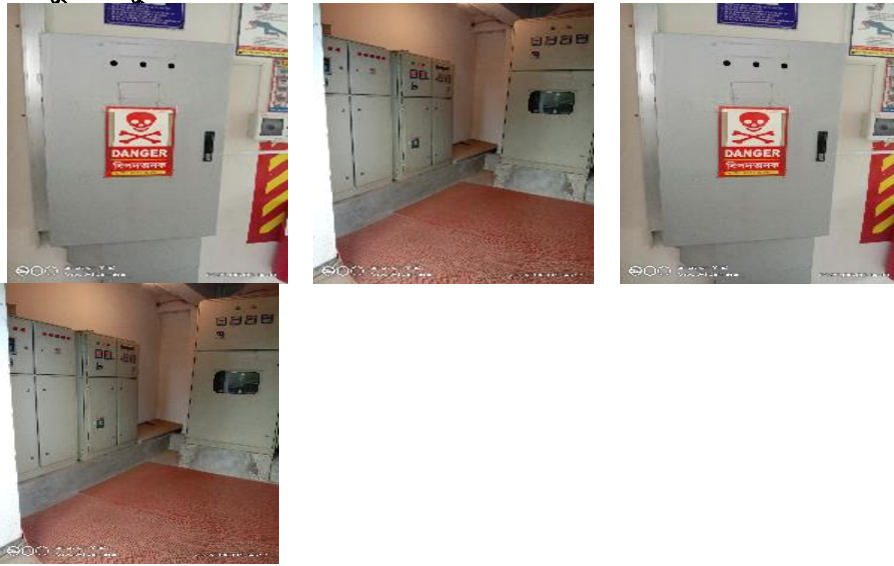
৫. পর্যবেক্ষণ

পরিদর্শন পর্যবেক্ষণ	☐ No instruction for first aid to electrical shock ☐ Access obstructed/barred ☐ No clear identification mark on distribution board
কাপ আইটেম ক্যাটাগরি

কার্যক্রম	☐ Provide instructions for first aid from exposure to electrical shock ☐ Remove obstruction to ensure access to MDB/MCB Box.
সুপারিশের তথ্যসূত্র	
কারখানার কার্যক্রম	2016-03-10 00:00:00
অগ্রাধিকার	প্রযোজ্য নয়
চূড়ান্ত সময়সীমা	০১-০১-১৯৭০
সংশোধিত সময়সীমা	০১-০১-১৯৭০
অগ্রগতির অবস্থা	চলমান
মন্তব্য	20-09-2020: Removed all obstruction to ensure access to MDB/MCB Box. 10-12-2020: Removed all obstruction to ensure access to MDB/MCB Box. 03-03-2021: Removed all obstruction to ensure access to MDB/MCB Box. 05-05-2021: 1. Instruction boards were found beside distribution boards but was missing in the substation room and generator room. 2. Distribution boards/MCC/MCB box were found to be accessible. 03-08-2022 visit observation: 1. Instruction for first aid to electrical shock were found missing some distribution board. 2. Some distribution boards were found obstructed & inaccessible. 23-01-2023 visit observation: 1. Instruction for first aid to electrical shock were found missing some distribution board. 2. Some distribution boards were found obstructed & inaccessible.

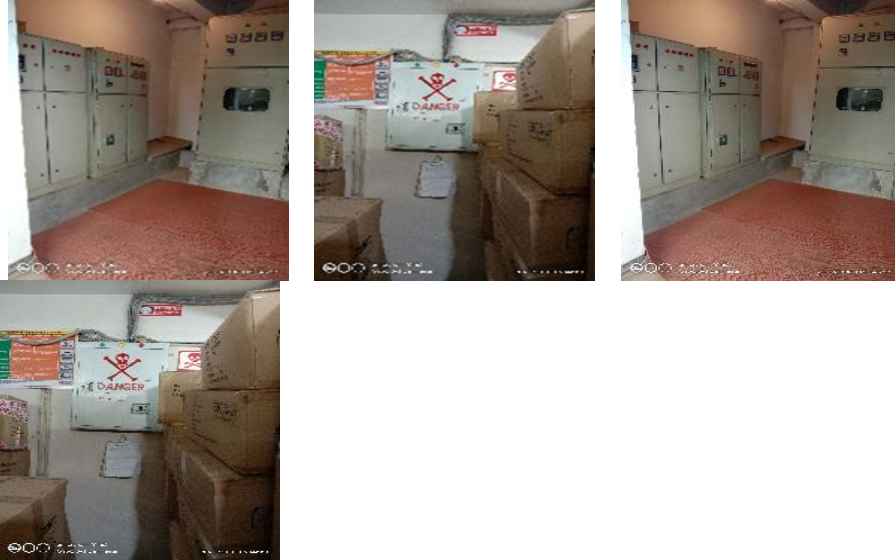
৬. পর্যবেক্ষণ

পরিদর্শন পর্যবেক্ষণ	□ Electric cables do not pass through service shaft or insulated conduits
কাপ আইটেম ক্যাটাগরি

কার্যক্রম	□ Provide service ducts or insulated conduits
সুপারিশের তথ্যসূত্র	
কারখানার কার্যক্রম	2016-07-11 00:00:00
অগ্রাধিকার	প্রযোজ্য নয়
চূড়ান্ত সময়সীমা	১৫-০৮-২০২২
সংশোধিত সময়সীমা	১৫-০৮-২০২২
অগ্রগতির অবস্থা	সংশোধিত
মন্তব্য	20-09-2020: Service ducts and insulated conduits found. 10-12-2020: Service ducts and insulated conduits found. 03-03-2021: Service ducts and insulated conduits found. 05-05-2021: Electric cables passes through insulated conduit. 03-08-2022 visit observation: Electric cables passes through service shaft or insulated conduit were found. 23-01-2023 visit observation: Electric cables passes through service shaft or insulated conduit were found.
