গণপ্রজাতন্ত্রী বাংলাদেশ সরকার
শ্রম ও কর্মসংস্থান মন্ত্রণালয়
কলকারখানা ও প্রতিষ্ঠান পরিদর্শন অধিদপ্তর

ক্যাপ পর্যবেক্ষণের তথ্য

কারখানার নাম	টিএমআর এ্যাপারেলস লি:
ঠিকানা	House-42, Road-2, Block-E, Ward-6, Turag, Dhaka
কারখানার কোড	DHK608
কালার কোড	
মূল্যায়নের ধরণ: কাঠামোগত মূল্যায়ন	পর্যবেক্ষণের তারিখ: ০২-০৪-২০২৩
১. পর্যবেক্ষণ

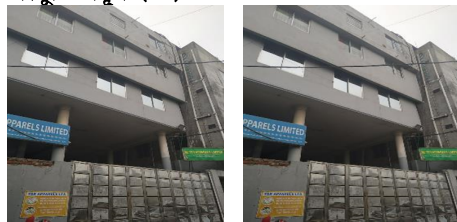
পরিদর্শন পর্বেবেক্ষণ	According to structural drawing, all floors have been shown in same level. However, in existing condition floor level are not same, West portions of the building are about 20-25 above the East portion level.
ক্যাপ আইটেম কাটাগরি

কার্যক্রম	Update calculations showing the structural adequacy of the building structure taking into account the factory design imposed loading and the as built structure.
সুপারিশের তথ্যসূত্র	
কারখানার কার্যক্রম	Structural adequacy of the building will be checked by the Engineer.
অগ্রাধিকার	প্রমোদ্য নয়
চূড়ান্ত সমসীমা	২৭-০৩-২০১৭
সংশোধিত সমসীমা	০১-০১-১৯৭০
অগ্রগতির অবস্থা	চলমান
মন্তব্য	24.09.2018: This issue will be covered in DEA which is submitted to DIFE which is pending. Factory has submitted as built architectural drawing, as built structural drawing and floor load plan. 05.11.2018: In task force meeting they got review and ask to re submit structural analysis and vetted load plan. 04.02.2019: Consulting firm have submitted as built architectural drawing, as built structural drawing, retrofit structural drawing vetted floor load plan to DIFE dated on 06.01.19. 24.09.2020: Task force meeting held on 16.04.2019 consulting firm review correction design and drawing has not submitted yet. 28.01.21 Visit observation: The consultant firm of this factory is EQMS. The firm did not submitted the correction design drawing after 16.04.19. 03.06.2021 visit observation: Consulting firm review correction design and drawing has not submitted yet. 22/08/2022: DEA report should be prepared and resubmitted to DIFE as soon as possible. 02/4/2023: Factory have lost track of their DEA work. they are preparing to restart the DEA work. Verbally they have stated that they are willing to do the DEA work as soon as possible.
