গণপ্রজাতন্ত্রী বাংলাদেশ সরকার
শ্রম ও কর্মসংস্থান মন্ত্রণালয়
কলকারখানা ও প্রতিষ্ঠান পরিদর্শন অধিদপ্তর

ক্যাপ পর্যবেক্ষণের তথ্য

কারখানার নাম	টিএমআর এ্যাপারেলস লি:
ঠিকানা	House-42, Road-2, Block-E, Ward-6, Turag, Dhaka
কারখানার কোড	DHK608
কালার কোড	
মূল্যায়নের ধরণ: কাঠামোগত মূল্যায়ন	পর্যবেক্ষণের তারিখ: ০২-০৪-২০২৩
১. পর্যবেক্ষণ

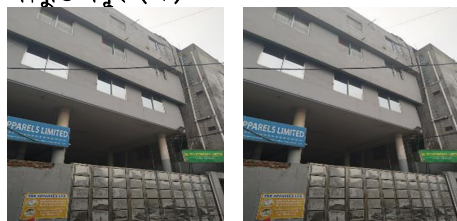
সংযুক্তিসমূহ (২)

পরিদর্শন পরিবেক্ষণ	According to structural drawing, all floors have been shown in same level. However, in existing condition floor level are not same, West portions of the building are about 2"-2" above the East portion level.
ক্যাপ আইটেম কাটাগরি

কার্যক্রম	Update calculations showing the structural adequacy of the building structure taking into account the factory design imposed loading and the as built structure.
সুপারিশের তথ্যসূত্র	
কারখানার কার্যক্রম	Structural adequacy of the building will be checked by the Engineer.
অগ্রাধিকার	প্রশোচ্য নয়
চূড়ান্ত সমসীমা	২৭-০৩-২০১৭
সংশোধিত সমসীমা	০১-০১-১৯৭০
অগ্রগতির অবস্থা	চলমান
মন্তব্য	24.09.2018: This issue will be covered in DEA which is submitted to DIFE which is pending. Factory has submitted as built architectural drawing, as built structural drawing and floor load plan. 05.11.2018: In task force meeting they got review and ask to re submit structural analysis and vetted load plan. 04.02.2019: Consulting firm have submitted as built architectural drawing, as built structural drawing, retrofit structural drawing vetted floor load plan to DIFE dated on 06.01.19. 24.09.2020: Task force meeting held on 16.04.2019 consulting firm review correction design and drawing has not submitted yet. 28.01.21 Visit observation: The consultant firm of this factory is EQMS. The firm did not submitted the correction design drawing after 16.04.19. 03.06.2021 visit observation: Consulting firm review correction design and drawing has not submitted yet. 22/08/2022: DEA report should be prepared and resubmitted to DIFE as soon as possible. 02/4/2023: Factory have lost track of their DEA work. they are preparing to restart the DEA work. Verbally they have stated that they are willing to do the DEA work as soon as possible.
