গণপ্রজাতন্ত্রী বাংলাদেশ সরকার
শ্রম ও কর্মসংস্থান মন্ত্রণালয়
কলকারখানা ও প্রতিষ্ঠান পরিদর্শন অধিদপ্তর

ক্যাপ পর্যবেক্ষণের তথ্য

কারখানার নাম	টিএসআর এ্যাপারেলস লি:
ঠিকানা	House-42, Road-2, Block-E, Ward-6, Turag, Dhaka
কারখানার কোড	DHK608
কালার কোড

মূল্যায়নের ধরণ: কঠামোগত মূল্যায়ন	পর্যবেক্ষণের তারিখ: ০২-০৪-২০২৩
১. পর্যবেক্ষণ

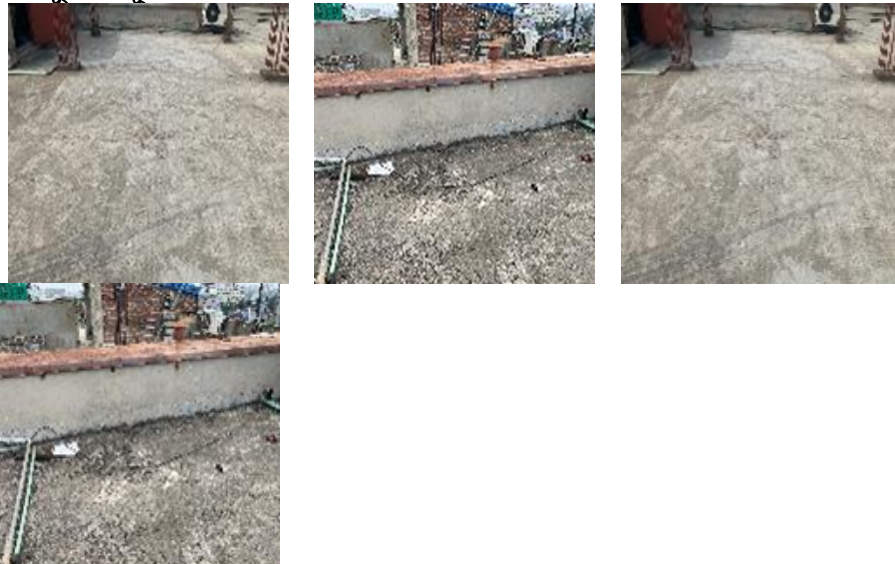
সংযুক্তিসমূহ (৪)

পরিদর্শন পর্যবেক্ষণ	Water ponding has been found in the roof top due to lack of proper drainage and slope in the roof. The source of water is due to rainfall.
ক্যাপ আইটেম ক্যাটাগরি

কার্যক্রম	Proper slope should be maintained on the roof top. Also engineer to inspect whether waterproofing material is applied or where it can be maintained. For both durability and serviceability, waterproofing on the roof slab is recommended.
সুপারিশের তথ্যসূত্র	
কারখানার কার্যক্রম	
অগ্রাধিকার	প্রযোজ্য নয়
চূড়ান্ত সময়সীমা	-
সংশোধিত সময়সীমা	০১-০১-১৯৭০
অগ্রগতির অবস্থা	সংশোধিত
মন্তব্য	24.09.2020: In roof top has proper drainage system. There is no water ponding. 28.01.21 Visit observation: Water ponding has not been found on visit date. The factory management repairs this issue. 03.06.2021 visit observation: No water ponding found in visit day, there has proper drainage system. 22/08/2022: No Water ponding was found on roof top and found proper drainage and slope on roof during inspection date. 02-04-2023: Completed.
