গণপ্রজাতন্ত্রী বাংলাদেশ সরকার  
শ্রম ও কর্মসংস্থান মন্ত্রণালয়  
কলকারখানা ও প্রতিষ্ঠান পরিদর্শন অধিদপ্তর

ক্যাপ পর্যবেক্ষণের তথ্য

কারখানার নাম	ক্যাপিটাল ক্যাশনস লিঃ
ঠিকানা	Dilan Complex ( Building-02 ), Dhaka Road, Chandona Chawrasta, Gazipur-1702.
কারখানার কোড	GZP063
কালার কোড	
মূল্যায়নের ধরণ: <a href="#">কাঠামোগত মূল্যায়ন</a>	পর্যবেক্ষণের তারিখ: ১৬-০২-২০২৩
১. পর্যবেক্ষণ

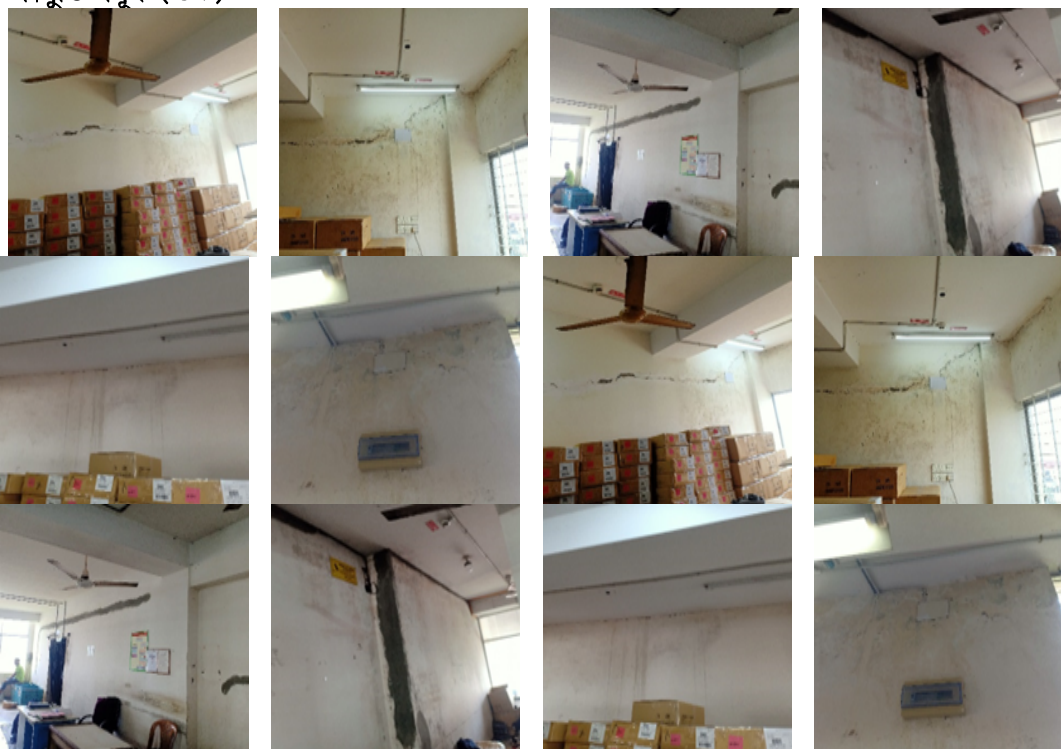
পরিদর্শন পর্যবেক্ষণ	Cracks and dampness
কাপ আইটেম ক্যাটাগরি

কার্যক্রম	Carry out repairing and remedial actions as directed by the Building Engineer for these cracks and dampness.
সুপারিশের তথ্যসূত্র	
কারখানার কার্যক্রম	Factory has remediated all cracks and dampness observed during the assessment.
অগ্রাধিকার	৬ মাস
চূড়ান্ত সময়সীমা	-
সংশোধিত সময়সীমা	০১-০১-১৯৭০
অগ্রগতির অবস্থা	চলমান
মন্তব্য	Capital Designs Ltd. has been replaced by Capital Fashions Ltd. Cracks have been found on masonry wall at different floor and in GF toilet zone. Some repairing works were found abruptly but crack investigation report was not available at site. Also, dampness was found on masonry wall at different floor. Water ponding was observed on roof top. 4th January 2021: Some non structural crack found on some partition wall at the time of inspection. Some repairing works were found abruptly but crack investigation report was not available at site. Dampness was found on masonry wall at different floor. Water ponding was observed on roof top. 13.04.2021: No major cracks were found only some hairline masonry cracks on the walls and dampness were seen on several places like the women's toilet on 2nd floor and men's toilet on 2nd floor. 19th August 2021: No major cracks found in primary structural elements. Dampness found in several places. 3rd August 2022: During visit date non structural wall crack found on the building. some cracks they are remediated & some cracks remediation is on going. Dampness found some position of the building. 16-02-2023: During visit date non structural wall crack found on the building. some cracks they are remediated & some cracks remediation is on going. Dampness found some position of the building.
