গণপ্রজাতন্ত্রী বাংলাদেশ সরকার
শ্রম ও কর্মসংস্থান মন্ত্রণালয়
কলকারখানা ও প্রতিষ্ঠান পরিদর্শন অধিদপ্তর

ক্যাপ পর্যবেক্ষণের তথ্য

কারখানার নাম	ক্যাপিটাল ক্যাশনস লিঃ		
ঠিকানা	Dilan Complex (Building-02), Dhaka Road, Chandona Chawrasta, Gazipur-1702.		
কারখানার কোড	GZP063		
কালার কোড			
মূল্যায়নের ধরণ: কঠামোগত মূল্যায়ন		পর্যবেক্ষণের তারিখ: ১৬-০২-২০২৩	
১. পর্যবেক্ষণ

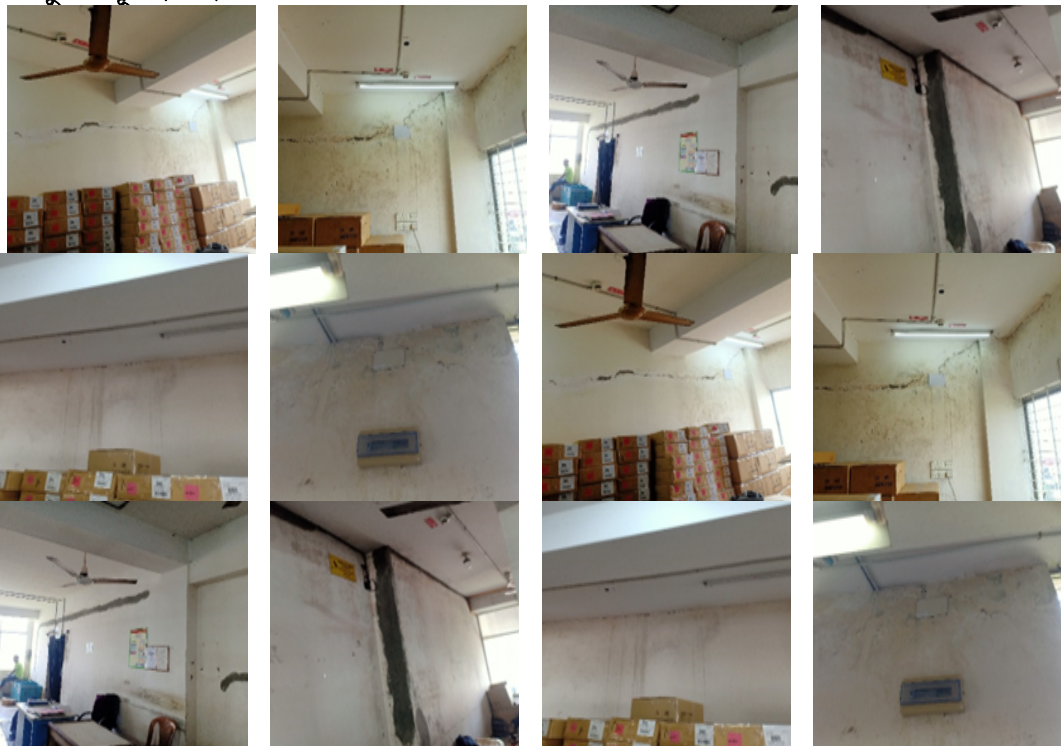
পরিদর্শন পর্যবেক্ষণ	Cracks and dampness
ক্যাপ আইটেম ক্যাটাগরি

কার্যক্রম	Carry out repairing and remedial actions as directed by the Building Engineer for these cracks and dampness.
সুপারিশের তথ্যসূত্র	
কারখানার কার্যক্রম	Factory has remediated all cracks and dampness observed during the assessment.
অগ্রাধিকার	৬ মাস
চূড়ান্ত সময়সীমা	-
সংশোধিত সময়সীমা	০১-০১-১৯৭০
অগ্রগতির অবস্থা	চলমান
মন্তব্য	Capital Designs Ltd. has been replaced by Capital Fashions Ltd. Cracks have been found on masonry wall at different floor and in GF toilet zone. Some repairing works were found abruptly but crack investigation report was not available at site. Also, dampness was found on masonry wall at different floor. Water ponding was observed on roof top. 4th January 2021: Some non structural crack found on some partition wall at the time of inspection. Some repairing works were found abruptly but crack investigation report was not available at site. Dampness was found on masonry wall at different floor. Water ponding was observed on roof top. 13.04.2021: No major cracks were found only some hairline masonry cracks on the walls and dampness were seen on several places like the women's toilet on 2nd floor and men's toilet on 2nd floor. 19th August 2021: No major cracks found in primary structural elements. Dampness found in several places. 3rd August 2022: During visit date non structural wall crack found on the building. some cracks they are remediated & some cracks remediation is on going. Dampness found some position of the building. 16-02-2023: During visit date non structural wall crack found on the building. some cracks they are remediated & some cracks remediation is on going. Dampness found some position of the building.
