গণপ্রজাতন্ত্রী বাংলাদেশ সরকার
শ্রম ও কর্মসংস্থান মন্ত্রণালয়
কলকারখানা ও প্রতিষ্ঠান পরিদর্শন অধিদপ্তর

ক্যাপ পর্যবেক্ষণের তথ্য

কারখানার নাম	সেঙ্গুইন এ্যাপারেলস লিঃ
ঠিকানা	1676/A, Rajakhali, Karnaphuli, Link Road
কারখানার কোড	CHT158
কালার কোড	
মূল্যায়নের ধরণ: কাঠামোগত মূল্যায়ন	পর্যবেক্ষণের তারিখ: ২২-০২-২০২৩
১. পর্যবেক্ষণ

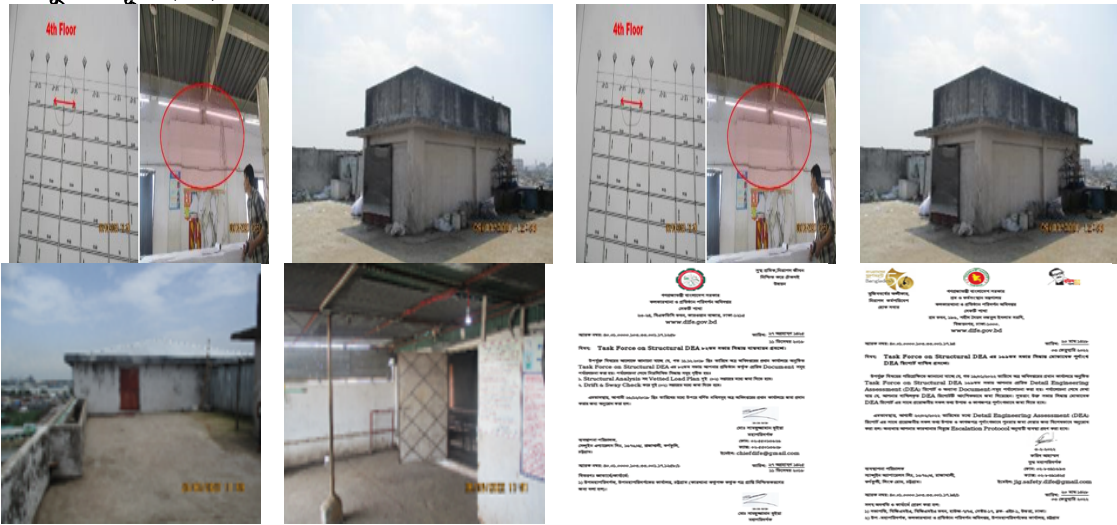
পরিদর্শন পর্যবেক্ষণ	As built drawing
ক্যাপ আইটেম ক্যাটাগরি

কার্যক্রম	Prepare as-built architectural and structural drawings and incorporate with report.
সুপারিশের তথ্যসূত্র	
কারখানার কার্যক্রম	
অগ্রাধিকার	৬ সপ্তাহ
চূড়ান্ত সময়সীমা	-
সংশোধিত সময়সীমা	০৫-১০-২০২২
অগ্রগতির অবস্থা	চলমান
মন্তব্য	<p>CVV1: 19–November–2019 As built structural and as built architectural drawing are available on site. Factory management submitted as built architectural drawing to RCC, DIFE on 30–September–2018. But some mismatches have been found with as built geometry. Water tank location in 5th floor, toilet built up and steel shed near south side do not match with as built condition. CVV2: 09–March–2020 As built architectural & structural drawing has been observed on site. However multiple mismatches has been found. In addition with previous observation steel beam and column layout mismatch at 4th floor, C4 column rebar arrangement not matched with as built condition, internal partition wall not matched with existing condition at some places, 5th floor south side steel shed not shown in drawing etc. On 22–11–2020:Factory still not submitted update design On 24.02.2021: As–built drawing has been submitted to DIFE office. 26.08.2021: No update available since the last visit. 26–05–2022 (CCVV) : No update available since the last visit. Two new sheds are found on roof which should be incorporated in DEA report and as–built drawings. On 22–02–2023 No improvement from the last visit. On 82 Task Force (Dated at 11 December 2018) on structural DEA it was suggested that structural analysis & Vetted Load Plan need to be submitted & Drift & Sway check needed to be included in Structural DEA. On 169th Task Force (Dated at 3 February) revised DEA have been asked from factory but the factory found non-responsive,</p>

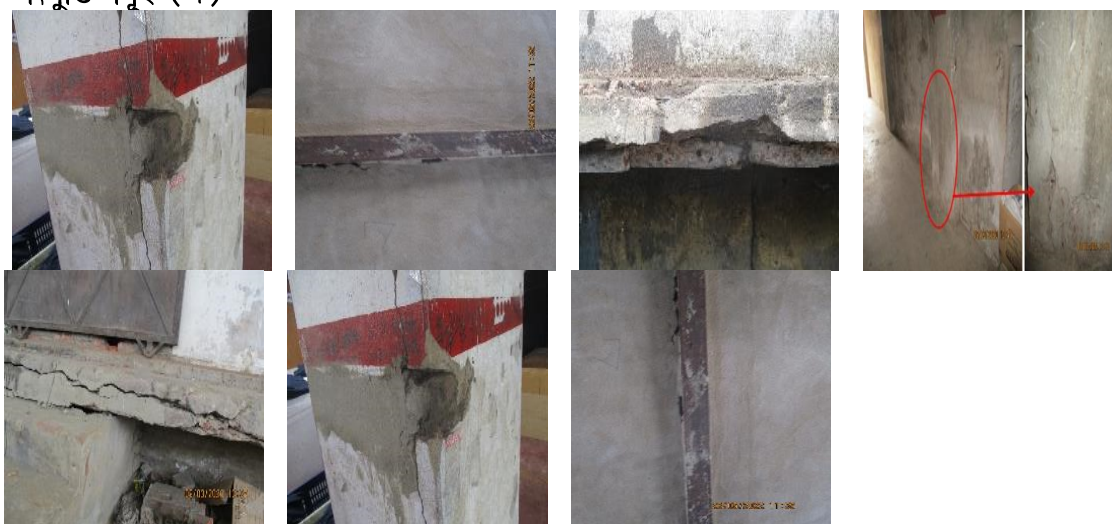
পরিদর্শন পর্যবেক্ষণ	Distress in Primary Structural Element
ক্যাপ আইটেম ক্যাটাগরি

কার্যক্রম	The owner or user of the building should be vigilant about development of any distress, particularly in primary structural elements such as columns, beams and slabs. If crack appear, propagate and widen, detail assessment and adoption of the remedial measures may become necessary.
সুপারিশের তথ্যসূত্র	
কারখানার কার্যক্রম	
অগ্রাধিকার	৬ সপ্তাহ
চূড়ান্ত সময়সীমা	-
সংশোধিত সময়সীমা	০৫-১০-২০২২
অগ্রগতির অবস্থা	শুরু হয়নি
মন্তব্য	CVV1: 19–November–2019 Ground, 1st and 2nd floor have been found closed and not possible to verify. Cracks have not been found at primary structural elements in 3rd, 4th and 5th floor. CVV2: 09–March–2020 Maximum portion of basement & ground floor and whole 1st, 2nd floor have not been possible to conduct verification visit due to lock at entrance. However crack at one ground floor column has been observed in grid A/22 & A/24. Crack have been found at 1st floor slab just beside stair-1 and basement floor slab at in front of parking. On 22–11–2020: Factory still not taken any steps to solve this issue. On 24.02.2021: No action has been taken yet. 26.08.2021: Factory still not take any action regarding this issue. 26–05–2022 (CCVV) : Verification is not possible on Basement, Ground, 1st and 2nd floor. Crack is found on one of 4th floor columns. Major cracks and rust on rebars have been found on ground floor due to excessive dampness. Rust on steel columns have been observed on roof shed. On 22–02–2023 No improvement from the last visit. Verification is not possible on Basement, Ground, 1st and 2nd floor. Crack is found on one of 4th floor columns. Major cracks and rust on rebars have been found on ground floor due to excessive dampness. Rust on steel columns have been observed on roof shed. DEA have not been found approved.
