গণপ্রজাতন্ত্রী বাংলাদেশ সরকার
শ্রম ও কর্মসংস্থান মন্ত্রণালয়
কলকারখানা ও প্রতিষ্ঠান পরিদর্শন অধিদপ্তর

ক্যাপ পর্যবেক্ষণের তথ্য

কারখানার নাম	মেঞ্জুইন এ্যাপারেলস লিঃ
ঠিকানা	1676/A, Rajakhali, Karnaphuli, Link Road
কারখানার কোড	CHT158
কালার কোড	
মূল্যায়নের ধরণ: কঠামোগত মূল্যায়ন	পর্যবেক্ষণের তারিখ: ২২-০২-২০২৩
১. পর্যবেক্ষণ

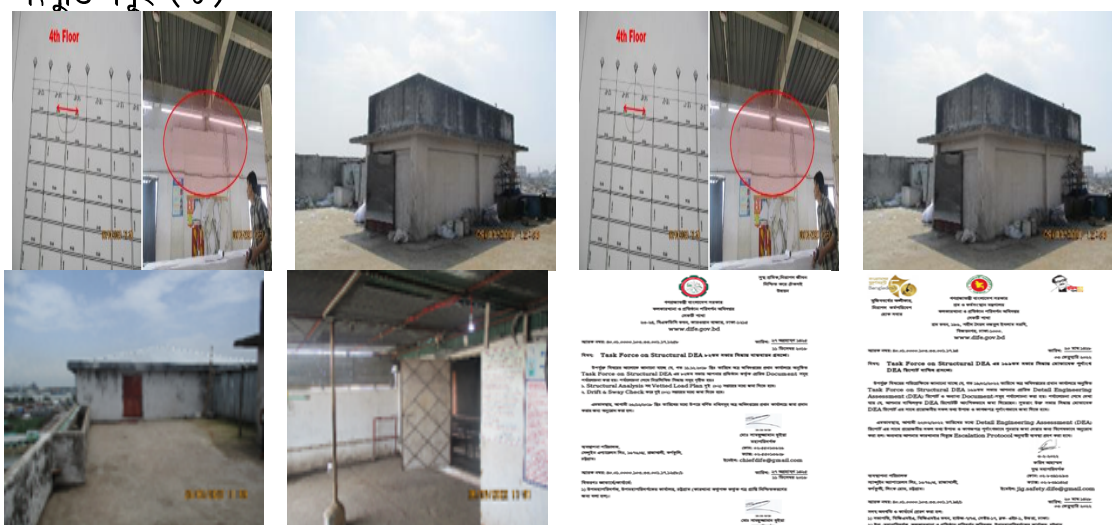
সংযুক্তিসমূহ (৮)

পরিদর্শন পর্যবেক্ষণ	As built drawing
ক্যাপ আইটেম ক্যাটাগরি

কার্যক্রম	Prepare as-built architectural and structural drawings and incorporate with report.
সুপারিশের তথ্যসূত্র	
কারখানার কার্যক্রম	
অগ্রাধিকার	৬ সপ্তাহ
চূড়ান্ত সময়সীমা	-
সংশোধিত সময়সীমা	০৫-১০-২০২২
অগ্রগতির অবস্থা	চলমান
মন্তব্য	<p>CVV1: 19-November-2019 As built structural and as built architectural drawing are available on site. Factory management submitted as built architectural drawing to RCC, DIFE on 30-September-2018. But some mismatches have been found with as built geometry. Water tank location in 5th floor, toilet built up and steel shed near south side do not match with as built condition. CVV2: 09-March-2020 As built architectural & structural drawing has been observed on site. However multiple mismatches has been found. In addition with previous observation steel beam and column layout mismatch at 4th floor, C4 column rebar arrangement not matched with as built condition, internal partition wall not matched with existing condition at some places, 5th floor south side steel shed not shown in drawing etc. On 22-11-2020:Factory still not submitted update design On 24.02.2021: As-built drawing has been submitted to DIFE office. 26.08.2021: No update available since the last visit. 26-05-2022 (CCVV): No update available since the last visit. Two new sheds are found on roof which should be incorporated in DEA report and as-built drawings. On 22-02-2023 No improvement from the last visit. On 82 Task Force (Dated at 11 December 2018) on structural DEA it was suggested that structural analysis & Vetted Load Plan need to be submitted & Drift & Sway check needed to be included in Structural DEA. On 169th Task Force (Dated at 3 February) revised DEA have been asked from factory but the factory found non-responsive,</p>

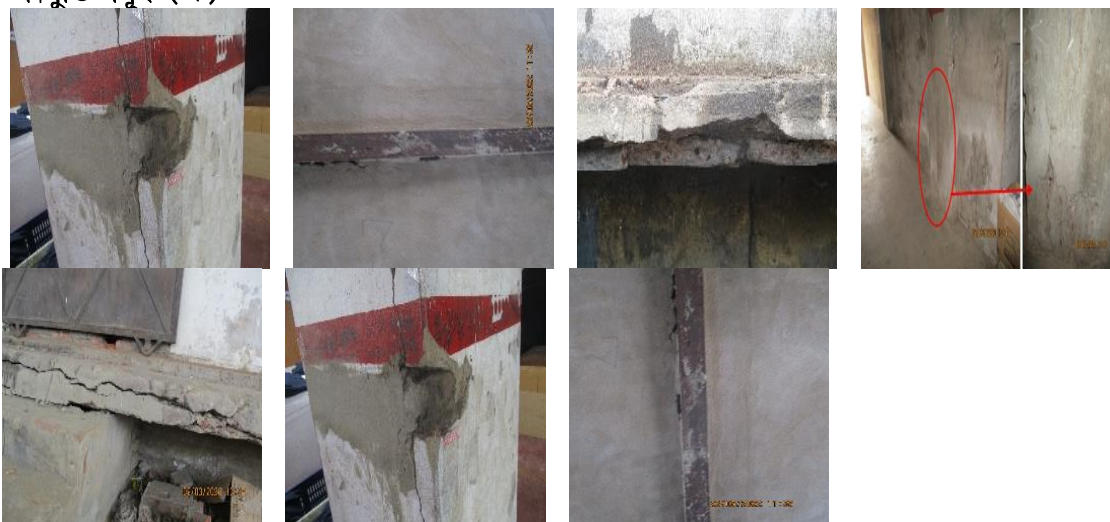
সংযুক্তি-সমূহ (৭)

পরিদর্শন পর্যবেক্ষণ	Distress in Primary Structural Element
ক্যাপ আইটেম ক্যাটাগরি

কার্যক্রম	The owner or user of the building should be vigilant about development of any distress, particularly in primary structural elements such as columns, beams and slabs. If crack appear, propagate and widen, detail assessment and adoption of the remedial measures may become necessary.
সুপারিশের তথ্যসূত্র	
কারখানার কার্যক্রম	
অগ্রাধিকার	৬ সপ্তাহ
চূড়ান্ত সময়সীমা	-
সংশোধিত সময়সীমা	০৫-১০-২০২২
অগ্রগতির অবস্থা	শুরু হয়নি
মন্তব্য	CVV1: 19–November–2019 Ground, 1st and 2nd floor have been found closed and not possible to verify. Cracks have not been found at primary structural elements in 3rd, 4th and 5th floor. CVV2: 09–March–2020 Maximum portion of basement & ground floor and whole 1st, 2nd floor have not been possible to conduct verification visit due to lock at entrance. However crack at one ground floor column has been observed in grid A/22 & A/24. Crack have been found at 1st floor slab just beside stair-1 and basement floor slab at in front of parking. On 22–11–2020: Factory still not taken any steps to solve this issue. On 24.02.2021: No action has been taken yet. 26.08.2021: Factory still not take any action regarding this issue. 26–05–2022 (CCVV): Verification is not possible on Basement, Ground, 1st and 2nd floor. Crack is found on one of 4th floor columns. Major cracks and rust on rebars have been found on ground floor due to excessive dampness. Rust on steel columns have been observed on roof shed. On 22–02–2023 No improvement from the last visit. Verification is not possible on Basement, Ground, 1st and 2nd floor. Crack is found on one of 4th floor columns. Major cracks and rust on rebars have been found on ground floor due to excessive dampness. Rust on steel columns have been observed on roof shed. DEA have not been found approved.
