গণপ্রজাতন্ত্রী বাংলাদেশ সরকার
শ্রম ও কর্মসংস্থান মন্ত্রণালয়
কলকারখানা ও প্রতিষ্ঠান পরিদর্শন অধিদপ্তর

ক্যাপ পর্যবেক্ষণের তথ্য

কারখানার নাম	মেসার্স মনটেক্স কেব্রিক্স লিমিটেড
ঠিকানা	Building-1, Nayapara, Kashimpur, Gazipur
কারখানার কোড	GZP238
কালার কোড

মূল্যায়নের ধরন: বৈদ্যুতিক মূল্যায়ন পর্যবেক্ষণের তারিখ: ২৪-০১-২০২৩

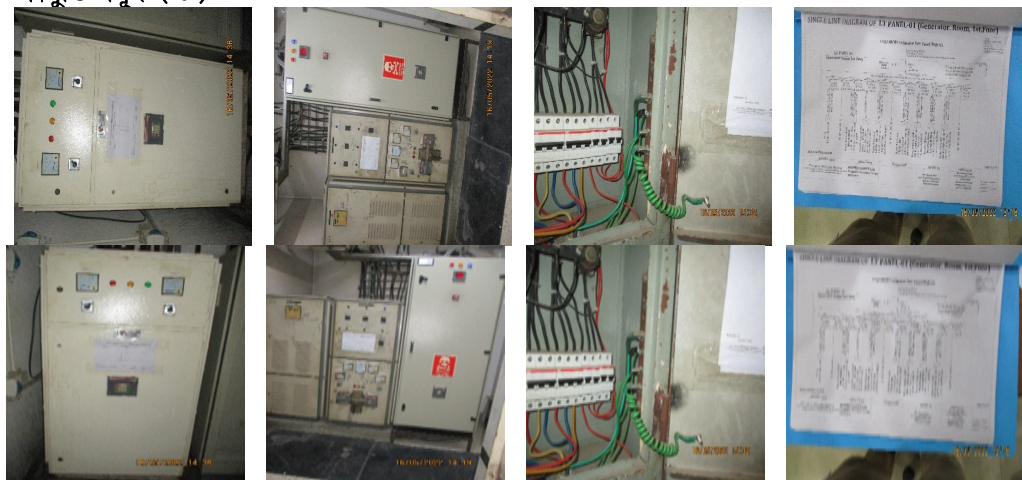
পরিদর্শন পর্যবেক্ষণ	□ No SLD/clear identification mark for MDB/DB/SDB □ MDB installed on the wooden board □ MDB/DB/SDB door not earthed □ Loose or broken box/socket □ MDB does not have duplicate earth leads
ক্যাপ আইটেম ক্যাটাগরি

কার্যক্রম	□ Provide clear identification mark on MDB/DB/SDB and provide SLD □ Install MDB/DB/SDB/SB/MCCB on nonflammable board. □ Provide earthing to door of MDB/DB/SDB. □ Repair broken socket □ Provide duplicate earth leads for MDB.
সুপারিশের তথ্যসূত্র	
কারখানার কার্যক্রম	
অগ্রাধিকার	৬ সপ্তাহ
চূড়ান্ত সময়সীমা	-
সংশোধিত সময়সীমা	০৯-০৯-১৯৭০
অগ্রগতির অবস্থা	চলমান
মন্তব্য	12-Feb-2019 (CVV-1): i) All the distribution boards do not have clear and permanent identification markings. Also single line diagram for electrical system are not available on most of the distribution boards. ii) Wooden boards have been replaced by non-inflammable board (metallic panel board). iii) Panel doors are properly grounded. iv) Loose or broken box/socket is not found. v) MDB does not have duplicate earth leads 17-Nov-2019 (CVV-2): i) All the distribution boards do not have clear and permanent identification markings. Also single line diagram for electrical system are not available on most of the distribution boards. ii) MCCBs and Electric Meters are installed on the wooden board. iii) Panel doors are properly grounded. iv) Loose or broken box/socket is not found. v) MDB does not have duplicate earth leads 06-Sep-2020 (CVV-3): i) All the distribution boards do not have clear and permanent identification markings. Also single line diagram for electrical system are not available on most of the distribution boards. ii) Wooden boards have been removed. iii) Panel doors are properly grounded. iv) Loose or broken box/socket is not found. v) MDB does not have duplicate earth leads. 06.12.2020: i) SLD/clear identification mark on distribution panel ii) Wooden boards have been removed. iii) Panel doors are properly grounded. iv) Loose or broken box/socket is found. but cables are connected without cable lug. v) MDB does not have duplicate earth leads. 16-05-2022 CCVV: i) Some distribution boards do not have clear and permanent identification markings. Although single line diagram for electrical system are available on most of the distribution boards but does not match with actual circuits ii) Wooden boards have been removed. iii) Panel doors are properly grounded. iv) Loose or broken box/socket is not found. v) Duplicate earth leads are provided for MDB. On 24.01.2023 CCVV: i) Some distribution boards do not have clear and permanent identification markings. Although single line diagram for electrical system are available on most of the distribution boards but does not match with actual circuits ii) Wooden boards have been removed. iii) Panel doors are properly grounded. iv) Loose or broken box/socket is not found. v) Duplicate earth leads are provided for MDB.
