গণপ্রজাতন্ত্রী বাংলাদেশ সরকার
শ্রম ও কর্মসংস্থান মন্ত্রণালয়
কলকারখানা ও প্রতিষ্ঠান পরিদর্শন অধিদপ্তর

ক্যাপ পর্যবেক্ষণের তথ্য

কারখানার নাম	এ আর আর ডিসেমোটর
ঠিকানা	3, NO, MADRASA BAZAR ROAD, MATUAIL, JATRABARI, DEMRA, DHAKA
কারখানার কোড	DHK007
কালার কোড	
মূল্যায়নের ধরণ: বৈদ্যুতিক মূল্যায়ন	পর্যবেক্ষণের তারিখ: ০৫-০৪-২০২৩
১. পর্যবেক্ষণ

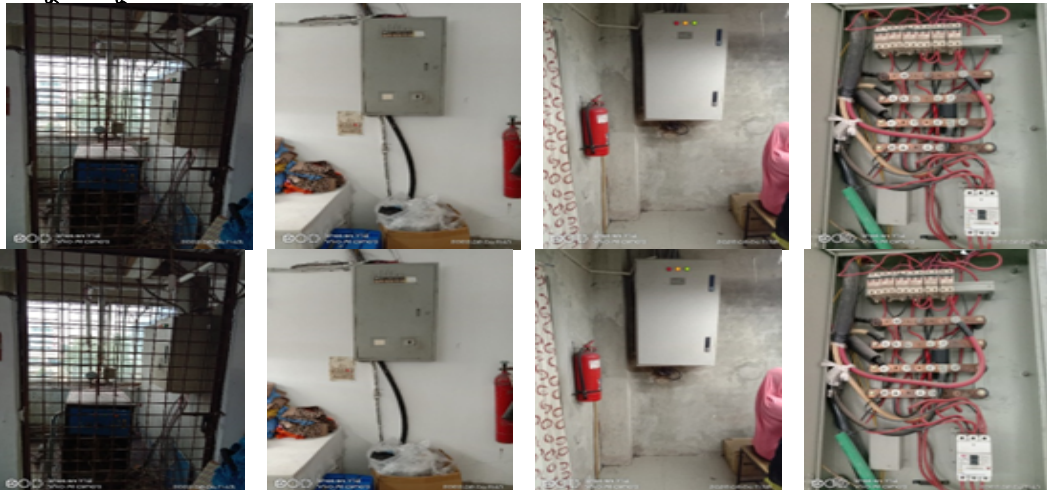
পরিদর্শন পর্যবেক্ষণ	MDB Panel door damaged/not present ☐ No instruction for first aid to electrical shock ☐ No clear identification mark on distribution board ☐ Access obstructed/barred ☐ Cable ends not properly soldered or crimped ☐ Connection without lug ☐ Messy wire inside ☐ MDB installed on the wooden board
ক্যাপ আইটেম ক্যাটাগরি

কার্যক্রম	Provide instructions for first aid from exposure to electrical shock ☐ Remove obstruction to ensure access to MDB/MCB Box ☐ Ensure well-dressed cabling with lugs ☐ Ensure proper door & properly enclose MDB panel.
সুপারিশের ভিত্তিসূত্র	
কারখানার কার্যক্রম	
অগ্রাধিকার	প্রযোজ্য নয়
চূড়ান্ত সময়সীমা	-
সংশোধিত সময়সীমা	-
অগ্রগতির অবস্থা	চলমান
মন্তব্য	19-10-2020: 1. No instruction boards for first aid and artificial respiratory system. 2. No obstruction observed for the distribution boards. 3. Electrical cables were found to be messy and terminated without proper sized lugs inside the distribution boards. 4. Distribution boards were found to have proper enclosure. 06-01-2020: On visit day MDB Panel door damaged not present. No instruction for first aid to electrical shock, No clear identification mark on distribution board, Access obstructed / barred, Cable ends not properly soldered or crimped, Connection without lug, Messy wire inside, MDB installed on the wooden board. 06/05/2021: 1. No instruction boards for first aid and artificial respiratory system. 2. No obstruction observed for the distribution boards. 3. Electrical cables were found to be messy and terminated without proper sized lugs inside the distribution boards. 4. Distribution boards were found to have proper enclosure. 22.08.2021: On visit day, 1. No instruction boards for first aid and artificial respiratory system. 2. No obstruction observed for the distribution boards. 3. Electrical cables were found to be messy and terminated without proper sized lugs inside the distribution boards. 4. Distribution boards were found to have proper enclosure. 04-08-2022: Visit observation, 1. No instruction boards for first aid and artificial respiratory system were found.. 2. Obstruction were observed for the some distribution boards. 3. Messy wire/cable and terminated without proper sized lugs inside the distribution boards were found. 4. Distribution boards were found to have proper enclosure. 05.04.2023: 1. No instruction boards for first aid and artificial respiratory system were found.. 2. Obstruction were observed for the some distribution boards. 3. Messy wire/cable and terminated without proper sized lugs inside the distribution boards were found. 4. Distribution boards were found to have proper enclosure.

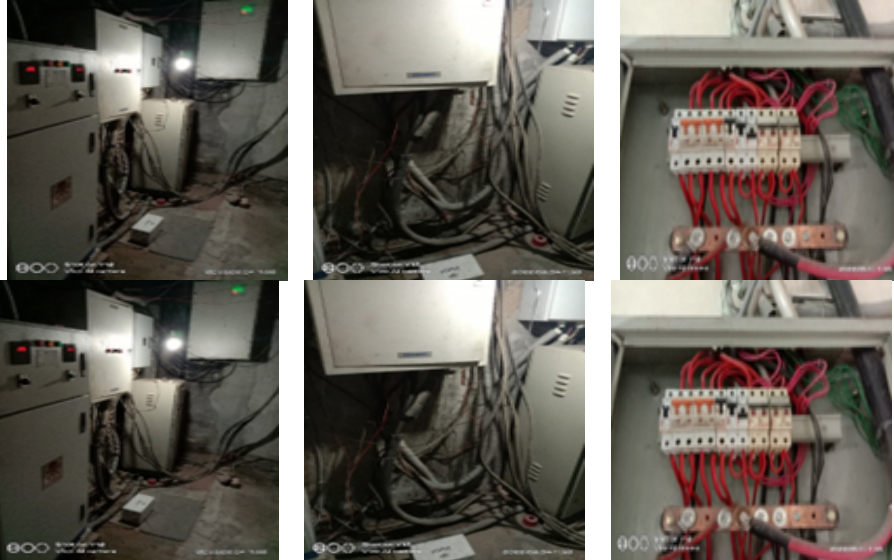
পরিদর্শন পর্যবেক্ষণ	Messy wire & Cables are loose and not through insulated conduit.
ক্যাপ আইটেম ক্যাটাগরি

কার্যক্রম	Provide electrical insulated conduits Replace undressed messy wiring
সুপারিশের তথ্যসূত্র	
কারখানার কার্যক্রম	
অগ্রাধিকার	প্রয়োজ্য নয়
চূড়ান্ত সময়সীমা	-
সংশোধিত সময়সীমা	-
অগ্রগতির অবস্থা	শুরু হয়নি
মন্তব্য	19-10-2020: Distribution boards were not found to be well dressed. Electrical cables were laid without proper cable laying techniques and were not insulated through out the conduit. 06-01-2021 on visit day Messy wire and Cables are loose and not through insulated conduit. 06/05/2021: Distribution boards were not found to be well dressed. Electrical cables were laid without proper cable laying techniques and were not insulated through out the conduit. 04-08-2022: Visit observation, 1. Undressed messy wire & cable laying without proper support were found. 2. Looping cable were observed in distribution boards. 05.04.2023: 1. Undressed messy wire & cable laying without proper support were found. 2. Looping cable were observed in distribution boards.
