গণপ্রজাতন্ত্রী বাংলাদেশ সরকার  
শ্রম ও কর্মসংস্থান মন্ত্রণালয়  
কলকারখানা ও প্রতিষ্ঠান পরিদর্শন অধিদপ্তর

ক্যাপ পর্যবেক্ষণের তথ্য

কারখানার নাম	এ আর আর ডিসেমোটিক্স
ঠিকানা	3, NO, MADRASA BAZAR ROAD, MATUAIL, JATRABARI, DEMRA, DHAKA
কারখানার কোড	DHK007
কালার কোড	
মূল্যায়নের ধরণ: <b>বৈদ্যুতিক মূল্যায়ন</b>	পর্যবেক্ষণের তারিখ: ০৫-০৪-২০২৩
১. পর্যবেক্ষণ

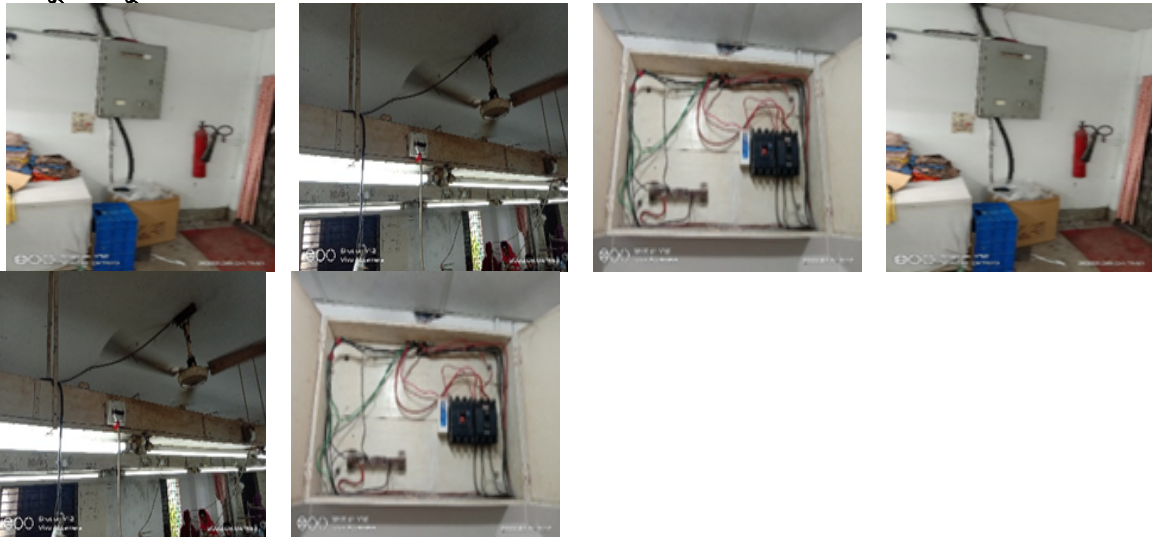
### সংযুক্তিসমূহ (৬)

পরিদর্শন পর্যবেক্ষণ	MDB Panel door damaged/not present <input type="checkbox"/> No instruction for first aid to electrical shock <input type="checkbox"/> No clear identification mark on distribution board <input type="checkbox"/> Access obstructed/barred <input type="checkbox"/> Cable ends not properly soldered or crimped <input type="checkbox"/> Connection without lug <input type="checkbox"/> Messy wire inside <input type="checkbox"/> MDB installed on the wooden board
ক্যাপ আইটেম ক্যাটাগরি

কার্যক্রম	Provide clear identification mark on distribution board. <input type="checkbox"/> Install MDB/SDB/SB or MCB on metal board.
সুপারিশের ভিত্তিসূত্র	
কারখানার কার্যক্রম	
অগ্রাধিকার	প্রয়োজ্য নয়
চূড়ান্ত সময়সীমা	-
সংশোধিত সময়সীমা	-
অগ্রগতির অবস্থা	চলমান
মন্তব্য	19-10-2020: 1. No clear identification mark found for any distribution boards. 2. Some distribution boards were found to be installed on a combustible material for e.g. distribution board in sample section were made of wood. 06-01-2020: On visit day MDB Panel door damaged not present. No instruction for first aid to electrical shock, No clear identification mark on distribution board, Access obstructed/barred, Cable ends not properly soldered or crimped, Connection without lug, Messy wire inside, MDB installed on the wooden board. 06/05/2021: 1. Clear identification mark is not provided on any of the distribution boards. 2. Most of the distribution boards are installed on metal boards. but one wooden boards is seen in sample section. wooden cable channels are seen. 22.08.2021: On visit day, 1. Clear identification mark is not provided on any of the distribution boards. 2. Most of the distribution boards are installed on metal boards. but one wooden boards is seen in sample section. wooden cable channels are seen. 04-08-2022: 1. Clear identification mark were not provided the distribution boards. 2. Most of the distribution boards are installed on metal boards. but one wooden boards is seen in sample section. wooden cable channels were found. 05-04-2023: Visit observation, 1. Clear identification mark were not provided the distribution boards. 2. Most of the distribution boards are installed on metal boards. but one wooden boards is seen in sample section. wooden cable channels were found.

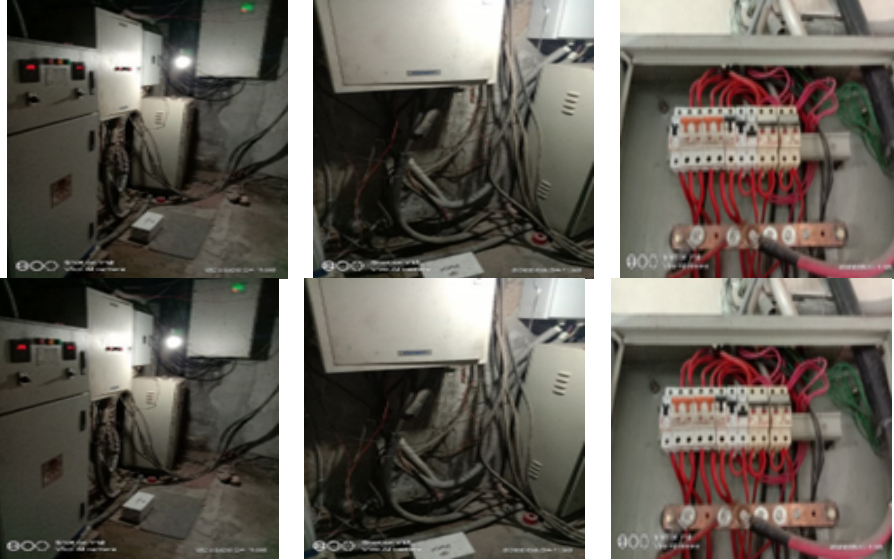
#### সংযুক্তিসমূহ ( ৬ )

পরিদর্শন পর্যবেক্ষণ	Messy wire & Cables are loose and not through insulated conduit.
ক্যাপ আইটেম ক্যাটাগরি

কার্যক্রম	Provide electrical insulated conduits    Replace undressed messy wiring
সুপারিশের তথ্যসূত্র	
কারখানার কার্যক্রম	
অগ্রাধিকার	প্রয়োজ্য নয়
চূড়ান্ত সময়সীমা	-
সংশোধিত সময়সীমা	-
অগ্রগতির অবস্থা	শুরু হয়নি
মন্তব্য	19-10-2020: Distribution boards were not found to be well dressed. Electrical cables were laid without proper cable laying techniques and were not insulated through out the conduit. 06-01-2021 on visit day Messy wire and Cables are loose and not through insulated conduit. 06/05/2021: Distribution boards were not found to be well dressed. Electrical cables were laid without proper cable laying techniques and were not insulated through out the conduit. 04-08-2022: Visit observation, 1. Undressed messy wire & cable laying without proper support were found. 2. Looping cable were observed in distribution boards. 05.04.2023: 1. Undressed messy wire & cable laying without proper support were found. 2. Looping cable were observed in distribution boards.
