গণপ্রজাতন্ত্রী বাংলাদেশ সরকার  
শ্রম ও কর্মসংস্থান মন্ত্রণালয়  
কলকারখানা ও প্রতিষ্ঠান পরিদর্শন অধিদপ্তর

ক্যাপ পর্যবেক্ষণের তথ্য

কারখানার নাম	এ আর আর ডিসিগেটিক্স
ঠিকানা	3, NO, MADRASA BAZAR ROAD, MATUAIL, JATRABARI, DEMRA, DHAKA
কারখানার কোড	DHK007
কালার কোড

মূল্যায়নের ধরণ: বৈদ্যুতিক মূল্যায়ন	পর্যবেক্ষণের তারিখ: ০৫-০৪-২০২৩
১. পর্যবেক্ষণ

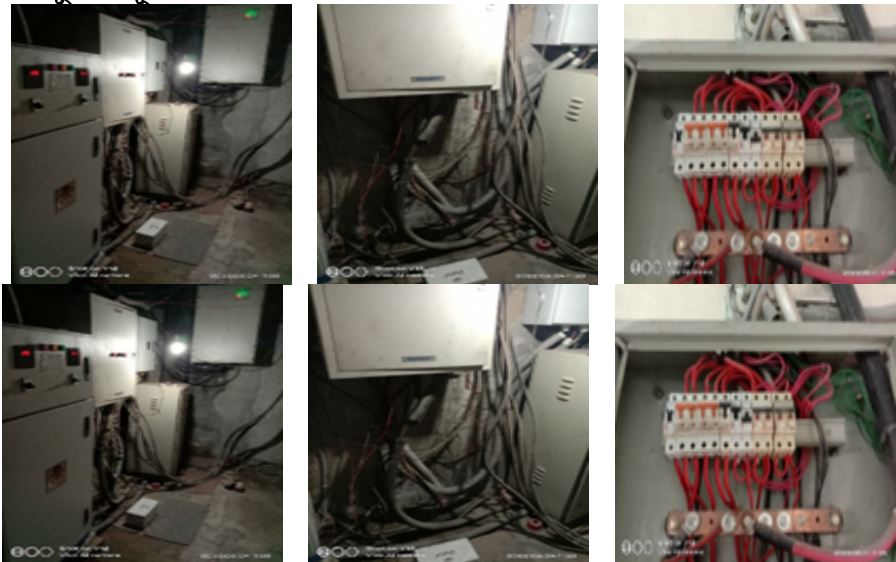
#### সংযুক্তিসমূহ (৬)

পরিদর্শন পর্যবেক্ষণ	Messy wire & Cables are loose and not through insulated conduit.
ক্যাপ আইটেম ক্যাটাগরি

কার্যক্রম	Provide electrical insulated conduits    Replace undressed messy wiring
সুপারিশের তথ্যসূত্র	
কারখানার কার্যক্রম	
অগ্রাধিকার	প্রযোজ্য নয়
চূড়ান্ত সময়সীমা	-
সংশোধিত সময়সীমা	-
অগ্রগতির অবস্থা	শুরু হয়নি
মন্তব্য	19-10-2020: Distribution boards were not found to be well dressed. Electrical cables were laid without proper cable laying techniques and were not insulated through out the conduit. 06-01-2021 on visit day Messy wire and Cables are loose and not through insulated conduit. 06/05/2021: Distribution boards were not found to be well dressed. Electrical cables were laid without proper cable laying techniques and were not insulated through out the conduit. 04-08-2022: Visit observation, 1. Undressed messy wire & cable laying without proper support were found. 2. Looping cable were observed in distribution boards. 05.04.2023: 1. Undressed messy wire & cable laying without proper support were found. 2. Looping cable were observed in distribution boards.
