গণপ্রজাতন্ত্রী বাংলাদেশ সরকার
শ্রম ও কর্মসংস্থান মন্ত্রণালয়
কলকারখানা ও প্রতিষ্ঠান পরিদর্শন অধিদপ্তর

ক্যাপ পর্যবেক্ষণের তথ্য

কারখানার নাম	এ আর আর ডিসেমোটিক্স
ঠিকানা	3, NO, MADRASA BAZAR ROAD, MATUAIL, JATRABARI, DEMRA, DHAKA
কারখানার কোড	DHK007
কালার কোড	
মূল্যায়নের ধরণ: বৈদ্যুতিক মূল্যায়ন	পর্যবেক্ষণের তারিখ: ০৫-০৪-২০২৩
১. পর্যবেক্ষণ

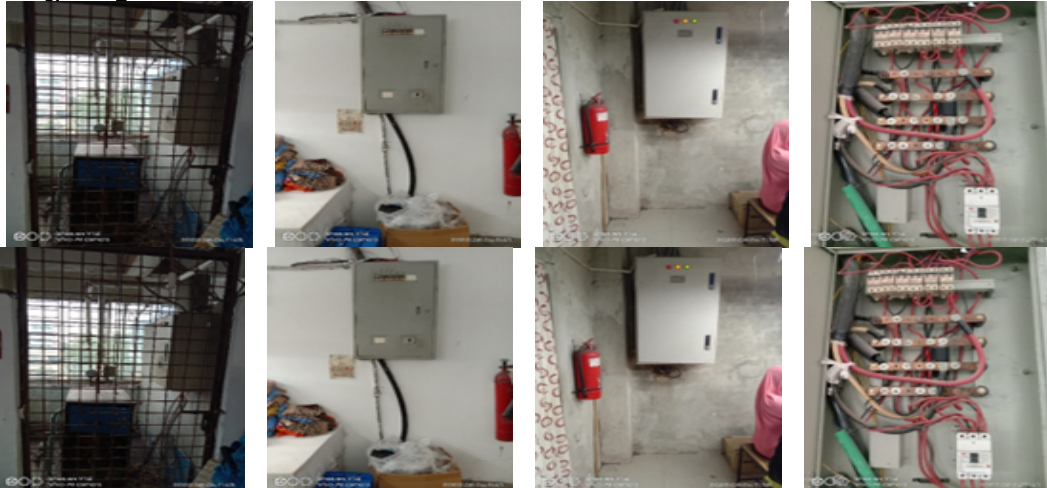
পরিদর্শন পর্যবেক্ষণ	MDB Panel door damaged/not present ☐ No instruction for first aid to electrical shock ☐ No clear identification mark on distribution board ☐ Access obstructed/barred ☐ Cable ends not properly soldered or crimped ☐ Connection without lug ☐ Messy wire inside ☐ MDB installed on the wooden board
ক্যাপ আইটেম ক্যাটাগরি

কার্যক্রম	Provide instructions for first aid from exposure to electrical shock ☐ Remove obstruction to ensure access to MDB/MCB Box ☐ Ensure well-dressed cabling with lugs ☐ Ensure proper door & properly enclose MDB panel.
সুপারিশের ভিত্তিসূত্র	
কারখানার কার্যক্রম	
অগ্রাধিকার	প্রযোজ্য নয়
চূড়ান্ত সময়সীমা	-
সংশোধিত সময়সীমা	-
অগ্রগতির অবস্থা	চলমান
মন্তব্য	19-10-2020: 1. No instruction boards for first aid and artificial respiratory system. 2. No obstruction observed for the distribution boards. 3. Electrical cables were found to be messy and terminated without proper sized lugs inside the distribution boards. 4. Distribution boards were found to have proper enclosure. 06-01-2020: On visit day MDB Panel door damaged not present. No instruction for first aid to electrical shock, No clear identification mark on distribution board, Access obstructed / barred, Cable ends not properly soldered or crimped, Connection without lug, Messy wire inside, MDB installed on the wooden board. 06/05/2021: 1. No instruction boards for first aid and artificial respiratory system. 2. No obstruction observed for the distribution boards. 3. Electrical cables were found to be messy and terminated without proper sized lugs inside the distribution boards. 4. Distribution boards were found to have proper enclosure. 22.08.2021: On visit day, 1. No instruction boards for first aid and artificial respiratory system. 2. No obstruction observed for the distribution boards. 3. Electrical cables were found to be messy and terminated without proper sized lugs inside the distribution boards. 4. Distribution boards were found to have proper enclosure. 04-08-2022: Visit observation, 1. No instruction boards for first aid and artificial respiratory system were found.. 2. Obstruction were observed for the some distribution boards. 3. Messy wire/cable and terminated without proper sized lugs inside the distribution boards were found. 4. Distribution boards were found to have proper enclosure. 05.04.2023: 1. No instruction boards for first aid and artificial respiratory system were found.. 2. Obstruction were observed for the some distribution boards. 3. Messy wire/cable and terminated without proper sized lugs inside the distribution boards were found. 4. Distribution boards were found to have proper enclosure.
