গণপ্রজাতন্ত্রী বাংলাদেশ সরকার
শ্রম ও কর্মসংস্থান মন্ত্রণালয়
কলকারখানা ও প্রতিষ্ঠান পরিদর্শন অধিদপ্তর

ক্যাপ পর্যবেক্ষণের তথ্য

কারখানার নাম	বেঙ্গল নিউট্রন লিঃ
ঠিকানা	59/1 Atis Dipankar Road,
কারখানার কোড	DHK099
কালার কোড	
মূল্যায়নের ধরণ: বৈদ্যুতিক মূল্যায়ন	পর্যবেক্ষণের তারিখ: ১৪-০২-২০২৩
১. পর্যবেক্ষণ

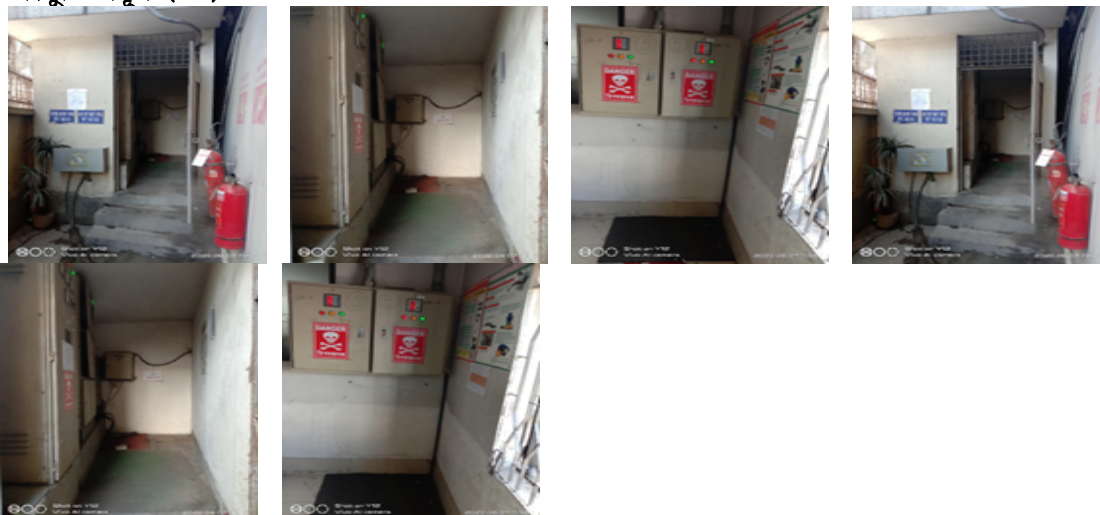
পরিদর্শন পর্যবেক্ষণ	Substation
ক্যাপ আইটেম ক্যাটাগরি

কার্যক্রম	§ 2.6.3 Page 11248 § 2.7.5 Page 11258 § 2.11.5 Page 11275 Electricity Rule 1937 § 46, 47, 50, 60
সুপারিশের তথ্যসূত্র	
কারখানার কার্যক্রম	No clear identification mark on distribution panel No instruction for first aid to electrical shock and artificial respiration Non-conductor mat not provided Same as above
অগ্রাধিকার	প্রয়োজ্য নয়
চূড়ান্ত সময়সীমা	০১-০১-১৯৭০
সংশোধিত সময়সীমা	-
অগ্রগতির অবস্থা	চলমান
মন্তব্য	13-01-2020: 1. Clear identification mark for distribution panel were done properly 2. Appropriate detector not found according to the NTPA guideline 3. Instruction board for first aid and electric shock recuperation not found at required place i.e substation room, generator room, boiler room beside distribution board, near every panels on the floor 4. Insulated rubber mat were not provided 17-08-2020: 1. Clear identification mark for distribution panel were done properly 2. Appropriate detector not found according to the NTPA guideline 3. Instruction board for first aid and electric shock recuperation not found at required place i.e. substation room, generator room, boiler room beside distribution board, near every panels on the floor 4. Insulated rubber mat were provided 03-11-2020 on visit day: Clear identification mark on distribution panel. instruction for first aid to electrical shock and artificial respiration. Non-conductor mat provided. 03-02-2021 on visit day: Clear identification mark on distribution panel. instruction for first aid to electrical shock and artificial respiration. Non-conductor mat provided. 12-08-2021 on visit day: Clear identification mark on distribution panel. instruction for first aid to electrical shock and artificial respiration. Non-conductor mat provided. 07-08-2022 Visit Observation: 1. Clear identification mark for distribution board were found. 2. Instruction for first aid to electrical shock and artificial respiration were found. 3. Electric grade rubber mat were not provided in front of some panel board. 4. Appropriate detector were not found according to the NTPA guideline. 14-02-2023 Visit Observation: 1. Clear identification mark for distribution board were found. 2. Instruction for first aid to electrical shock and artificial respiration were not found of some panel boards. 3. Electric grade rubber mat were not provided in front of some panel board. 4. Appropriate detector were not found according to the NTPA guideline.

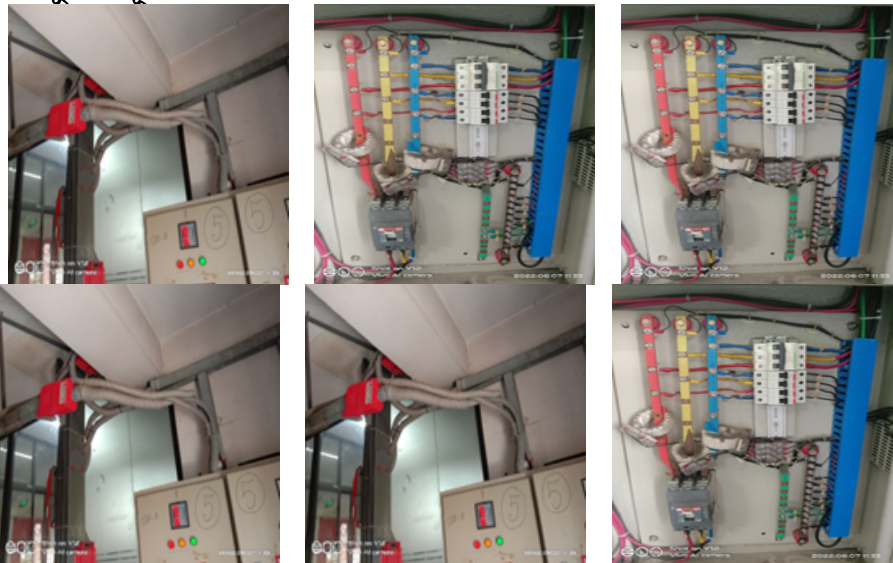
পরিদর্শন পর্যবেক্ষণ	Wiring/ Cabling
কাপ আইটেম ক্যাটাগরি

কার্যক্রম	§ 2.5.4 Page 11244
সুপারিশের তথ্যসূত্র	
কারখানার কার্যক্রম	Electric cables do not pass through service shaft or insulated conduits Connections without lug Undressed messy wiring Same as above
অগ্রাধিকার	প্রযোজ্য নয়
চূড়ান্ত সমন্বয়সীমা	০১-০১-১৯৭০
সংশোধিত সমন্বয়সীমা	-
অগ্রগতির অবস্থা	সংশোধিত
মন্তব্য	13-01-2020: 1. Cables were insulated properly and BBT used as a riser. Holes needs to be sealed properly 2. Cables were terminated with appropriate lugs 3. Cables were properly clipped and drawn. 17-08-2020: 1. Cables were insulated properly and BBT used as a riser. Holes are sealed properly 2. Cables were terminated with appropriate lugs 3. Cables were properly clipped and drawn. 03-11-2020 on visit day: 1. Cables were insulated properly & BBT used as a riser. Holes are sealed properly. 2. Cables were terminated with appropriate lugs. 3. Cables were properly clipped and drawn 03-02-2021 on visit day: 1. Cables were insulated properly & BBT used as a riser. Holes are sealed properly. 2. Cables were terminated with appropriate lugs. 3. Cables were properly clipped and drawn 07-08-2022 Visit Observation: 1. Cables were insulated properly and BBT used as a riser. Holes are sealed properly 2. Cables were terminated with appropriate lugs 3. Cables were properly clipped and drawn. 14-02-2023 Visit Observation: 1. Cables were insulated properly and BBT used as a riser. Holes are sealed properly 2. Cables were terminated with appropriate lugs 3. Cables were properly clipped and drawn.
