গণপ্রজাতন্ত্রী বাংলাদেশ সরকার
শ্রম ও কর্মসংস্থান মন্ত্রণালয়
কলকারখানা ও প্রতিষ্ঠান পরিদর্শন অধিদপ্তর

ক্যাপ পর্যবেক্ষণের তথ্য

কারখানার নাম	বেঙ্গল নিটেক্স লিঃ
ঠিকানা	59/1 Atis Dipankar Road,
কারখানার কোড	DHK099
কালার কোড	
মূল্যায়নের ধরণ: বৈদ্যুতিক মূল্যায়ন	পর্যবেক্ষণের তারিখ: ১৪-০২-২০২৩
১. পর্যবেক্ষণ

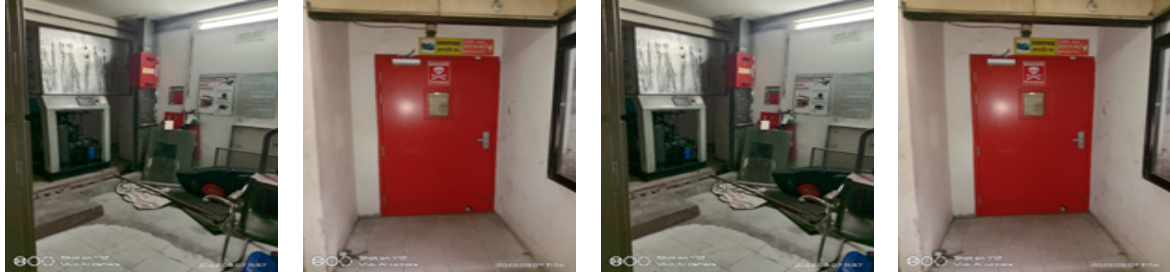
পরিদর্শন পর্যবেক্ষণ	Generator Room
ক্যাপ আইটেম ক্যাটাগরি

কার্যক্রম	□ Sec. 4.9.3 □ Electricity Rule 1937 § 49
সুপারিশের তথ্যসূত্র	
কারখানার কার্যক্রম	□ Provide fire rated enclosure from floor to ceiling and an approved fire rated self closing swing door for the Generator room □ Install appropriate detectors. □ Ensure double earthing of generator frame □ Provide cover on the cable trench
অগ্রাধিকার	প্রয়োজ্য নয়
চূড়ান্ত সমন্বয়সীমা	০১-০১-১৯৭০
সংশোধিত সমন্বয়সীমা	-
অগ্রগতির অবস্থা	সংশোধিত
মন্তব্য	13-01-2020: 1. Generator room is not properly fire rated enclosed or segregated from the rest of the occupancy and fire rated self-closing swing door found 2. Detector found but not according to design related NTPA guideline or BNBC standard 3. Double earthing found for generator 4. Cable trenches were found covered 17-08-2020: 1. Provided fire rated enclosure from floor to ceiling and an approved fire rated self closing swing door for the Generator room. 2. Same as above. 3. Double earthing of generator frame 4. Provided cover on the cable trench. 03-11-2020 on visit day Found fire rated enclosure from floor to ceiling and an approved fire rated self closing swing door for the Generator room. two point earthing on generator. Found cover on the cable trench. 03-02-2021 on visit day: Found fire rated enclosure from floor to ceiling and an approved fire rated self closing swing door for the Generator room. two point earthing on generator. Found cover on the cable trench. 12-08-2021 on visit day: Found fire rated enclosure from floor to ceiling and an approved fire rated self closing swing door for the Generator room. two point earthing on generator. Found cover on the cable trench. 07-08-2022 Visit Observation: During visit date no generator found in generator room. Factory person confirmed that they will no more used generator for standby source for that reason they has been omitted generator from factory. 14-02-2023 Visit Observation: During visit date no generator found in generator room. Factory person confirmed that they will no more used generator for standby source for that reason they has been omitted generator from factory.

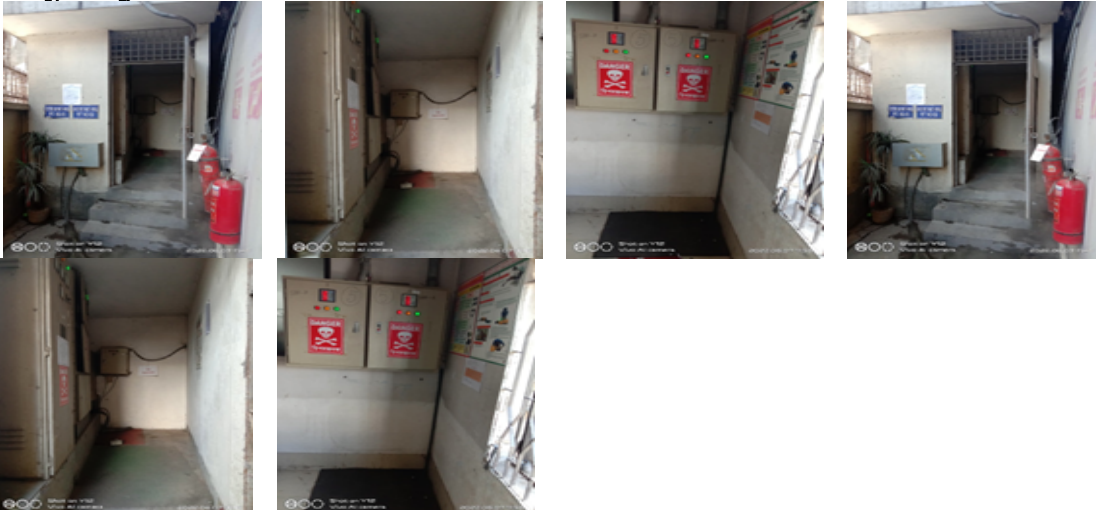
পরিদর্শন পর্যবেক্ষণ	Substation
ক্যাপ আইটেম ক্যাটাগরি

কার্যক্রম	§ 2.6.3 Page 11248 § 2.7.5 Page 11258 § 2.11.5 Page 11275 Electricity Rule 1937 § 46, 47, 50, 60
সুপারিশের ভিত্তিসূত্র	
কারখানার কার্যক্রম	No clear identification mark on distribution panel No instruction for first aid to electrical shock and artificial respiration Non-conductor mat not provided Same as above
অগ্রাধিকার	প্রয়োজ্য নয়
চূড়ান্ত সময়সীমা	০১-০১-১৯৭০
সংশোধিত সময়সীমা	-
অগ্রগতির অবস্থা	চলমান
মন্তব্য	13-01-2020: 1. Clear identification mark for distribution panel were done properly 2. Appropriate detector not found according to the NTPA guideline 3. Instruction board for first aid and electric shock recuperation not found at required place i.e substation room, generator room, boiler room beside distribution board, near every panels on the floor 4. Insulated rubber mat were not provided 17-08-2020: 1. Clear identification mark for distribution panel were done properly 2. Appropriate detector not found according to the NTPA guideline 3. Instruction board for first aid and electric shock recuperation not found at required place i.e. substation room, generator room, boiler room beside distribution board, near every panels on the floor 4. Insulated rubber mat were provided 03-11-2020 on visit day: Clear identification mark on distribution panel. instruction for first aid to electrical shock and artificial respiration. Non-conductor mat provided. 03-02-2021 on visit day: Clear identification mark on distribution panel. instruction for first aid to electrical shock and artificial respiration. Non-conductor mat provided. 12-08-2021 on visit day: Clear identification mark on distribution panel. instruction for first aid to electrical shock and artificial respiration. Non-conductor mat provided. 07-08-2022 Visit Observation: 1. Clear identification mark for distribution board were found. 2. Instruction for first aid to electrical shock and artificial respiration were found. 3. Electric grade rubber mat were not provided in front of some panel board. 4. Appropriate detector were not found according to the NTPA guideline. 14-02-2023 Visit Observation: 1. Clear identification mark for distribution board were found. 2. Instruction for first aid to electrical shock and artificial respiration were not found of some panel boards. 3. Electric grade rubber mat were not provided in front of some panel board. 4. Appropriate detector were not found according to the NTPA guideline.

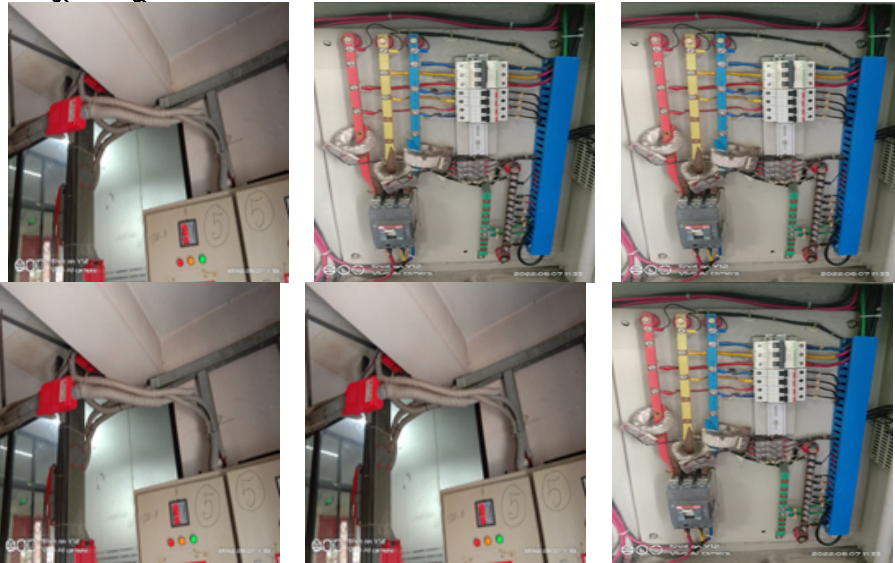
পরিদর্শন পর্ষবেষ্টিত	Wiring/ Cabling
কাপ আইটেম ক্যাটাগরি

কার্যক্রম	§ 2.5.4 Page 11244
সুপারিশের তথ্যসূত্র	
কারখানার কার্যক্রম	Electric cables do not pass through service shaft or insulated conduits Connections without lug Undressed messy wiring Same as above
অগ্রাধিকার	প্রযোজ্য নয়
চূড়ান্ত সময়সীমা	০১-০১-১৯৭০
সংশোধিত সময়সীমা	-
অগ্রগতির অবস্থা	সংশোধিত
মন্তব্য	13-01-2020: 1. Cables were insulated properly and BBT used as a riser. Holes needs to be sealed properly 2. Cables were terminated with appropriate lugs 3. Cables were properly clipped and drawn. 17-08-2020: 1. Cables were insulated properly and BBT used as a riser. Holes are sealed properly 2. Cables were terminated with appropriate lugs 3. Cables were properly clipped and drawn. 03-11-2020 on visit day: 1. Cables were insulated properly & BBT used as a riser. Holes are sealed properly. 2. Cables were terminated with appropriate lugs. 3. Cables were properly clipped and drawn 03-02-2021 on visit day: 1. Cables were insulated properly & BBT used as a riser. Holes are sealed properly. 2. Cables were terminated with appropriate lugs. 3. Cables were properly clipped and drawn 07-08-2022 Visit Observation: 1. Cables were insulated properly and BBT used as a riser. Holes are sealed properly 2. Cables were terminated with appropriate lugs 3. Cables were properly clipped and drawn. 14-02-2023 Visit Observation: 1. Cables were insulated properly and BBT used as a riser. Holes are sealed properly 2. Cables were terminated with appropriate lugs 3. Cables were properly clipped and drawn.
