গণপ্রজাতন্ত্রী বাংলাদেশ সরকার
শ্রম ও কর্মসংস্থান মন্ত্রণালয়
কলকারখানা ও প্রতিষ্ঠান পরিদর্শন অধিদপ্তর

ক্যাপ পর্যবেক্ষণের তথ্য

কারখানার নাম	ক্যাশন পয়েন্ট লিঃ
ঠিকানা	Plot# 41-42, BSCIC I/E, Konabari, Gazipur
কারখানার কোড	GZP119
কালার কোড

মূল্যায়নের ধরণ: বৈদ্যুতিক মূল্যায়ন	পর্যবেক্ষণের তারিখ: ২৭-০২-২০২৩
১. পর্যবেক্ষণ

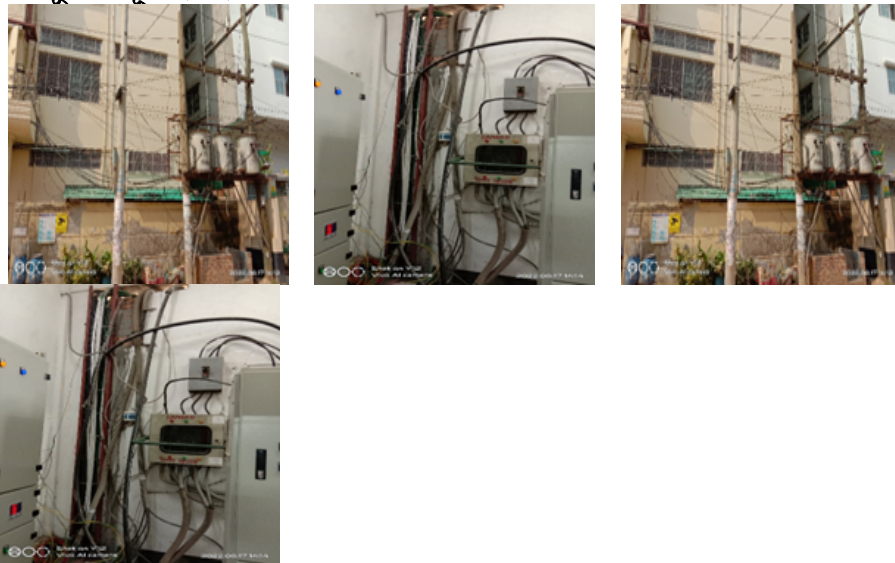
পরিদর্শন পর্যবেক্ষণ	Electrical cables do not run through separate service ducts Not sealed with noncombustible material at each floor level for electrical services duct
কাপ আইটেম ক্যাটাগরি

কার্যক্রম	Provide service duct for electrical cables. Ensure prevention of fire and smoke propagation through vertical shafts by providing fire rated enclosures around the openings along with seals in shafts and ducts at floor separations.
সুপারিশের তথ্যসূত্র	
কারখানার কার্যক্রম	
অগ্রাধিকার	৬ মাস
চূড়ান্ত সময়সীমা	-
সংশোধিত সময়সীমা	০১-০১-১৯৭০
অগ্রগতির অবস্থা	চলমান
মন্তব্য	08-10-2020 (CVV-1): 1. Electrical cables do not run through separate service ducts. 2. Cables penetrations through wall is not adequately covered and sealed with fire resistive elements. 19.01.2021: Electrical cables do not run through separate service ducts. 11-04-2021 (CVV-3): 1. Electrical cables do not run through separate Service ducts. 2. Cables penetration through wall are adequately covered and sealed. 22-08-2021 (CVV-4): 1. Electrical cables do not run through separate service ducts. 2. Cables penetrations through wall is not adequately covered and sealed with fire resistive elements. 17-08-2022 visit observation: 1. Electrical cables do not run through separate service ducts. 2. Cables penetrations through wall is not adequately covered and sealed with fire resistive elements. 27-02-2023 visit observation: 1. Electrical cables do not run through separate service ducts. 2. Cables penetrations through wall is not adequately covered and sealed with fire resistive elements.
