গণপ্রজাতন্ত্রী বাংলাদেশ সরকার  
শ্রম ও কর্মসংস্থান মন্ত্রণালয়  
কলকারখানা ও প্রতিষ্ঠান পরিদর্শন অধিদপ্তর

ক্যাপ পর্যবেক্ষণের তথ্য

কারখানার নাম	ক্যাশন পয়েন্ট লিঃ
ঠিকানা	Plot#41-42, BSCIC I/E, Konabari, Gazipur
কারখানার কোড	GZP119
কালার কোড	
মূল্যায়নের ধরণ: <b>বৈদ্যুতিক মূল্যায়ন</b>	পর্যবেক্ষণের তারিখ: ২৭-০২-২০২৩
১. পর্যবেক্ষণ

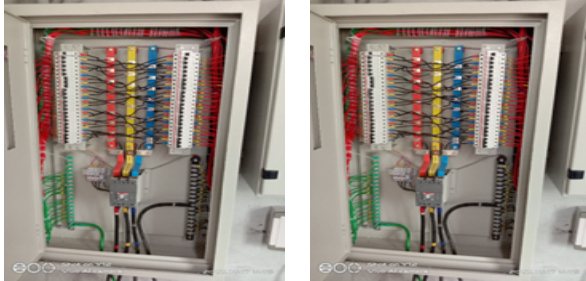
### সংযুক্তিসমূহ (২)

পরিদর্শন পর্যবেক্ষণ	□ Undressed and messy wiring/cables
ক্যাপ আইটেম ক্যাটাগরি

কার্যক্রম	□ Replace undressed messy wiring/cables
সুপারিশের তথ্যসূত্র	
কারখানার কার্যক্রম	
অগ্রাধিকার	৬ সপ্তাহ
চূড়ান্ত সময়সীমা	--
সংশোধিত সময়সীমা	০১-০১-১৯৭০
অগ্রগতির অবস্থা	সংশোধিত
মন্তব্য	08-10-2020 (CVV-2): Undressed messy wire is not present inside the Distribution Boards. 19.01.2021: Undressed and messy wiring/cables was available. 11-04-2021 (CVV-3): Undressed messy wire are not present inside the Distribution Boards. 22.08.2201 (CVV-4): Undressed and messy wiring/cables was available. 17-08-2022 visit observation: Undressed and messy wiring were not found. 27-02-2023 visit observation: Undressed and messy wiring were not found.
