গণপ্রজাতন্ত্রী বাংলাদেশ সরকার
শ্রম ও কর্মসংস্থান মন্ত্রণালয়
কলকারখানা ও প্রতিষ্ঠান পরিদর্শন অধিদপ্তর

ক্যাপ পর্যবেক্ষণের তথ্য

কারখানার নাম	এস আই নিটিং লি:
ঠিকানা	26/1, Shataish Road, Tongi, Gazipur
কারখানার কোড	GZP292
কালার কোড	
মূল্যায়নের ধরন: বৈদ্যুতিক মূল্যায়ন	পর্যবেক্ষণের তারিখ: ২৩-০১-২০২৩
১. পর্যবেক্ষণ

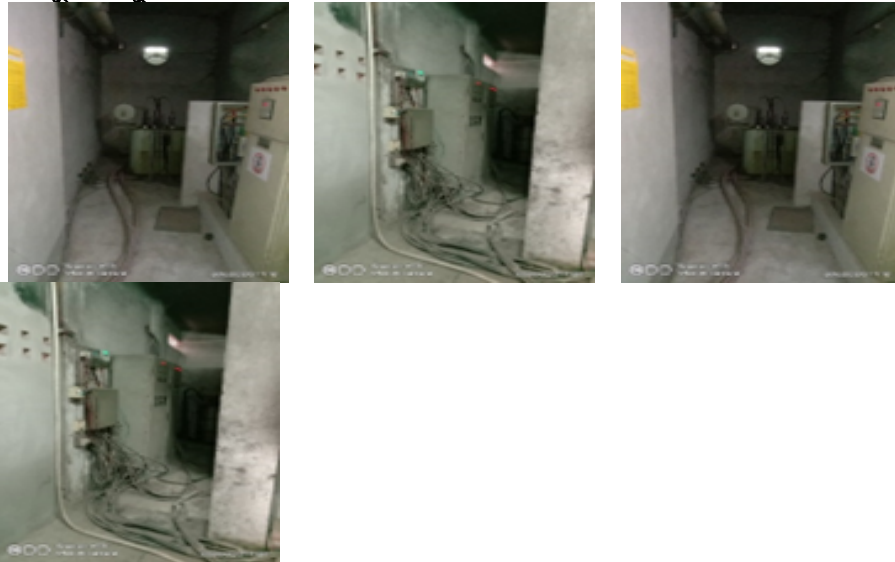
পরিদর্শন পর্যবেক্ষণ	□ Electrical cables do not run through separate Service ducts
কাপ আইটেম ক্যাটাগরি

কার্যক্রম	□ Ensure prevention of fire and smoke propagation through vertical shafts by providing fire rated enclosures around the openings along with seals in shafts and ducts at floor separations. □ Provide service duct for electrical cables
সুপারিশের তথ্যসূত্র	
কারখানার কার্যক্রম	We will do as per guideline within the mentioned timeline.
অগ্রাধিকার	প্রযোজ্য নয়
চূড়ান্ত সময়সীমা	১২-০৫-২০১৭
সংশোধিত সময়সীমা	০১-০১-১৯৭০
অগ্রগতির অবস্থা	শুরু হয়নি
মন্তব্য	08-10-2020 (CVV-1): Electrical cables do not run through separate Service ducts. On 26-01-2021 (CVV-2): Electrical cables do not run through separate Service ducts and it is in critical condition. On 03-05-2021 (CVV-3): Electrical cables do not run through separate Service ducts and it was in same condition as previous. On 23-08-2021 (CVV-4): Electrical cables do not run through separate Service ducts and it was in same condition as previous. 01-09-2022 visit observation: Electrical cables do not run through separate service ducts. 23-01-2023: Same as previous visit.

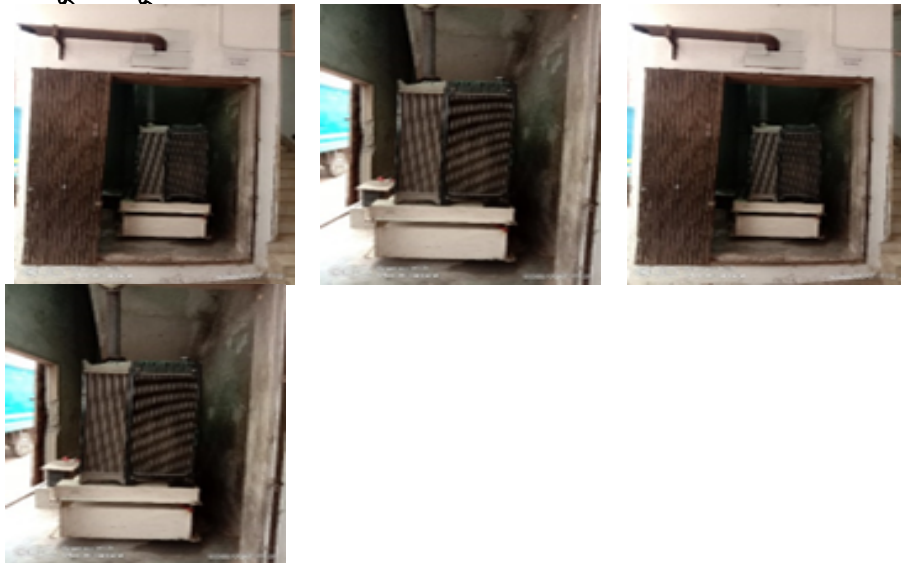
পরিদর্শন পর্যবেক্ষণ	□ The generator room is not properly segregated from the rest of the occupancy □ The generator room smaller than the required size □ Combustible material inside □ No over-current protection provided □ No earth-fault protection
ক্যাপ আইটেম ক্যাটাগরি

কার্যক্রম	□ Produce design drawings to demonstrate the incorporation of fire rated enclosure from floor to ceiling and an approved fire rated self-closing swing door for the Generator room. □ Provide over current and earth fault protection
সুপারিশের তথ্যসূত্র	
কারখানার কার্যক্রম	We will provide design drawing according to guideline.
অগ্রাধিকার	প্রযোজ্য নয়
চূড়ান্ত সময়সীমা	২৪-১২-২০১৬
সংশোধিত সময়সীমা	০১-০১-১৯৭০
অগ্রগতির অবস্থা	শুরু হয়নি
মন্তব্য	08-10-2020 (CVV-1): □ The generator room is not properly segregated from the rest of the occupancy □ No over-current protection provided □ No earth-fault protection 26-01-2021 (CVV-2): # The generator room is not properly segregated from the rest of the occupancy # No over-current protection provided # No earth-fault protection 03-05-2021 (CVV-3): It was in same condition as previous. # The generator room is not properly segregated from the rest of the occupancy # No over-current protection provided # No earth-fault protection 23-08-2021 (CVV-4): It was in same condition as previous. i) The generator room is not properly segregated from the rest of the occupancy ii) No over-current protection provided iii) No earth-fault protection 01-09-2022 visit observation: 1. The generator room was not properly segregated from the rest of the occupancy 2. No over-current & earth-fault protection were provided 23-01-2023: Same as previous visit.

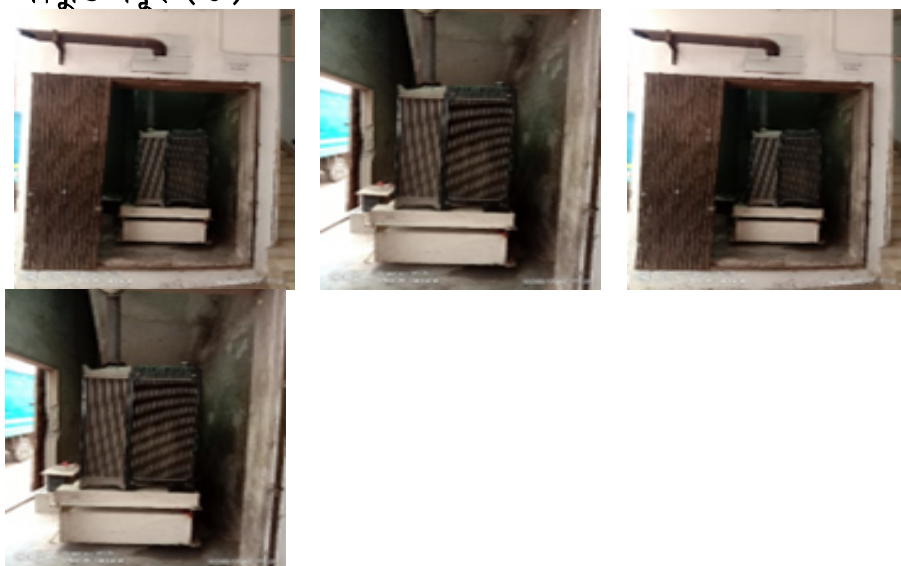
পরিদর্শন পর্যবেক্ষণ	□ The generator room is not properly segregated from the rest of the occupancy □ The generator room smaller than the required size □ Combustible material inside □ No over-current protection provided □ No earth-fault protection
ক্যাপ আইটেম ক্যাটাগরি

কার্যক্রম	□ Provide fire rated enclosure from floor to ceiling and an approved fire rated selfclosing swing door for the Generator room □ Install appropriate detectors.
সুপারিশের তথ্যসূত্র	
কারখানার কার্যক্রম	We will install fire door according to guideline.
অগ্রাধিকার	প্রযোজ্য নয়
চূড়ান্ত সময়সীমা	১২-০৫-২০১৭
সংশোধিত সময়সীমা	০১-০১-১৯৭০
অগ্রগতির অবস্থা	শুরু হয়নি
মন্তব্য	08-10-2020 (CVV-1): □ Provide fire rated enclosure from floor to ceiling and an approved fire rated self-closing swing door for the Generator room □ Install appropriate detectors. 26-01-2021 (CVV-2): # Fire rated enclosure from floor to ceiling and fire rated self-closing swing door for the generator was not provided. # Appropriate detectors was not installed. 03-05-2021 (CVV-3): It was in same condition as previous. # Fire rated enclosure from floor to ceiling and fire rated self-closing swing door for the generator was not provided. # Appropriate detectors was not installed. 23-08-2021 (CVV-4): It was in same condition as previous. i) Fire rated enclosure from floor to ceiling and fire rated self-closing swing door for the generator was not provided. ii) Appropriate detectors was not installed. 01-09-2022 visit observation: 1.Fire rated enclosure from floor to ceiling and fire rated self-closing swing door for the generator were not provided. 2.Appropriate detectors were not installed. 23-01-2023: Same as previous visit.

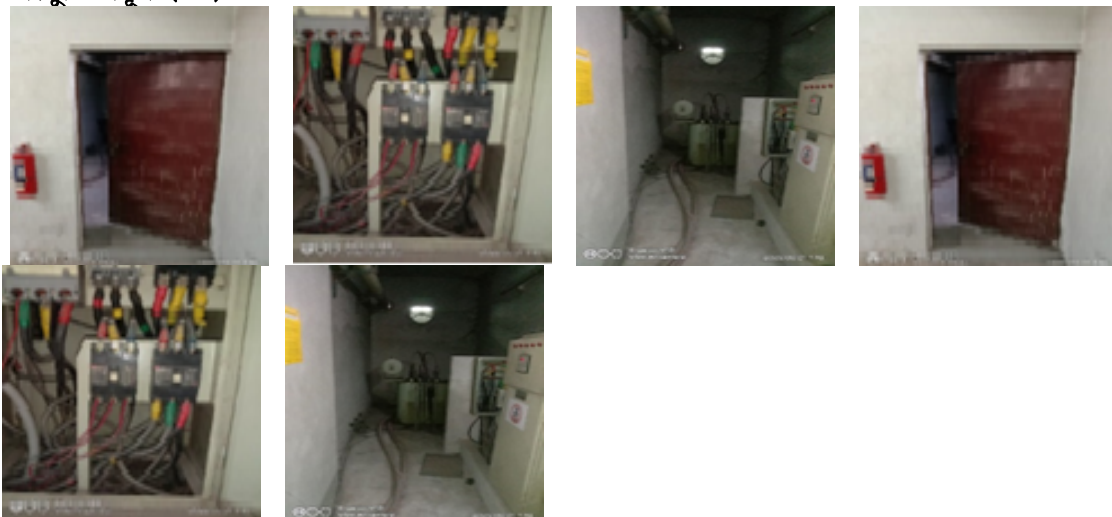
পরিদর্শন পর্যবেক্ষণ	Substation located on higher floor Access limited/barred Connection without lug Partition wall not extended up to the ceiling Panel body & door not earthed Electric cables do not pass through service shaft or insulated conduits
ক্যাপ আইটেম ক্যাটাগরি

কার্যক্রম	Provide easy access to the substation Produce design drawings to demonstrate the incorporation of fire rated enclosure from floor to ceiling and an approved fire rated self-closing swing door for the Substation room. Ensure earthing of panel body & door with fitted condition.
সুপারিশের তথ্যসূত্র	
কারখানার কার্যক্রম	We will provide design drawing according to guideline.
অগ্রাধিকার	প্রযোজ্য নয়
চূড়ান্ত সময়সীমা	২৪-১২-২০১৬
সংশোধিত সময়সীমা	০১-০১-১৯৭০
অগ্রগতির অবস্থা	চলমান
মন্তব্য	08-10-2020(CVV-1): Substation located on higher floor Access limited/barred Connection without lug Partition wall not extended up to the ceiling Panel body & door not earthed Electric cables do not pass through service shaft or insulated conduits 26-01-2021(CVV-2): # Substation was not located higher floor # Access was limited/barred # Connection without lug was found at several DB # Partition wall not extended up to the ceiling # Panel body & door not earthed # Electric cables do not pass through service shaft or insulated conduits 03-05-2021(CVV-3): It was in same condition as previous # Substation was not located higher floor # Access was limited/barred # Connection without lug was found at several DB # Partition wall not extended up to the ceiling # Panel body & door not earthed # Electric cables do not pass through service shaft or insulated conduits 23-08-2021(CVV-4): It was in same condition as previous i) Substation was not located higher floor ii) Access was limited/barred iii) Connection without lug was found at several DB iv) Partition wall not extended up to the ceiling v) Panel body & door not earthed vi) Electric cables do not pass through service shaft or insulated conduits 01-09-2022 visit observation: 1.Substation was not easy accessible. 2.Substation room were not fire rated and fire door were not installed. 3.Earthing of panel board including panel door were not provided. 23-01-2023: 1.Substation was easy accessible. 2.Substation room were not fire rated and fire door were not installed. 3.Earthing of panel board including panel door were not provided.

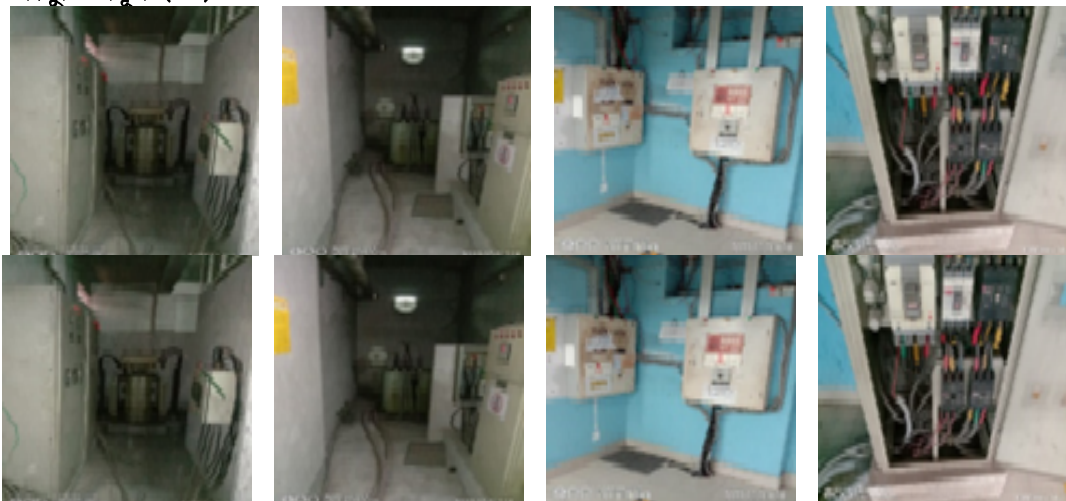
পরিদর্শন পর্যবেক্ষণ	Substation located on higher floor Access limited/barred Connection without lug Partition wall not extended up to the ceiling Panel body & door not earthed Electric cables do not pass through service shaft or insulated conduits
কাপ আইটেম ক্যাটাগরি

কার্যক্রম	Remove combustible materials from substation. Ensure accessibility and ventilation to substation Provide instructions for first aid and artificial respiration from exposure to electrical shock. Provide cover on the cable trench and rubber mat in front of the panel Ensure well-dressed cabling with lugs
সুপারিশের ভিত্তিসূত্র	
কারখানার কার্যক্রম	We will provide first aid and artificial respiration soon.
অগ্রাধিকার	প্রয়োজ্য নয়
চূড়ান্ত সময়সীমা	০৪-১০-২০১৬
সংশোধিত সময়সীমা	০১-০১-১৯৭০
অগ্রগতির অবস্থা	চলমান
মন্তব্য	08-10-2020 (CVV-1): Remove combustible materials from substation. Ensure accessibility and ventilation to substation Provide instructions for first aid and artificial respiration from exposure to electrical shock. Provide cover on the cable trench and rubber mat in front of the panel. Ensure well-dressed cabling with lugs 26-01-2021 (CVV-2): # Combustible materials was not found at substation room # Accessibility and ventilation to substation was not provided. # Instruction for First aid and artificial respiration was not found at substation room. # Cable trench and Rubber mat was not provided in front of DB. # Cable dressing was not provided appropriately. 03-05-2021 (CVV-3): It was in same condition as previous. # Combustible materials was not found at substation room. # Accessibility and ventilation to substation was not provided. # Instruction for First aid and artificial respiration was not found at substation room. On 23-08-2021 (CVV-4): It was in same condition as previous. i) Combustible materials was not found at substation room. ii) Accessibility and ventilation to substation was not provided. iii) Instruction for First aid and artificial respiration was not found at substation room. iv) Cable trench and Rubber mat was not provided in front of DB. v) Cable dressing was not provided appropriately. 01-09-2022 visit observation: 1. Combustible materials was not found at substation room 2. Accessibility and ventilation to substation were not provided. 3. Instruction for First aid and artificial respiration were not found at substation room. 4. Cable trench and Rubber mat were not provided in front of DB. 5. Cable dressing was not provided appropriately. 23-01-2023: Same as previous visit.

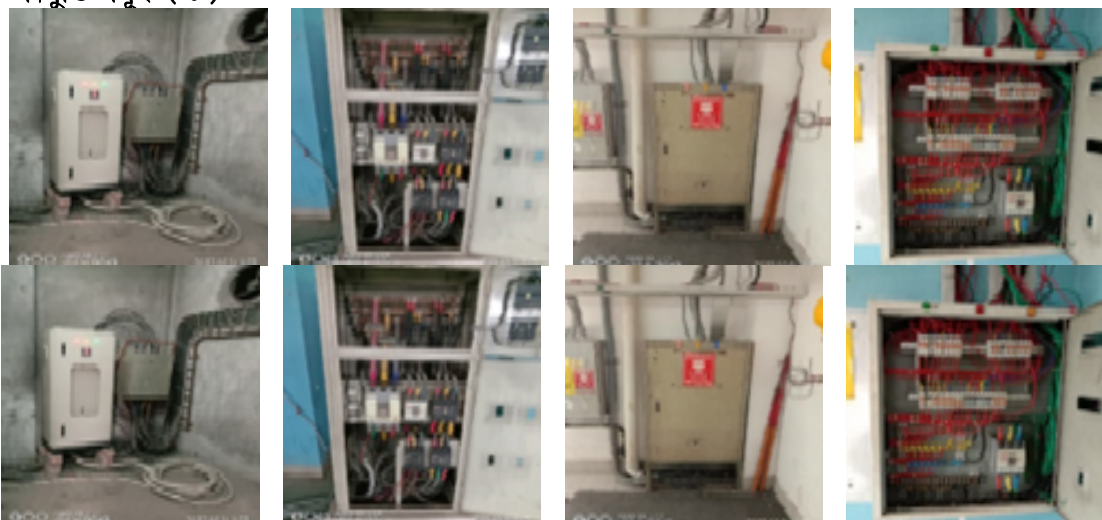
পরিদর্শন পর্যবেক্ষণ	<input type="checkbox"/> No instruction for first aid to electrical shock <input type="checkbox"/> Access obstructed/barred <input type="checkbox"/> Connection without lug <input type="checkbox"/> Undressed messy wire inside <input type="checkbox"/> Body & door not earthed <input type="checkbox"/> Installed on wooden board <input type="checkbox"/> MCCB/MCB box broken/loose <input type="checkbox"/> Does not have duplicate earth leads
ক্যাপ আইটেম ক্যাটাগরি

কার্যক্রম	<input type="checkbox"/> Repair broken/loose MCCB/MCB box. <input type="checkbox"/> Provide duplicate earth leads. <input type="checkbox"/> Provide earthing to body & door. <input type="checkbox"/> Identify cause of burning inside distribution box and take remedial measures <input type="checkbox"/> Provide clear identification mark on distribution board. <input type="checkbox"/> Install MDB/SDB/SB or MCB on metal board.
সুপারিশের তথ্যসূত্র	
কারখানার কার্যক্রম	We have some distribution boards are grounded.
অগ্রাধিকার	প্রয়োজ্য নয়
চূড়ান্ত সময়সীমা	২৬-১১-২০১৬
সংশোধিত সময়সীমা	০১-০১-১৯৭০
অগ্রগতির অবস্থা	চলমান
মন্তব্য	08-10-2020 (CVV-1): <input type="checkbox"/> No instruction for first aid to electrical shock <input type="checkbox"/> Access obstructed/barred <input type="checkbox"/> Connection without lug <input type="checkbox"/> Undressed messy wire inside <input type="checkbox"/> Body & door not earthed <input type="checkbox"/> Installed on wooden board <input type="checkbox"/> MCCB/MCB box broken/loose <input type="checkbox"/> Does not have duplicate earth leads 26-01-2021 (CVV-2): #Connection without lug # Body & door not earthed # Installed on wooden board # MCCB/MCB box was not broken/loose # Does not have duplicate earth leads 03-05-2021 (CVV-3): It was in same condition as previous. #Connection without lug # Body & door not earthed # Installed on wooden board # MCCB/MCB box was not broken/loose # Does not have duplicate earth leads 23-08-2021 (CVV-4): It was in same condition as previous. i) Connection without lug ii) Body & door not earthed iii) Installed on wooden board iv) MCCB/MCB box was not broken/loose v) Does not have duplicate earth leads 01-09-2022 visit observation: 1.Panel board were not install properly. 2.Duplicate earth leads were not provided in MDB. 3.Body & door earthing were found in distribution boards. 4.No visible burn were observed. 5.Clear identification mark on distribution board were not found. 6.MDB/SDB/SB or MCB were installed on metal board. 23-01-2023: Same as previous visit.

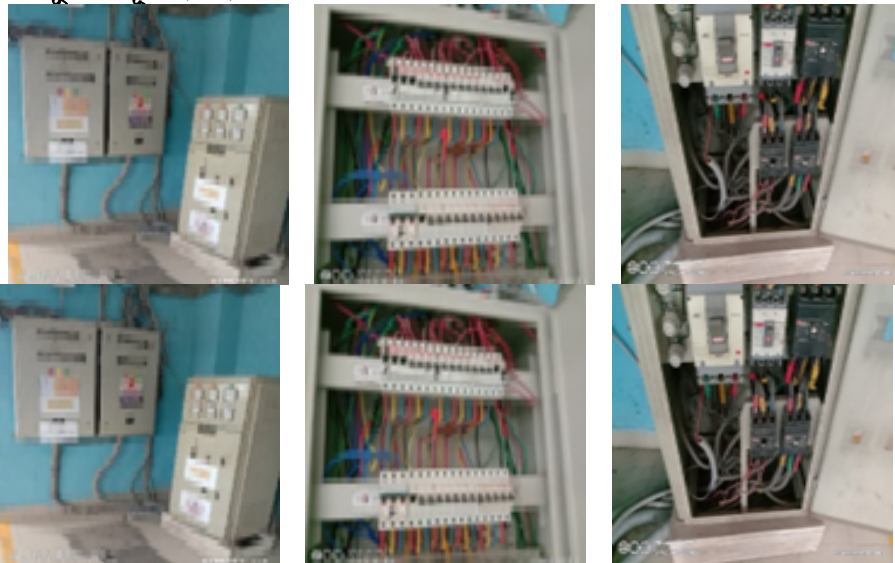
পরিদর্শন পর্যবেক্ষণ	□ No instruction for first aid to electrical shock □ Access obstructed/barred □ Connection without lug □ Undressed messy wire inside □ Body & door not earthed □ Installed on wooden board □ MCCB/MCB box broken/loose □ Does not have duplicate earth leads
ক্যাপ আইটেম ক্যাটাগরি

কার্যক্রম	□ Provide instructions for first aid from exposure to electrical shock □ Remove obstruction to ensure access to MDB/MCCB Box □ Ensure well-dressed cabling with lugs
সুপারিশের তথ্যসূত্র	
কারখানার কার্যক্রম	We will provide first aid and artificial respiration soon. Sockets are provided for some cables.
অগ্রাধিকার	প্রয়োজ্য নয়
চূড়ান্ত সময়সীমা	০৪-১০-২০১৬
সংশোধিত সময়সীমা	০১-০১-১৯৭০
অগ্রগতির অবস্থা	চলমান
মন্তব্য	08-10-2020 (CVV-1): □ No instruction for first aid to electrical shock □ Access obstructed/barred □ Connection without lug □ Undressed messy wire inside □ Body & door not earthed □ Installed on wooden board □ MCCB/MCB box broken/loose □ Does not have duplicate earth leads 26-01-2021 (CVV-2): # No instruction for first aid to electrical shock # Access obstructed/barred # Undressed messy wire inside 03-05-2021 (CVV-3): It was in same condition as previous # No instruction for first aid to electrical shock # Access obstructed/barred # Undressed messy wire inside 23-08-2021 (CVV-4): It was in same condition as previous i) No instruction for first aid to electrical shock ii) Access obstructed/barred iii) Undressed messy wire inside 01-09-2022 visit observation: 1. Instructions for first aid from exposure to electrical shock were not provided at required location. 2. Panel board were found easy accessible. 3. Un-dressed cabling without lugs were found. 23-01-2023: Same as previous visit.
