গণপ্রজাতন্ত্রী বাংলাদেশ সরকার
শ্রম ও কর্মসংস্থান মন্ত্রণালয়
কলকারখানা ও প্রতিষ্ঠান পরিদর্শন অধিদপ্তর

ক্যাপ পর্যবেক্ষণের তথ্য

| কারখানার নাম | এ্যাংগোরা মোটোরস লিঃ |
| মূল্যায়নের ধরণ: কাঠামোগত মূল্যায়ন | পর্যবেক্ষণের তারিখ: ০৩-০৪-২০২৩ |

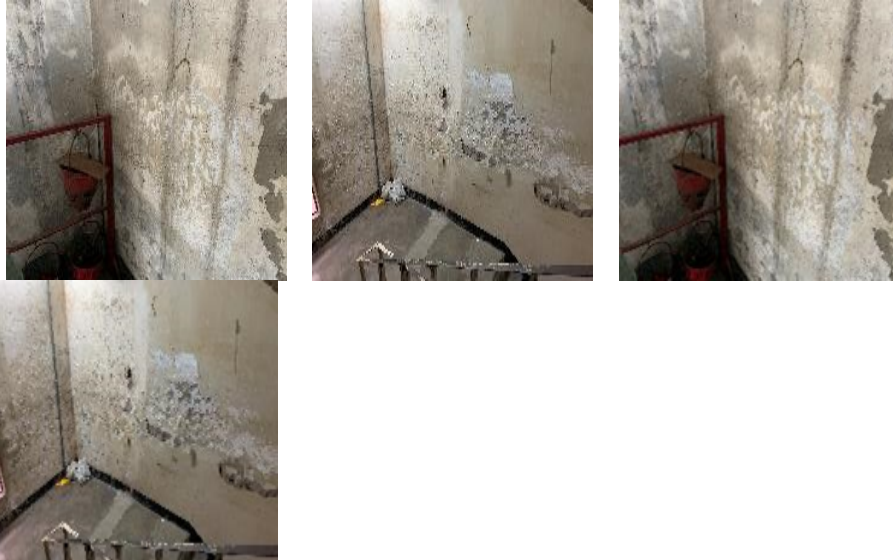
| পরিদর্শন পর্ববেক্ষণ | Crack and Dampness |

| মন্তব্য | 20.09.2020: Crack and partially damaged net cements finished toping on floor and stair cases. Some places repair. It is ongoing process. 10/12/2020: Dampness found mostly on toilet areas walls which are mostly observed in the stair cases. They should be checked by an engineer and corrected properly. 07/06/2021: Dampness found mostly on toilet areas walls which are mostly observed in the stair cases. The factory management is now saying that they will solve this issue within one month. 22.08.2021: Dampness found mostly on toilet areas walls which are mostly observed in the stair cases. The factory management is now saying that they will solve this issue within one month. 01/08/2022: Cracks and dampness were found in the stair cases on the date of inspection. 03/04/2023: Cracks and dampness were found in the stair cases on the date of inspection. |

| কার্যক্রম | Cracked and partially damaged net cement finished topping in floors and stair cases of the building shall be repaired by adopting appropriate method for both aesthetic and serviceability requirements. |

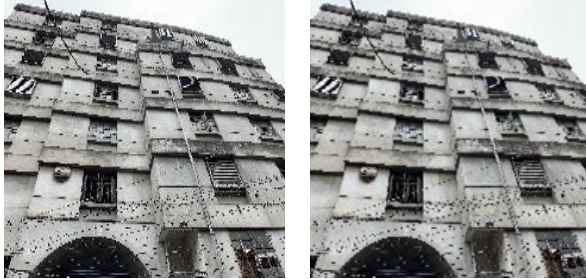
| পরিদর্শন পর্ববেক্ষণ | Un-Approved vertical extension |

| মন্তব্য | 20.09.2020: There is no un approved vertical extension. Roof top will need keep clean. 10/12/2020: No un-Approved vertical extension found on the visiting date. 07/06/2021: No un-Approved vertical extension found during inspection. 22.08.2021: No un-Approved vertical extension found during inspection. 01/08/2022: No un-Approved vertical extension found during inspection date. 03/04/2023: During the visit date no un approved vertical extension was observed. |

| কার্যক্রম | The roof top shall be kept clean. The small store room used for waste fabric shall be removed from the roof top to satisfy the requirements of RAJUK approved plan. The roof top should be kept clean and tidy. |
