গণপ্রজাতন্ত্রী বাংলাদেশ সরকার  
শ্রম ও কর্মসংস্থান মন্ত্রণালয়  
কলকারখানা ও প্রতিষ্ঠান পরিদর্শন অধিদপ্তর

ক্যাপ পর্যবেক্ষণের তথ্য

কারখানার নাম	কারনুর গার্মেন্টস লিমিটেড।		
ঠিকানা	1028/1/2, Malibagh Bazar Road,		
কারখানার কোড	DHK203		
কালার কোড			
মূল্যায়নের ধরণ: বৈদ্যুতিক মূল্যায়ন		পর্যবেক্ষণের তারিখ: ২৩-০১-২০২৩	
১. পর্যবেক্ষণ

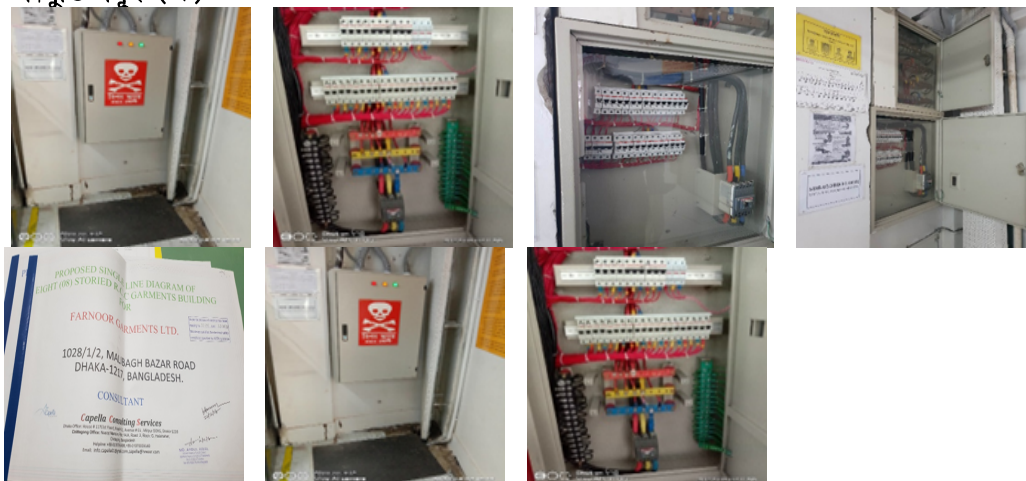
### সংযুক্তিসমূহ (৭)

পরিদর্শন পর্যবেক্ষণ	<input type="checkbox"/> No instruction for first aid to electrical shock <input type="checkbox"/> Access obstructed/barred <input type="checkbox"/> Connection without lug <input type="checkbox"/> Body & door not earthed <input type="checkbox"/> No clear identification mark on distribution board <input type="checkbox"/> SLD of circuit not available
ক্যাপ আইটেম ক্যাটাগরি

কার্যক্রম	<input type="checkbox"/> Provide duplicate earth leads. <input type="checkbox"/> Provide earthing to body & door. <input type="checkbox"/> Provide clear identification mark on distribution board <input type="checkbox"/> Connection without lug <input type="checkbox"/> Install MDB/SDB/SB or MCB on metal board.
সুপারিশের তথ্যসূত্র	
কারখানার কার্যক্রম	Initiative has been taken and they have complete this issue
অগ্রাধিকার	প্রয়োজ্য নয়
চূড়ান্ত সময়সীমা	-
সংশোধিত সময়সীমা	০১-০১-১৯৭০
অগ্রগতির অবস্থা	সংশোধিত
মন্তব্য	<p>30-06-2020 : Electrical single line diagram and layout drawings are available at site. 1. Provided clear identification mark on distribution board. 2. Found instruction board for first aid to electrical shock and artificial respiration. 3. Body &amp; Door of DB is properly earthed. 4. Insulation of rubber mats in front of Distribution boards are sufficient. 5. Multiple looping are not found in DB/MDB. 6. Connection without lug present in DB. 7. SLD of circuit are available. 19-01-2021 Visit Observation: Electrical single line diagram and layout drawings are available at site. 1. Provided clear identification mark on distribution board. 2. Found instruction board for first aid to electrical shock and artificial respiration. 3. Body &amp; Door of DB is properly earthed. 4. Insulation of rubber mats in front of Distribution boards are sufficient. 5. Multiple looping are not found in DB/MDB. 6. Connection without lug present in DB. 7. SLD of circuit are available. 16-08-2021 Visit Observation: Electrical single line diagram and layout drawings are available at site. 1. Provided clear identification mark on distribution board. 2. Found instruction board for first aid to electrical shock and artificial respiration. 3. Body &amp; Door of DB is properly earthed. 4. Insulation of rubber mats in front of Distribution boards are sufficient. 5. Multiple looping are not found in DB/MDB. 6. Connection without lug present in DB. 7. SLD of circuit are available. 02-08-2022 Visit Observation: Electrical single line diagram and layout drawings are available at site. 1. Provided clear identification mark on distribution board. 2. Found instruction board for first aid to electrical shock and artificial respiration. 3. Body &amp; Door of DB is properly earthed. 4. Insulation of rubber mats in front of Distribution boards are sufficient. 5. Multiple looping are not found in DB/MDB. 6. Connection without lug present in DB. 7. SLD of circuit are available. 23-01-2023: Electrical single line diagram and layout drawings are available at site. 1. Provided clear identification mark on distribution board. 2. Found instruction board for first aid to electrical shock and artificial respiration. 3. Body &amp; Door of DB is properly earthed. 4. Insulation of rubber mats in front of Distribution boards are sufficient. 5. Multiple looping are not found in DB/MDB. 6. Connection without lug present in DB. 7. SLD of circuit are available.</p>

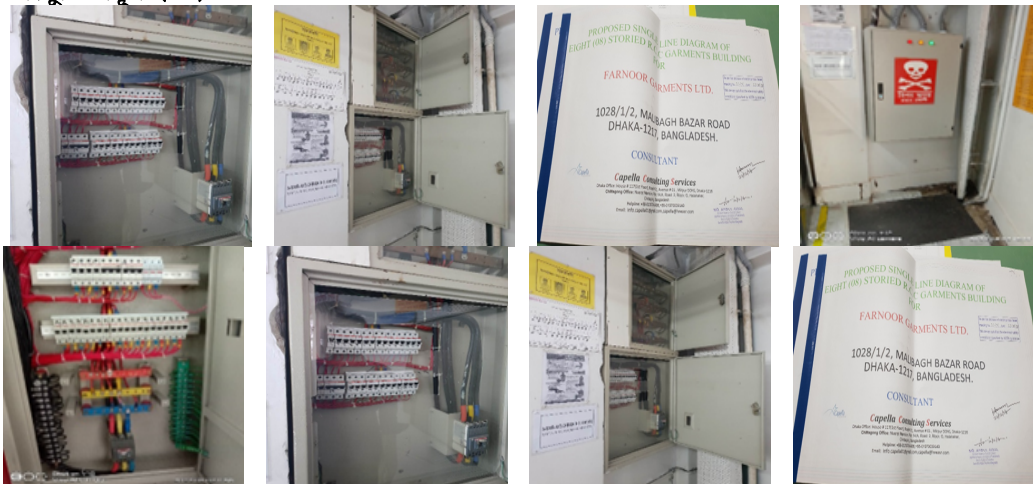
## সংযুক্তিসমূহ (৮)

পরিদর্শন পর্যবেক্ষণ	□ No instruction for first aid to electrical shock □ Access obstructed/barred □ Connection without lug □ Body & door not earthed □ No clear identification mark on distribution board □ SLD of circuit not available
ক্যাপ আইটেম ক্যাটাগরি

কার্যক্রম	□ Provide instructions for first aid from exposure to electrical shock □ Remove obstruction to ensure access to MDB/MCB Box
সুপারিশের তথ্যসূত্র	
কারখানার কার্যক্রম	Initiative has been taken and they have complete this issue
অগ্রাধিকার	প্রয়োজ্য নয়
চূড়ান্ত সময়সীমা	-
সংশোধিত সময়সীমা	০১-০১-১৯৭০
অগ্রগতির অবস্থা	সংশোধিত
মন্তব্য	30-06-2020: Electrical single line diagram and layout drawings are available at site. 1. Provided clear identification mark on distribution board. 2. Found instruction board for first aid to electrical shock and artificial respiration. 3. Body & Door of DB is properly earthed. 4. Insulation of rubber mats in front of Distribution boards are sufficient. 5. Multiple looping are not found in DB/MDB. 6. Connection without lug present in DB. 7. SLD of circuit are available. 19-01-2021 Visit Observation: Electrical single line diagram and layout drawings are available at site. 1. Provided clear identification mark on distribution board. 2. Found instruction board for first aid to electrical shock and artificial respiration. 3. Body & Door of DB is properly earthed. 4. Insulation of rubber mats in front of Distribution boards are sufficient. 5. Multiple looping are not found in DB/MDB. 6. Connection without lug present in DB. 7. SLD of circuit are available. 16-08-2021 Visit Observation: Electrical single line diagram and layout drawings are available at site. 1. Provided clear identification mark on distribution board. 2. Found instruction board for first aid to electrical shock and artificial respiration. 3. Body & Door of DB is properly earthed. 4. Insulation of rubber mats in front of Distribution boards are sufficient. 5. Multiple looping are not found in DB/MDB. 6. Connection without lug present in DB. 7. SLD of circuit are available. 02-08-2022 Visit Observation: Electrical single line diagram and layout drawings are available at site. 1. Provided clear identification mark on distribution board. 2. Found instruction board for first aid to electrical shock and artificial respiration. 3. Body & Door of DB is properly earthed. 4. Insulation of rubber mats in front of Distribution boards are sufficient. 5. Multiple looping are not found in DB/MDB. 6. Connection without lug present in DB. 7. SLD of circuit are available. 23-01-2023: Electrical single line diagram and layout drawings are available at site. 1. Provided clear identification mark on distribution board. 2. Found instruction board for first aid to electrical shock and artificial respiration. 3. Body & Door of DB is properly earthed. 4. Insulation of rubber mats in front of Distribution boards are sufficient. 5. Multiple looping are not found in DB/MDB. 6. Connection without lug present in DB. 7. SLD of circuit are available.
