গণপ্রজাতন্ত্রী বাংলাদেশ সরকার  
শ্রম ও কর্মসংস্থান মন্ত্রণালয়  
কলকারখানা ও প্রতিষ্ঠান পরিদর্শন অধিদপ্তর

ক্যাপ পর্যবেক্ষণের তথ্য

কারখানার নাম	কারনুর গার্মেন্টস লিমিটেড।
ঠিকানা	1028/1/2, Malibagh Bazar Road,
কারখানার কোড	DHK203
কালার কোড	
মূল্যায়নের ধরণ: <b>বৈদ্যুতিক মূল্যায়ন</b>	পর্যবেক্ষণের তারিখ: ২৩-০১-২০২৩
১. পর্যবেক্ষণ

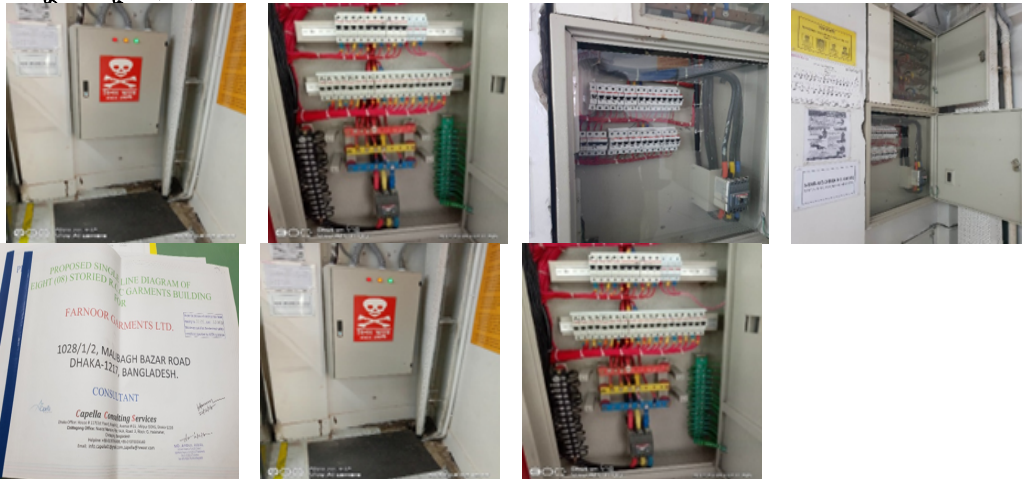
পরিদর্শন পর্যবেক্ষণ	<input type="checkbox"/> No instruction for first aid to electrical shock <input type="checkbox"/> Access obstructed/barred <input type="checkbox"/> Connection without lug <input type="checkbox"/> <input type="checkbox"/> Body & door not earthed <input type="checkbox"/> No clear identification mark on distribution board <input type="checkbox"/> SLD of circuit not available
ক্যাপ আইটেম ক্যাটাগরি

কার্যক্রম	<input type="checkbox"/> Provide duplicate earth leads. <input type="checkbox"/> Provide earthing to body & door. <input type="checkbox"/> Provide clear identification mark on distribution board <input type="checkbox"/> Connection without lug <input type="checkbox"/> Install MDB/SDB/SB or MCB on metal board.
সুপারিশের তথ্যসূত্র	
কারখানার কার্যক্রম	Initiative has been taken and they have complete this issue
অগ্রাধিকার	প্রশোজা লব
চূড়ান্ত সময়সীমা	-
সংশোধিত সময়সীমা	০১-০১-১৯৭০
অগ্রগতির অবস্থা	সংশোধিত
মন্তব্য	<p>30-06-2020 : Electrical single line diagram and layout drawings are available at site. 1. Provided clear identification mark on distribution board. 2. Found instruction board for first aid to electrical shock and artificial respiration. 3. Body &amp; Door of DB is properly earthed. 4. Insulation of rubber mats in front of Distribution boards are sufficient. 5. Multiple looping are not found in DB/MDB. 6. Connection without lug present in DB. 7. SLD of circuit are available. 19-01-2021 Visit Observation: Electrical single line diagram and layout drawings are available at site. 1. Provided clear identification mark on distribution board. 2. Found instruction board for first aid to electrical shock and artificial respiration. 3. Body &amp; Door of DB is properly earthed. 4. Insulation of rubber mats in front of Distribution boards are sufficient. 5. Multiple looping are not found in DB/MDB. 6. Connection without lug present in DB. 7. SLD of circuit are available. 16-08-2021 Visit Observation: Electrical single line diagram and layout drawings are available at site. 1. Provided clear identification mark on distribution board. 2. Found instruction board for first aid to electrical shock and artificial respiration. 3. Body &amp; Door of DB is properly earthed. 4. Insulation of rubber mats in front of Distribution boards are sufficient. 5. Multiple looping are not found in DB/MDB. 6. Connection without lug present in DB. 7. SLD of circuit are available. 02-08-2022 Visit Observation: Electrical single line diagram and layout drawings are available at site. 1. Provided clear identification mark on distribution board. 2. Found instruction board for first aid to electrical shock and artificial respiration. 3. Body &amp; Door of DB is properly earthed. 4. Insulation of rubber mats in front of Distribution boards are sufficient. 5. Multiple looping are not found in DB/MDB. 6. Connection without lug present in DB. 7. SLD of circuit are available. 23-01-2023: Electrical single line diagram and layout drawings are available at site. 1. Provided clear identification mark on distribution board. 2. Found instruction board for first aid to electrical shock and artificial respiration. 3. Body &amp; Door of DB is properly earthed. 4. Insulation of rubber mats in front of Distribution boards are sufficient. 5. Multiple looping are not found in DB/MDB. 6. Connection without lug present in DB. 7. SLD of circuit are available.</p>

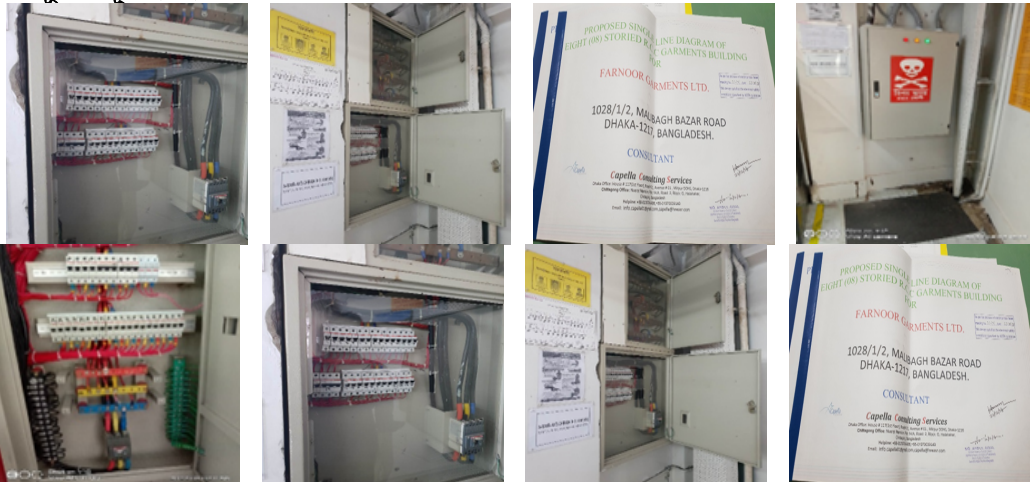
পরিদর্শন পর্যবেক্ষণ	<input type="checkbox"/> No instruction for first aid to electrical shock <input type="checkbox"/> Access obstructed/barred <input type="checkbox"/> Connection without lug <input type="checkbox"/> <input type="checkbox"/> Body & door not earthed <input type="checkbox"/> No clear identification mark on distribution board <input type="checkbox"/> SLD of circuit not available
ক্যাপ আইটেম ক্যাটাগরি

কার্যক্রম	<input type="checkbox"/> Provide instructions for first aid from exposure to electrical shock <input type="checkbox"/> Remove obstruction to ensure access to MDB/MCB Box
সুপারিশের তথ্যসূত্র	
কারখানার কার্যক্রম	Initiative has been taken and they have complete this issue
অগ্রাধিকার	প্রয়োজ্য নয়
চূড়ান্ত সময়সীমা	-
সংশোধিত সময়সীমা	০১-০১-১৯৭০
অগ্রগতির অবস্থা	সংশোধিত
মন্তব্য	<p>30-06-2020: Electrical single line diagram and layout drawings are available at site. 1. Provided clear identification mark on distribution board. 2. Found instruction board for first aid to electrical shock and artificial respiration. 3. Body &amp; Door of DB is properly earthed. 4. Insulation of rubber mats in front of Distribution boards are sufficient. 5. Multiple looping are not found in DB/MDB. 6. Connection without lug present in DB. 7. SLD of circuit are available. 19-01-2021 Visit Observation: Electrical single line diagram and layout drawings are available at site. 1. Provided clear identification mark on distribution board. 2. Found instruction board for first aid to electrical shock and artificial respiration. 3. Body &amp; Door of DB is properly earthed. 4. Insulation of rubber mats in front of Distribution boards are sufficient. 5. Multiple looping are not found in DB/MDB. 6. Connection without lug present in DB. 7. SLD of circuit are available. 16-08-2021 Visit Observation: Electrical single line diagram and layout drawings are available at site. 1. Provided clear identification mark on distribution board. 2. Found instruction board for first aid to electrical shock and artificial respiration. 3. Body &amp; Door of DB is properly earthed. 4. Insulation of rubber mats in front of Distribution boards are sufficient. 5. Multiple looping are not found in DB/MDB. 6. Connection without lug present in DB. 7. SLD of circuit are available. 02-08-2022 Visit Observation: Electrical single line diagram and layout drawings are available at site. 1. Provided clear identification mark on distribution board. 2. Found instruction board for first aid to electrical shock and artificial respiration. 3. Body &amp; Door of DB is properly earthed. 4. Insulation of rubber mats in front of Distribution boards are sufficient. 5. Multiple looping are not found in DB/MDB. 6. Connection without lug present in DB. 7. SLD of circuit are available. 23-01-2023: Electrical single line diagram and layout drawings are available at site. 1. Provided clear identification mark on distribution board. 2. Found instruction board for first aid to electrical shock and artificial respiration. 3. Body &amp; Door of DB is properly earthed. 4. Insulation of rubber mats in front of Distribution boards are sufficient. 5. Multiple looping are not found in DB/MDB. 6. Connection without lug present in DB. 7. SLD of circuit are available.</p>

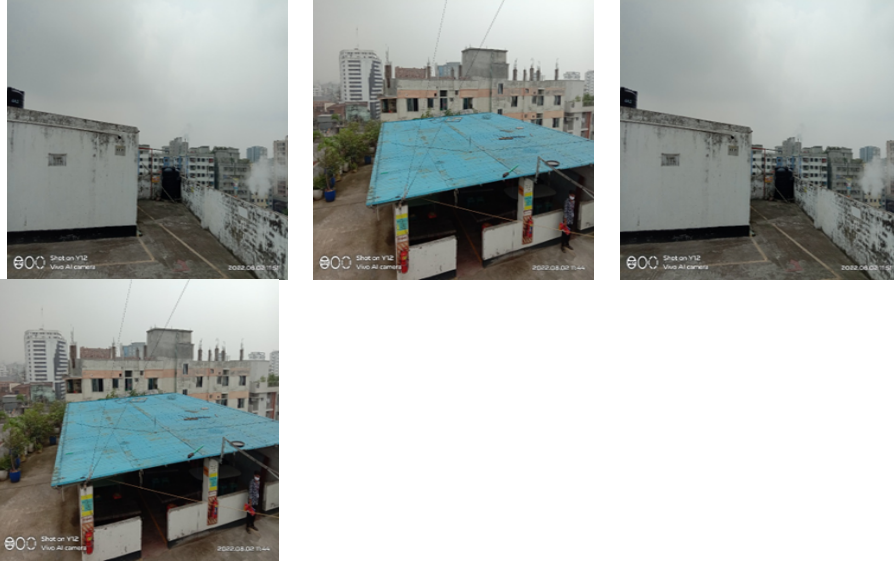
পরিদর্শন পর্যবেক্ষণ	☐ No lightning protection system not available
কাপ আইটেম ক্যাটাগরি

কার্যক্রম	☐ Provide appropriate Lightning protection system. ☐ Provide air termination network
সুপারিশের তথ্যসূত্র	
কারখানার কার্যক্রম	Initiative has been taken and they have complete this issue
অগ্রাধিকার	৬ মাস
চূড়ান্ত সময়সীমা	-
সংশোধিত সময়সীমা	০১-০১-১৯৭০
অগ্রগতির অবস্থা	সংশোধিত
মন্তব্য	On 30-06-2020 Visit Observation: Provided LPS system. 19-01-2021 Visit Observation: Approved LPS design found on site. But Lightning protection system is not install. 16-08-2021 Visit Observation: Approved LPS design found on site. But Lightning protection system is not install. 02-08-2022 Visit Observation: Lightning protection system (LPS) is installed but mismatch has been found with approved drawing. Air terminal & main conductor missing in some area. Need to install as per standard & update drawing. 23-01-2023 Visit Observation: Lightning protection system (LPS) were installed on roof of the building.
