গণপ্রজাতন্ত্রী বাংলাদেশ সরকার
শ্রম ও কর্মসংস্থান মন্ত্রণালয়
কলকারখানা ও প্রতিষ্ঠান পরিদর্শন অধিদপ্তর

ক্যাপ পর্যবেক্ষণের তথ্য

কারখানার নাম	কারনুর গার্মেন্টস লিমিটেড।
ঠিকানা	1028/1/2, Malibagh Bazar Road,
কারখানার কোড	DHK203
কালার কোড

মূল্যায়নের ধরণ: বৈদ্যুতিক মূল্যায়ন	পর্যবেক্ষণের তারিখ: ২৩-০১-২০২৩
১. পর্যবেক্ষণ

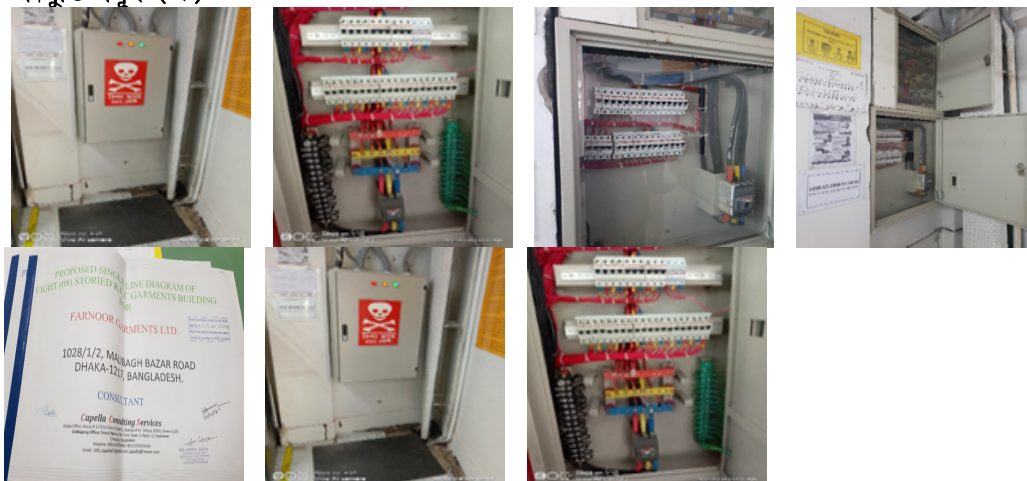
পরিদর্শন পর্যবেক্ষণ	<input type="checkbox"/> No instruction for first aid to electrical shock <input type="checkbox"/> Access obstructed/barred <input type="checkbox"/> Connection without lug <input type="checkbox"/> Body & door not earthed <input type="checkbox"/> No clear identification mark on distribution board <input type="checkbox"/> SLD of circuit not available
ক্যাপ আইটেম ক্যাটাগরি

কার্যক্রম	<input type="checkbox"/> Provide duplicate earth leads. <input type="checkbox"/> Provide earthing to body & door. <input type="checkbox"/> Provide clear identification mark on distribution board <input type="checkbox"/> Connection without lug <input type="checkbox"/> Install MDB/SDB/SB or MCB on metal board.
সুপারিশের তথ্যসূত্র	
কারখানার কার্যক্রম	Initiative has been taken and they have complete this issue
অগ্রাধিকার	প্রয়োজ্য নয়
চূড়ান্ত সময়সীমা	-
সংশোধিত সময়সীমা	০১-০১-১৯৭০
অগ্রগতির অবস্থা	সংশোধিত
মন্তব্য	<p>30-06-2020 : Electrical single line diagram and layout drawings are available at site. 1. Provided clear identification mark on distribution board. 2. Found instruction board for first aid to electrical shock and artificial respiration. 3. Body & Door of DB is properly earthed. 4. Insulation of rubber mats in front of Distribution boards are sufficient. 5. Multiple looping are not found in DB/MDB. 6. Connection without lug present in DB. 7. SLD of circuit are available. 19-01-2021 Visit Observation: Electrical single line diagram and layout drawings are available at site. 1. Provided clear identification mark on distribution board. 2. Found instruction board for first aid to electrical shock and artificial respiration. 3. Body & Door of DB is properly earthed. 4. Insulation of rubber mats in front of Distribution boards are sufficient. 5. Multiple looping are not found in DB/MDB. 6. Connection without lug present in DB. 7. SLD of circuit are available. 16-08-2021 Visit Observation: Electrical single line diagram and layout drawings are available at site. 1. Provided clear identification mark on distribution board. 2. Found instruction board for first aid to electrical shock and artificial respiration. 3. Body & Door of DB is properly earthed. 4. Insulation of rubber mats in front of Distribution boards are sufficient. 5. Multiple looping are not found in DB/MDB. 6. Connection without lug present in DB. 7. SLD of circuit are available. 02-08-2022 Visit Observation: Electrical single line diagram and layout drawings are available at site. 1. Provided clear identification mark on distribution board. 2. Found instruction board for first aid to electrical shock and artificial respiration. 3. Body & Door of DB is properly earthed. 4. Insulation of rubber mats in front of Distribution boards are sufficient. 5. Multiple looping are not found in DB/MDB. 6. Connection without lug present in DB. 7. SLD of circuit are available. 23-01-2023: Electrical single line diagram and layout drawings are available at site. 1. Provided clear identification mark on distribution board. 2. Found instruction board for first aid to electrical shock and artificial respiration. 3. Body & Door of DB is properly earthed. 4. Insulation of rubber mats in front of Distribution boards are sufficient. 5. Multiple looping are not found in DB/MDB. 6. Connection without lug present in DB. 7. SLD of circuit are available.</p>

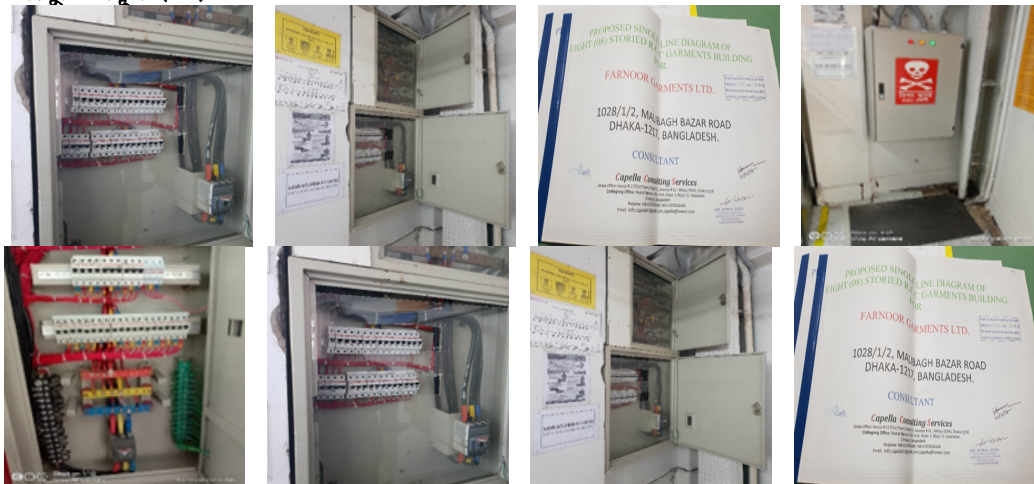
পরিদর্শন পর্যবেক্ষণ	□ No instruction for first aid to electrical shock □ Access obstructed/barred □ Connection without lug □ Body & door not earthed □ No clear identification mark on distribution board □ SLD of circuit not available
ক্যাপ আইটেম ক্যাটাগরি

কার্যক্রম	□ Provide instructions for first aid from exposure to electrical shock □ Remove obstruction to ensure access to MDB/MCB Box
সুপারিশের তথ্যসূত্র	
কারখানার কার্যক্রম	Initiative has been taken and they have complete this issue
অগ্রাধিকার	প্রয়োজ্য নয়
চূড়ান্ত সময়সীমা	-
সংশোধিত সময়সীমা	০১-০১-১৯৭০
অগ্রগতির অবস্থা	সংশোধিত
মন্তব্য	30-06-2020: Electrical single line diagram and layout drawings are available at site. 1. Provided clear identification mark on distribution board. 2. Found instruction board for first aid to electrical shock and artificial respiration. 3. Body & Door of DB is properly earthed. 4. Insulation of rubber mats in front of Distribution boards are sufficient. 5. Multiple looping are not found in DB/MDB. 6. Connection without lug present in DB. 7. SLD of circuit are available. 19-01-2021 Visit Observation: Electrical single line diagram and layout drawings are available at site. 1. Provided clear identification mark on distribution board. 2. Found instruction board for first aid to electrical shock and artificial respiration. 3. Body & Door of DB is properly earthed. 4. Insulation of rubber mats in front of Distribution boards are sufficient. 5. Multiple looping are not found in DB/MDB. 6. Connection without lug present in DB. 7. SLD of circuit are available. 16-08-2021 Visit Observation: Electrical single line diagram and layout drawings are available at site. 1. Provided clear identification mark on distribution board. 2. Found instruction board for first aid to electrical shock and artificial respiration. 3. Body & Door of DB is properly earthed. 4. Insulation of rubber mats in front of Distribution boards are sufficient. 5. Multiple looping are not found in DB/MDB. 6. Connection without lug present in DB. 7. SLD of circuit are available. 02-08-2022 Visit Observation: Electrical single line diagram and layout drawings are available at site. 1. Provided clear identification mark on distribution board. 2. Found instruction board for first aid to electrical shock and artificial respiration. 3. Body & Door of DB is properly earthed. 4. Insulation of rubber mats in front of Distribution boards are sufficient. 5. Multiple looping are not found in DB/MDB. 6. Connection without lug present in DB. 7. SLD of circuit are available. 23-01-2023: Electrical single line diagram and layout drawings are available at site. 1. Provided clear identification mark on distribution board. 2. Found instruction board for first aid to electrical shock and artificial respiration. 3. Body & Door of DB is properly earthed. 4. Insulation of rubber mats in front of Distribution boards are sufficient. 5. Multiple looping are not found in DB/MDB. 6. Connection without lug present in DB. 7. SLD of circuit are available.
