গণপ্রজাতন্ত্রী বাংলাদেশ সরকার
শ্রম ও কর্মসংস্থান মন্ত্রণালয়
কলকারখানা ও প্রতিষ্ঠান পরিদর্শন অধিদপ্তর

ক্যাপ পর্যবেক্ষণের তথ্য

কারখানার নাম	কারনুর গার্মেন্টস লিমিটেড।
ঠিকানা	1028/1/2, Malibagh Bazar Road,
কারখানার কোড	DHK203
কালার কোড	
মূল্যায়নের ধরণ: কাঠামোগত মূল্যায়ন	পর্যবেক্ষণের তারিখ: ২৩-০১-২০২৩
১. পর্যবেক্ষণ

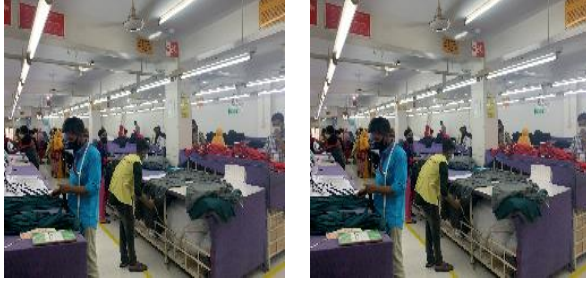
পরিদর্শন পর্যবেক্ষণ	Distress in primary structural elements
কাপ আইটেম ক্যাটাগরি

কার্যক্রম	The owner or user of the building should be vigilant about development of any distress, particularly in primary structural elements of the building. If cracks appear, propagate and widen, detailed assessment and adoption of remedial measures may become necessary.
সুপারিশের তথ্যসূত্র	
কারখানার কার্যক্রম	No distress in Primary Structural Element has been found until today since the day of assessment
অগ্রাধিকার	৬ মাস
চূড়ান্ত সময়সীমা	-
সংশোধিত সময়সীমা	২৫-১২-২০২২
অগ্রগতির অবস্থা	সংশোধিত
মন্তব্য	01/10/2020: There are no major Distress in Primary Structural Element. 19/01/2021: No distress in any primary structural elements found on the visiting date. But it a matter of regular inspection, so it should be inspected regularly for this issue. 16/08/2021: Same as previous. No distress in any primary structural elements found on the visiting date. 02/08/2022: No distress were found in any primary structural elements during the inspection date. 23-01-2023: No distress were found in any primary structural elements during the inspection date.
