গণপ্রজাতন্ত্রী বাংলাদেশ সরকার
শ্রম ও কর্মসংস্থান মন্ত্রণালয়
কলকারখানা ও প্রতিষ্ঠান পরিদর্শন অধিদপ্তর

ক্যাপ পর্যবেক্ষণের তথ্য

| কারখানার নাম | কারনুর গার্মেন্টস লিমিটেড। |
| মূল্যায়নের ধরণ: কাঠামোগত মূল্যায়ন | পর্যবেক্ষণের তারিখ: ২৩-০১-২০২৩ |

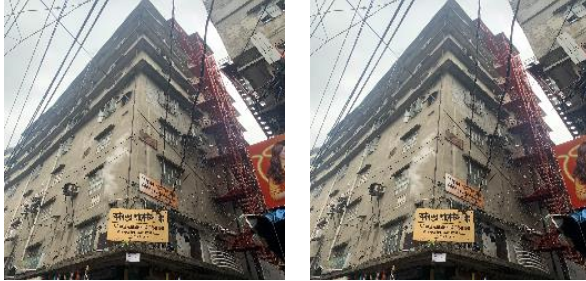
| পরিদর্শন পর্যবেক্ষণ | Horizontal and vertical extension |

| মন্তব্য | 01/10/2020: There are no horizontal or vertical extension was found on the date of inspection. 19/01/2021: No horizontal or vertical extension found on the visiting date. 16/08/2021: Same as previous. No horizontal or vertical extension found on the visiting date. 02/08/2022: No horizontal or vertical extension was found during the inspection date. 23-01-2023: No horizontal or vertical extension was found during the inspection date. |

| কার্যক্রম | No horizontal and vertical extension shall be made with out detail investigation and no further construction is to be carried out on this building untill check structural adequacy. |
