গণপ্রজাতন্ত্রী বাংলাদেশ সরকার  
শ্রম ও কর্মসংস্থান মন্ত্রণালয়  
কলকারখানা ও প্রতিষ্ঠান পরিদর্শন অধিদপ্তর

ক্যাপ পর্যবেক্ষণের তথ্য

| কারখানার নাম | এয়াপারেল ইন্ডাস্ট্রি লিঃ | | |
| মূল্যায়নের ধরন: বৈদ্যুতিক মূল্যায়ন | | পর্যবেক্ষণের তারিখ: ০৫-০৪-২০২৩ | |

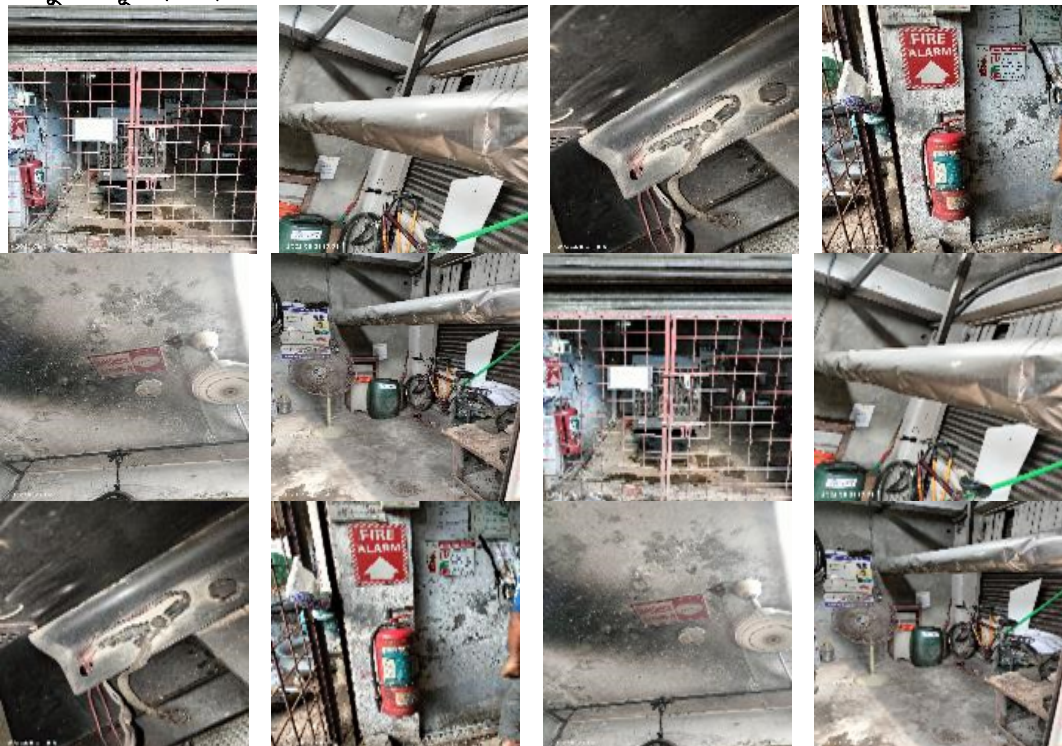
### সংযুক্তিসমূহ (১২)

| পরিদর্শন<br>পর্যবেক্ষণ | The generator room smaller than the required size<br>Inadequate ventilation of the generator room<br>No detector in generator room<br>No fire-fighting equipment is present in the generator room<br>One point frame earthing of generator instead of two<br>Oil/lint/dirt in generator room<br>No detector in generator room |

| মন্তব্য | 6-07-2020, 02-11-2020: The generator room smaller than the required size. Inadequate ventilation of the generator room. No detector in generator room. One point frame earthing of generator instead of two. 02-06-2021, 11-08-2021: 1. Generator room does not have appropriate size according to NTPA table-4.3. 2. Inadequate ventilation of generator room. 3. The appropriate type and number of firefighting equipment is not installed inside the generator room. 4. Generator frame earthing (grounding) is not provided at two separate points. 5. The generator room is not clean and free of dirt, debris, and improperly stored materials. 6. No appropriate detectors installed for generator room. 21-08-2022 : 1. The generator room smaller than the required size. 2. Inadequate ventilation of the generator room. 3. No appropriate detectors installed for generator room. 4. The appropriate type and number of firefighting equipment is not installed inside the generator room. 5. One point frame earthing of generator instead of two. 6. Oil/lint/dirt in generator room. 05-04-2023 : Same as before. |

| কার্যক্রম | Produce design drawings to demonstrate the incorporation of proper sized generator room.<br>Provide fire-fighting equipment as required by the Guidelines.<br>Provide two-point earthing for the generator frame. |

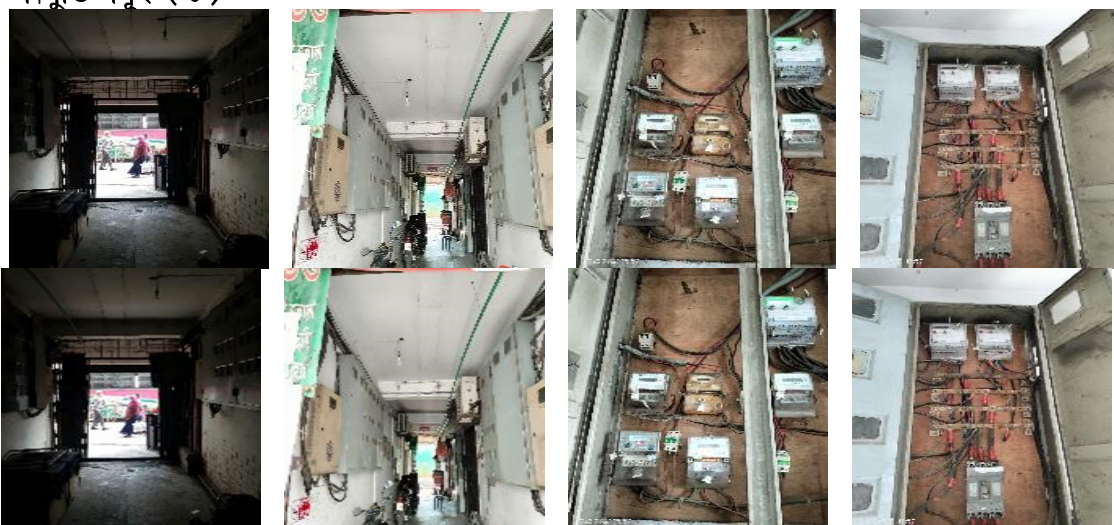
#### সংযুক্তিসমূহ ( ৮ )

| পরিদর্শন<br>পর্যবেক্ষণ | <p>☐ Ventilation of substation is poor ☐ No SLD/clear identification mark on distribution panel ☐ No instruction for first aid to electrical shock and artificial respiration ☐ No indicating lamps on the panel ☐ Temporary connection from the substation ☐ Loose cabling/connection without lug/and no cable trench ☐ Non-conductive mat not provided/ insufficient ☐ No detector in substation</p> |

| মন্তব্য | <p>06-07-2020 , 02-11-2020 : No SLD/clear identification mark on distribution panel .No instruction for first aid to electrical shock and artificial respiration. Non-conductive mat not provided/ insufficient. No detector in substation. 02-06-2021, 11-08-2021 : 1.Inadequate ventilation of substation room. 2.No clear identification markings of panel boards. 3.Instruction board for first aid and artificial respiration is not located in substation room. 4.Meters and other electrical devices ( Ammeter, Voltmeter, PFI Auto Controller, etc. ) installed on the main electrical equipment are not operational. 5.Panel body earthing continuity conductor ( ECC ) have no adequate size and door earthing were not present in some panel boards. 6.Some cables does not have proper lugs when terminated in the breaker or bus bar. 7.No appropriate detectors installed for Substation room. 21-08-2022 : 1. Ventilation of substation is poor. 2. No SLD/clear identification mark on distribution panel. 3. No instruction for first aid to electrical shock and artificial respiration. 4. No indicating lamps on the panel. 5. Temporary connection from the substation. 6. Loose cabling/connection without lug/and no cable trench. 7. Non-conductive mat not provided/insufficient. 8. No detector in substation. 05-04-2023 : Same as before.</p> |

| কার্যক্রম | ☐ Provide clear identification mark on distribution panel and relevant SLD |

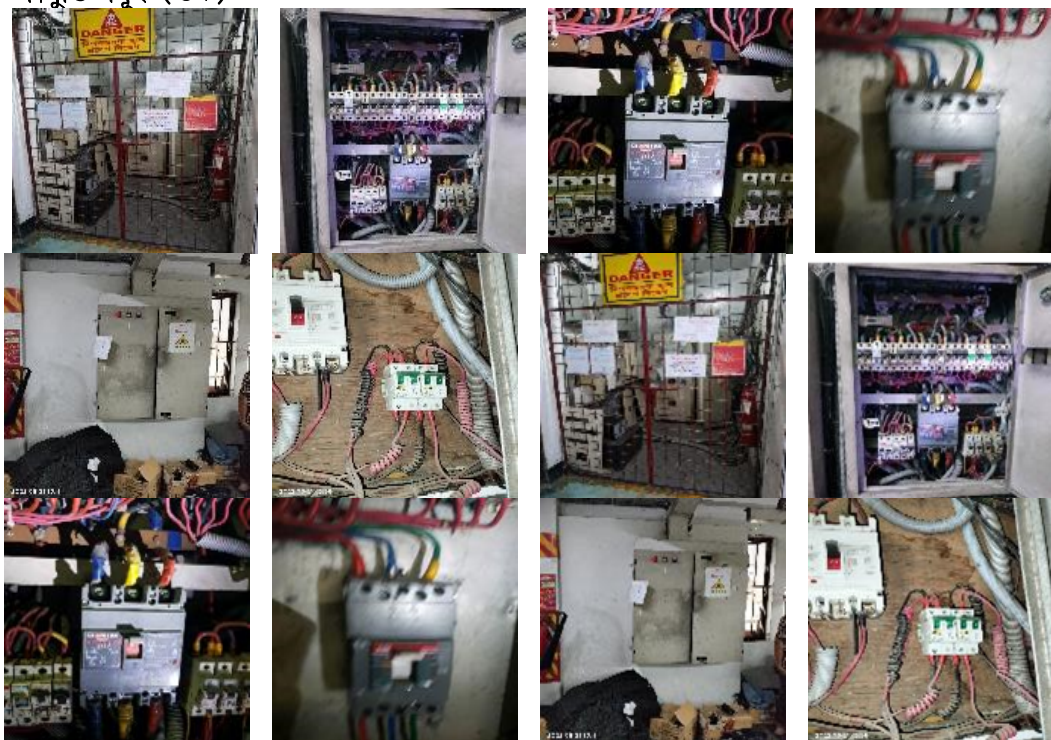
#### সংযুক্তিসমূহ (১২)

| পরিদর্শন<br>পর্যবেক্ষণ | □ No SLD/clear identification mark for MDB/DB/SDB □ Access obstructed/barred □ MDB/DB/SDB/SB or MCB installed on the wooden board □ MDB/DB/SDB body and door not earthed □ No or empty earth bar/neutral bar □ MDB/DB/SDB installed at inaccessible height □ MDB does not have duplicate earth leads |

| মন্তব্য | The generator room smaller than the required size. Inadequate ventilation of the generator room. No detector in generator room. One point frame earthing of generator instead. 02-11-2020 Visit Observation: The generator room smaller than the required size. Inadequate ventilation of the generator room. No detector in generator room. One point frame earthing of generator instead. 02-06-2021, 11-08-2021 : 1.No clear identification markings of MDB/DB/SDB panels. 2.MDB/DB/SDB/SB or MCB boards were not found to be placed on wooden board. 3.Body & Door of DB is not properly earthed. Total system earthing is not properly done as per NTPA. 4.MDB boards were found to be inaccessible in height. 5.MDB does not have duplicate earth leads. 21-08-2022 : 1. No SLD/clear identification mark for MDB/DB/SDB. 2. Access obstructed/barred. 3. MDB/DB/SDB/SB or MCB installed on the wooden board. 4. MDB/DB/SDB body and door not earthed. 5. No or empty earth bar/neutral bar. 6. MDB/DB/SDB installed at inaccessible height. 7. MDB does not have duplicate earth leads. 05-04-2023: Same as before. |

| কার্যক্রম | □ Provide clear identification mark on MDB/DB/SDB and provide SLD □ Install MDB/DB/SDB/SB/MCCB on noninflammable board. □ Provide earthing to body and door of MDB/DB/SDB. □ Provide earth bar and neutral bar in MDB/DB/SDB □ Relocate MDB/DB/SDB at accessible height □ Provide duplicate earth leads for MDB. |
