গণপ্রজাতন্ত্রী বাংলাদেশ সরকার
শ্রম ও কর্মসংস্থান মন্ত্রণালয়
কলকারখানা ও প্রতিষ্ঠান পরিদর্শন অধিদপ্তর

ক্যাপ পর্যবেক্ষণের তথ্য

| কারখানার নাম | বেঙ্গল নিটেক্স লিঃ |
| মূল্যায়নের ধরণ: কাঠামোগত মূল্যায়ন | পর্যবেক্ষণের তারিখ: ১৪-০২-২০২৩ |

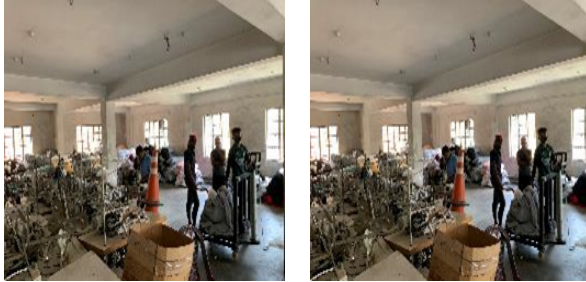
| পরিদর্শন পর্যবেক্ষণ | Dampnes and Cracks |

| কার্যক্রম | Moderate to major damp/efflorescence on plaster of the exterior wall of the basement floor of the building was observed. At several locations in stairs net cement finished surfaces (non- structural part) were found to be cracked and partially damaged. Cracked and partially damaged net cement finished topping in floors and stair cases of the building shall be repaired by adopting appropriate method for both aesthetic and serviceability requirements. |
| মন্তব্য | 17/08/2020: Dampness was found in different areas. Also finds a hairline crack in structural element. DEA report was not availed in factory. Consultant works on this issues. CVV-2 Dated 03.11.2020: No dampness occurred during the field visit. 03.02.2021: Factory management solved this issue. No dampness found on inspection day. On 08/04/2021: Completed as previous inspection. On 12.08.2021: Factory management solved this issue. No dampness found on inspection day. newly painted this building. 07/08/2022: No Dampness and cracks were found during the inspection date. 14/02/2023: No Dampness and cracks were found during the inspection date. |
