গণপ্রজাতন্ত্রী বাংলাদেশ সরকার  
শ্রম ও কর্মসংস্থান মন্ত্রণালয়  
কলকারখানা ও প্রতিষ্ঠান পরিদর্শন অধিদপ্তর

ক্যাপ পর্যবেক্ষণের তথ্য

কারখানার নাম	কোজিমা লিরিক গার্মেন্টস লি:
ঠিকানা	Plot-309, Chandon, Noljani, Gazipur
কারখানার কোড	GZP193
কালার কোড

মূল্যায়নের ধরণ: <b>বৈদ্যুতিক মূল্যায়ন</b>	পর্যবেক্ষণের তারিখ: <b>৩০-০১-২০২৩</b>
<b>১. পর্যবেক্ষণ</b>

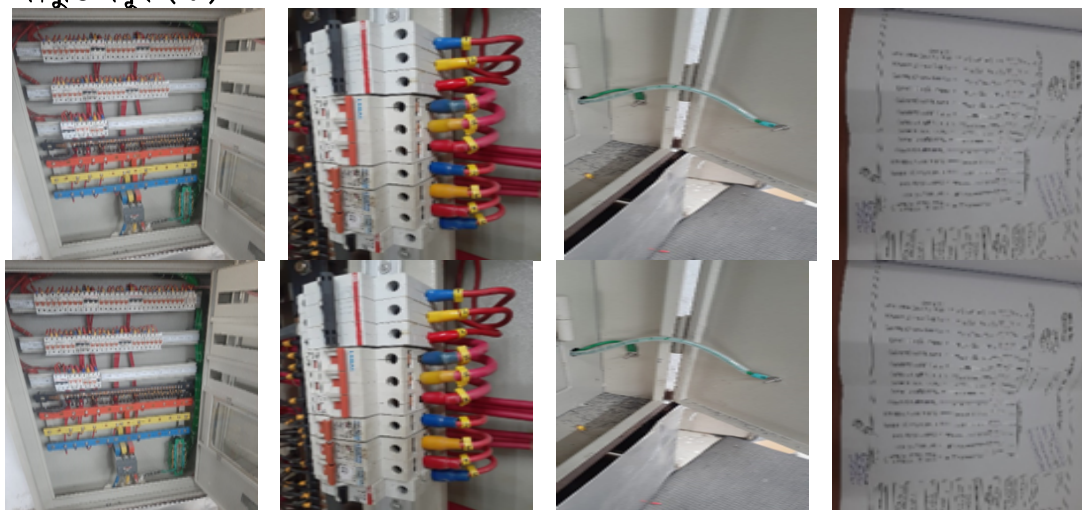
পরিদর্শন পর্যবেক্ষণ	□ No instruction for first aid to electrical shock □ Connection without lug □ Body & door not earthed □ No or empty earth bar/neutral bar □ MCCB/MCB box broken/loose □ Does not have duplicate earth leads □ As built Electrical Single Line Drawing (SLD) not available □ As built Electrical Layout Line Drawing (ELD) not available □ Wiring diagram for all distribution board not available
কাপ আইটেম ক্যাটাগরি

কার্যক্রম	□ Provide instructions for first aid from exposure to electrical shock. □ Provide as built Electrical Single Line Drawing (SLD) □ Provide as built Electrical Layout Line Drawing (ELD) □ Provide wiring diagram for all distribution board
সুপারিশের তথ্যসূত্র	
কারখানার কার্যক্রম	We will engage a DIFE listed consulting firm to complete this issue.
অগ্রাধিকার	প্রয়োজ্য নয়
চূড়ান্ত সময়সীমা	২৪-০৭-২০১৭
সংশোধিত সময়সীমা	০১-০১-১৯৭০
অগ্রগতির অবস্থা	সংশোধিত
মন্তব্য	01.10.2020: First aid instructions are not there but lugs issues are solved in many panels without 2 panels, some body and doors are earthed, new mcb/mccb box installed, as built sld and eld will be done after full remediation, wiring diagram is not available. 7.01.2021 CVV 3: New mcb/mccb box installed, as built sld and eld will be done after full remediation, wiring diagram is not available. First aid instructions are not there but lugs issues are solved in many panels without 2 panels, 08.06.2021: New mcb/mccb box installed, as built sld and eld will be done after full remediation, wiring diagram is not available. First aid instructions are not there but lugs issues are solved in many panels without some DB. 25.08.2021: New mcb/mccb box installed, as built sld and eld will be done after full remediation, wiring diagram is not available. First aid instructions are not there but lugs issues are solved in many panels without some DB. 04-08-2022 : New mcb/mccb box installed, as built sld and eld will be done after full remediation, wiring diagram is not available. First aid instructions are not there but lugs issues are solved in many panels without some DB. 30-01-2023: First aid instruction board found in DB. Connection not found without lug. All Door earthed properly. Earth and neutral bar found connected. No broken box found. duplicate earth lead found. As build SLD found but some mismatched found. ELD found during visit. Waring diagram found for all DB's.
