গণপ্রজাতন্ত্রী বাংলাদেশ সরকার
শ্রম ও কর্মসংস্থান মন্ত্রণালয়
কলকারখানা ও প্রতিষ্ঠান পরিদর্শন অধিদপ্তর

ক্যাপ পর্যবেক্ষণের তথ্য

| কারখানার নাম | কোজিমা লিরিক গার্মেন্টস লি: |
| মূল্যায়নের ধরণ: বৈদ্যুতিক মূল্যায়ন | পর্যবেক্ষণের তারিখ: ৩০-০১-২০২৩ |

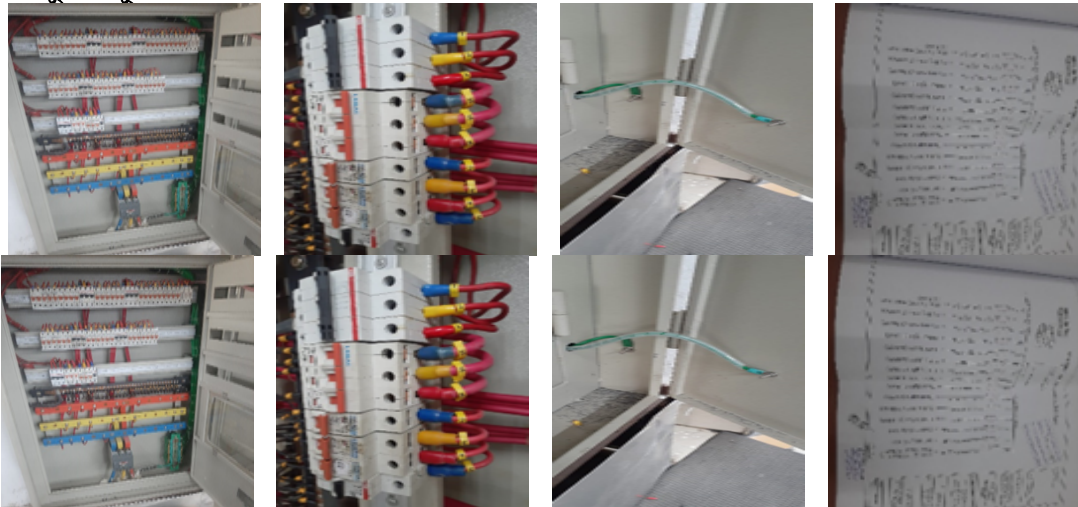
সংযুক্তিসমূহ (৮)

| পরিদর্শন পর্যবেক্ষণ | <input type="checkbox"/> No instruction for first aid to electrical shock <input type="checkbox"/> Connection without lug <input type="checkbox"/> Body & door not earthed <input type="checkbox"/> No or empty earth bar/neutral bar <input type="checkbox"/> MCCB/MCB box broken/loose <input type="checkbox"/> Does not have duplicate earth leads <input type="checkbox"/> As built Electrical Single Line Drawing (SLD) not available <input type="checkbox"/> As built Electrical Layout Line Drawing (ELD) not available <input type="checkbox"/> Wiring diagram for all distribution board not available |

| মন্তব্য | <p>01.10.2020: First aid instructions are not there but lugs issues are solved in many panels without 2 panels, some body and doors are earthed, new mcb/mccb box installed, as built sld and eld will be done after full remediation, wiring diagram is not available. 7.01.2021 CVV 3: New mcb/mccb box installed, as built sld and eld will be done after full remediation, wiring diagram is not available. First aid instructions are not there but lugs issues are solved in many panels without 2 panels, 08.06.2021: New mcb/mccb box installed, as built sld and eld will be done after full remediation, wiring diagram is not available. First aid instructions are not there but lugs issues are solved in many panels without some DB. 25.08.2021: New mcb/mccb box installed, as built sld and eld will be done after full remediation, wiring diagram is not available. First aid instructions are not there but lugs issues are solved in many panels without some DB. 04-08-2022 : New mcb/mccb box installed, as built sld and eld will be done after full remediation, wiring diagram is not available. First aid instructions are not there but lugs issues are solved in many panels without some DB. 30-01-2023: First aid instruction board found in DB. Connection not found without lug. All Door earthed properly. Earth and neutral bar found connected. No broken box found. duplicate earth lead found. As build SLD found but some mismatched found. ELD found during visit. Waring diagram found for all DB's.</p> |

| কার্যক্রম | <input type="checkbox"/> Provide instructions for first aid from exposure to electrical shock. <input type="checkbox"/> Provide as built Electrical Single Line Drawing (SLD) <input type="checkbox"/> Provide as built Electrical Layout Line Drawing (ELD) <input type="checkbox"/> Provide wiring diagram for all distribution board |

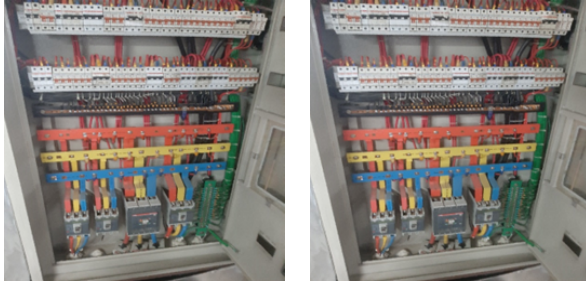
সংযুক্তিসমূহ (২)

| পরিদর্শন পর্যবেক্ষণ | □ Undressed and messy wiring/cables |

| মন্তব্য | 01.10.2020: First aid instructions are not there but lugs issues are solved in many panels without 2 panels, some body and doors are earthed, new mcb/mccb box installed, as built sld and eld will be done after full remediation, wiring diagram is not available. 7.01.2021 CVV 3: New mcb/mccb box installed, as built sld and eld will be done after full remediation, wiring diagram is not available. First aid instructions are not there but lugs issues are solved in many panels without 2 panels. 08.06.2021: New mcb/mccb box installed, as built sld and eld will be done after full remediation, wiring diagram is not available. First aid instructions are not there but lugs issues are solved in many panels without some DB. 25.08.2021: New mcb/mccb box installed, as built sld and eld will be done after full remediation, wiring diagram is not available. First aid instructions are not there but lugs issues are solved in many panels without some DB. 04-08-2022 : New mcb/mccb box installed, as built sld and eld will be done after full remediation, wiring diagram is not available. First aid instructions are not there but lugs issues are solved in many panels without some DB. 30-01-2023: Undressed Cable not found in DB's. |

| কার্যক্রম | □ Replace undressed messy wiring/cables |
