গণপ্রজাতন্ত্রী বাংলাদেশ সরকার  
শ্রম ও কর্মসংস্থান মন্ত্রণালয়  
কলকারখানা ও প্রতিষ্ঠান পরিদর্শন অধিদপ্তর

ক্যাপ পর্যবেক্ষণের তথ্য

কারখানার নাম	টিবিএইচ ক্যাশন টেক্স
ঠিকানা	Kha-10/A, Bepari Para,
কারখানার কোড	DHK581
কালার কোড	
মূল্যায়নের ধরণ: <b>অগ্নি মূল্যায়ন</b>	পর্যবেক্ষণের তারিখ: ০২-০২-২০২৩
১. পর্যবেক্ষণ

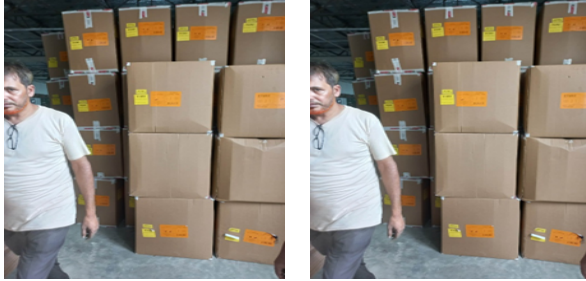
পরিদর্শন পর্যবেক্ষণ	☐ Clearance from ceiling less than 1/3rd of ceiling height. ☐ Naked lights in storage ☐ Others same as above
কাপ আইটেম ক্যাটাগরি

কার্যক্রম	☐ Rearrange storage items to ensure proper clearance from ceiling.
সুপারিশের তথ্যসূত্র	
কারখানার কার্যক্রম	
অগ্রাধিকার	প্রযোজ্য নয়
চূড়ান্ত সময়সীমা	-
সংশোধিত সময়সীমা	০১-০১-১৯৭০
অগ্রগতির অবস্থা	শুরু হয়নি
মন্তব্য	16/08/2018: Clearance from 1/3rd of ceiling height has maintained in storage area 23/10/2018: Corrected. 27/02/2019: Corrected. 24/04/2019: Corrected. 14/01/2020: During inspection proper housekeeping was not seen in bonded ware house. Finished goods area was found fully loaded with packaging boxes and clearance from 1/3rd from ceiling was not maintained. 01/09/2021 ( CVV1 ):During inspection proper housekeeping was not seen in bonded ware house. 03.08.2022: During inspection proper housekeeping was not seen in bonded ware house. 02.02.2023: Same as previous visit.

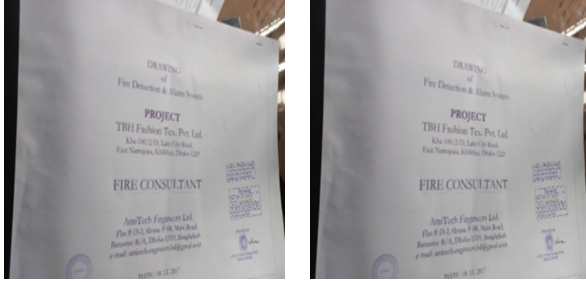
পরিদর্শন পর্যবেক্ষণ	□ The generator room is not properly segregated from the rest of the occupancy due to presence of non Fire-rated Door □ No detector in generator room □ One point frame earthing of generator instead of two □ No over current or earth fault protection provided
কাপ আইটেম ক্যাটাগরি

কার্যক্রম	□ Produce design drawings to demonstrate the incorporation of fire rated enclosure from floor to ceiling and an approved fire rated self-closing swing door for the Generator room. □ Provide over current and earth fault protection
সুপারিশের তথ্যসূত্র	
কারখানার কার্যক্রম	# We will provide adequate fire separation in generator room soon. # We will provide protection for each circuit.
অগ্রাধিকার	৬ সপ্তাহ
চূড়ান্ত সময়সীমা	০৮-১১-২০১৬
সংশোধিত সময়সীমা	০৯-০৯-১৯৭০
অগ্রগতির অবস্থা	সংশোধিত
মন্তব্য	16/08/2018: Factory has submitted fire protection system design & drawing to DIFE for approval. 23/10/2018: same as last follow up. Pending in DIFE RCC for approval. 27/02/2019: reviewed by DIFE,RCC taskforce and corrections were given. 24/04/2019: Fire Alarm & Detection System, Fire Protection System, Fire Evacuation System design/drawing Approved by DIFE,RCC taskforce. 01/09/2021 (CVV1): Fire Alarm & Detection System, Fire Protection System, Fire Evacuation System design/drawing Approved by DIFE,RCC taskforce. 03.08.2022: The factory has got approval design from DIFE. 02.02.2023: Completed.

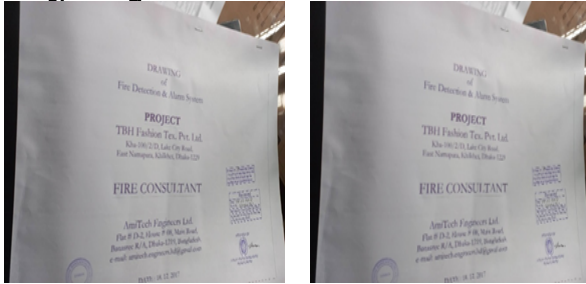
পরিদর্শন পর্যবেক্ষণ	□ Non-standard fire alarm system □ No detectors
কাপ আইটেম ক্যাটাগরি

কার্যক্রম	□ Provide design drawings for the fire detection and alarm system in accordance with the Guideline requirements and hazard situation, ( with appropriate specifications and drawings ) showing how they will be implemented along with implementation plan.
সুপারিশের তথ্যসূত্র	
কারখানার কার্যক্রম	We will provide dwsign drawing for fire detection and alarm system.
অগ্রাধিকার	৬ সপ্তাহ
চূড়ান্ত সময়সীমা	০৮-১১-২০১৬
সংশোধিত সময়সীমা	০১-০১-১৯৭০
অগ্রগতির অবস্থা	সংশোধিত
মন্তব্য	16/08/2018: Factory has submitted fire detection and alarm system drawing to DIFE for approval. 23/10/2018: Same as last follow up. Pending in DIFE RCC for approval. 27/02/2019: Reviewed by DIFE,RCC taskforce and corrections were given. 24/04/2019: Fire Alarm & Detection System, Fire Protection System, Fire Evacuation System design/drawing Approved by DIFE,RCC taskforce. 14/01/2020: Factory management has informed that they will start installation work according to RCC taskforce approved design/drawing from March 2020. 01/09/2021 ( CVV1 ):Factory management has informed that they will start installation work according to RCC taskforce approved design/drawing from March 2020. 03.08.2022: The factory has got approval design from DIFE. 02.02.2023: Completed.
