গণপ্রজাতন্ত্রী বাংলাদেশ সরকার  
শ্রম ও কর্মসংস্থান মন্ত্রণালয়  
কলকারখানা ও প্রতিষ্ঠান পরিদর্শন অধিদপ্তর

ক্যাপ পর্যবেক্ষণের তথ্য

| কারখানার নাম | বগুটা এ্যাপারেলস লি: |
| মূল্যায়নের ধরণ: <b>বৈদ্যুতিক মূল্যায়ন</b> | পর্যবেক্ষণের তারিখ: <b>০৩-০৪-২০২৩</b> |

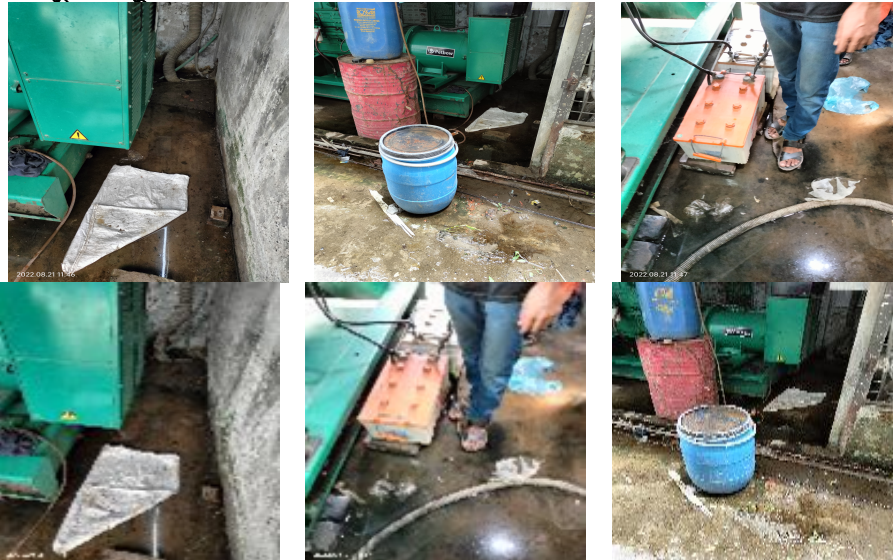
| পরিদর্শন<br>পর্যবেক্ষণ | Combustible materials inside generator room One point frame earthing of generator instead of two |

| মন্তব্য | 31.12.2019 (CVV-1): 1. Combustible materials are found in generator Room. 2. Generator frame earthing (grounding) is not provided at two separate points.<br>22.03.2020 (CVV-2): 1. Combustible materials are found in generator Room. 2. Generator frame earthing (grounding) is not provided at two separate points.<br>09.06.2021 (CVV), 1. Combustible materials are found in generator Room. 2. Generator frame earthing (grounding) is not provided at two separate points.<br>10-08-2021: On visit day Combustible materials are found in generator Room. Generator frame earthing (grounding) is not provided at two separate points. 21-08-2022 : 1. Combustible materials & water found in generator room 2. One point frame earthing of generator instead of two 03-04-2023 : Same as before. |

| কার্যক্রম | Remove Combustible materials from generator room. Ensure double earthing of generator frame |

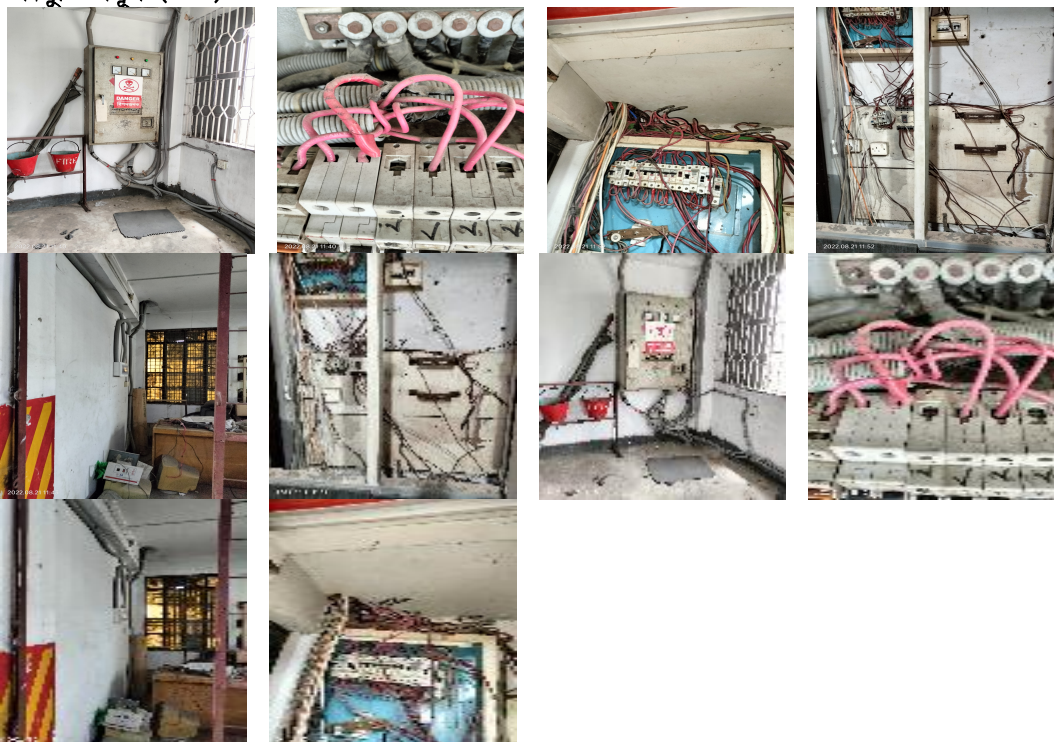
| পরিদর্শন<br>পর্যবেক্ষণ | <input type="checkbox"/> No instruction for first aid to electrical shock <input type="checkbox"/> Access obstructed/barred <input type="checkbox"/> Cable ends not properly soldered or crimped <input type="checkbox"/> Connection without lug <input type="checkbox"/> Undressed messy wire inside <input type="checkbox"/> Combustible materials near DB |

| মন্তব্য | <p>31.12.2019 (CVV-1): 1. No instruction for first aid to electrical shock. 2. Access obstructed/barred. 3. Cable ends not properly soldered or crimped. 4. Connection without lug. 5. Undressed messy wire inside. 6. Combustible materials near DB. 22.03.2020 (CVV-2): 1. No instruction for first aid to electrical shock. 2. Access obstructed/barred. 3. Cable ends not properly soldered or crimped. 4. Connection without lug. 5. Undressed messy wire inside. 6. Combustible materials near DB. 09.06.2021 (CVV): 1. No instruction for first aid to electrical shock. 2. Access obstructed/barred. 3. Cable ends not properly soldered or crimped. 4. Connection without lug. 5. Undressed messy wire inside. 6. Combustible materials near DB. 10-08-2021: 1. No instruction for first aid to electrical shock. 2. Access obstructed/barred. 3. Cable ends not properly soldered or crimped. 4. Connection without lug. 5. Undressed messy wire inside. 6. Combustible materials near DB. 21-08-2022: 1. No instruction for first aid to electrical shock. 2. Access obstructed/barred. 3. Cable ends not properly soldered or crimped. 4. Connection without lug. 5. Undressed messy wire inside. 6. Combustible materials near DB. 03-04-2023 : Same as before.</p> |

| কার্যক্রম | <input type="checkbox"/> Provide instructions for first aid from exposure to electrical shock <input type="checkbox"/> Remove obstruction to ensure access to MDB/MCB Box <input type="checkbox"/> Ensure well-dressed cabling with lugs <input type="checkbox"/> Remove combustible materials from DB's nearest zone. |

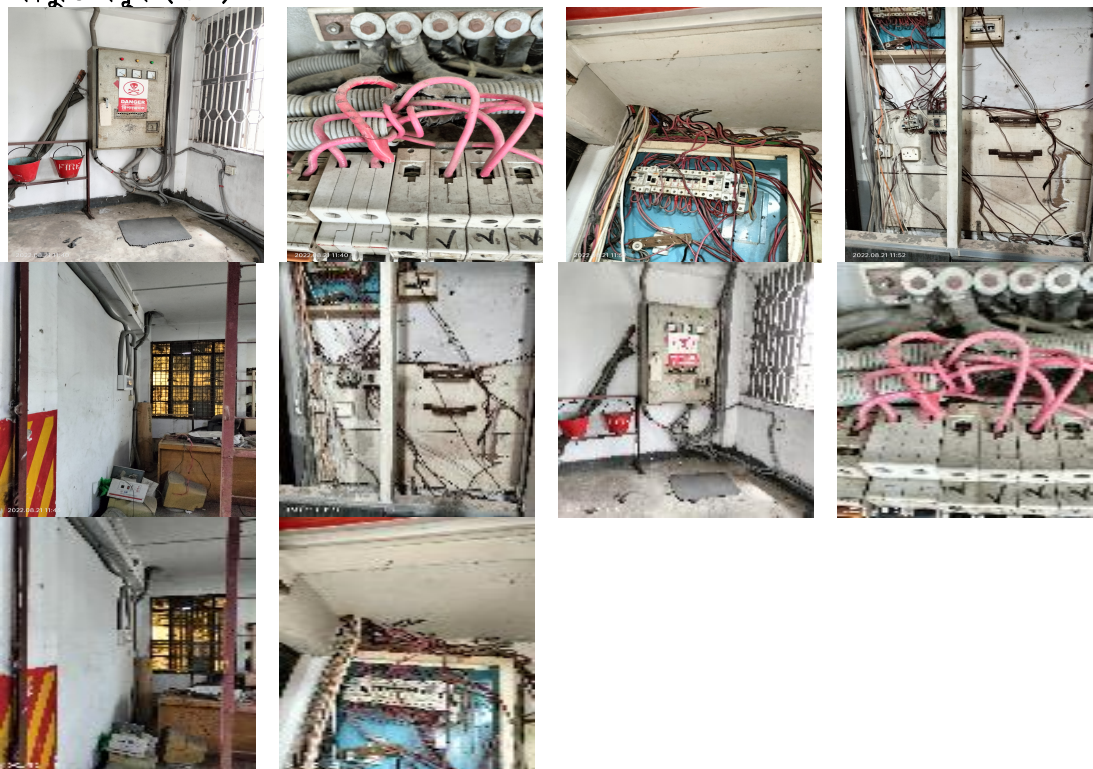
| পরিদর্শন<br>পর্যবেক্ষণ | □ Cable ends not properly soldered or crimped □ Connection without lug □ Undressed messy wire inside |

| মন্তব্য | 31.12.2019 (CVV-1): 1. Cable ends are not soldered and crimped in distribution boards. 2. Connections without lugs are found in distribution boards. 3. Undress messy wire is found in distribution boards. 22.03.2020 (CVV-2): 1. Cable ends are not soldered and crimped in distribution boards. 2. Connections without lugs are found in distribution boards. 3. Undress messy wire is found in distribution boards. 09.06.2021 (CVV): 1. Cable ends are not soldered and crimped in distribution boards. 2. Connections without lugs are found in distribution boards. 3. Undress messy wire is found in distribution boards. 10-08-2021: 1. Cable ends are not soldered and crimped in distribution boards. 2. Connections without lugs are found in distribution boards. 3. Undress messy wire is found in distribution boards. 21-08-2022: 1. Cable ends are not soldered and crimped in distribution boards. 2. Connections without lugs are found in distribution boards. 3. Undress messy wire is found in distribution boards. 03-04-2023: Same as before. |

| কার্যক্রম | □ Ensure secured connections with lug □ Replace undressed messy wiring/cables □ Properly solder cable ends |
