গণপ্রজাতন্ত্রী বাংলাদেশ সরকার
শ্রম ও কর্মসংস্থান মন্ত্রণালয়
কলকারখানা ও প্রতিষ্ঠান পরিদর্শন অধিদপ্তর

ক্যাপ পর্যবেক্ষণের তথ্য

কারখানার নাম	আইসিয়ার ক্যাশনস লিমিটেড		
ঠিকানা	55, SHOVPUR, RAJFULBARIA, SAVAR, DHAKA		
কারখানার কোড	DHK028		
কালার কোড

মূল্যায়নের ধরণ: বৈদ্যুতিক মূল্যায়ন	পর্যবেক্ষণের তারিখ: ০৯-০৪-২০২৩
১. পর্যবেক্ষণ

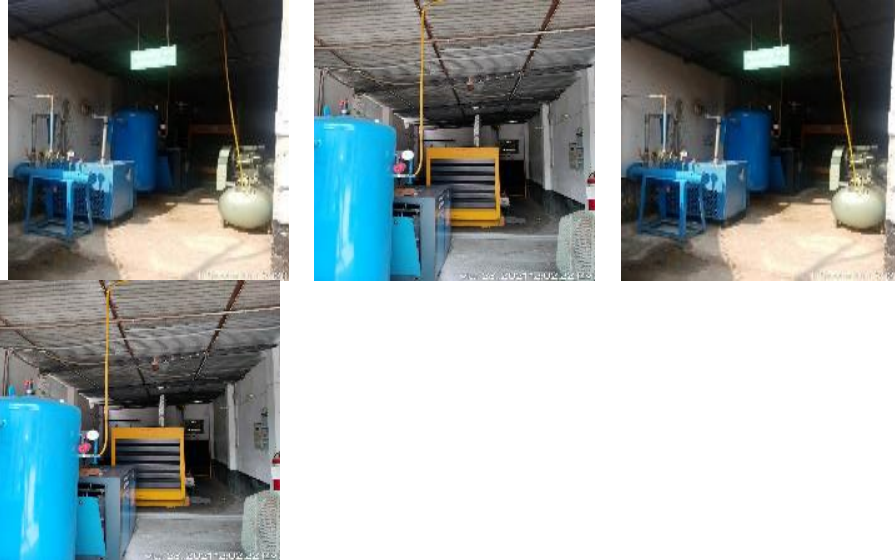
সংযুক্তিসমূহ (৪)

পরিদর্শন পর্যবেক্ষণ	Combustible materials inside generator room □ No cable trench with cover
কাপ আইটেম ক্যাটাগরি

কার্যক্রম	Provide fire rated enclosure from floor to P27.1 ceiling and an approved fire rated selfclosing swing door for the Generator room
সুপারিশের তথ্যসূত্র	
কারখানার কার্যক্রম	We have taken initiative & it will be completed within timeline.
অগ্রাধিকার	৬ মাস
চূড়ান্ত সময়সীমা	-
সংশোধিত সময়সীমা	০১-০১-১৯৭০
অগ্রগতির অবস্থা	সংশোধিত
মন্তব্য	Previous timeline: NA, during cap explanation (CAP01) factory claimed completed. Final Timeline: 11/8/2017, Factory has taken action and they have agreed to implement within final timeline. 02-09-2020 Visit Observation: Combustible materials inside generator room. 01.12.2020 (CVV) : Combustible materials is not found in generator room. 28-03-2021 Visit Observation: Combustible materials is not found in generator room. 28-08-2021 on visit day Combustible materials is not found in generator room. 23-08-2022 : 1. Combustible materials inside generator room. 2. No cable trench with cover 09-04-2023 : 1.No Combustible materials was found inside generator room. 2.Cable trench was found with cover. 3.Generator room outside of factory building that's why no fire separation was required.

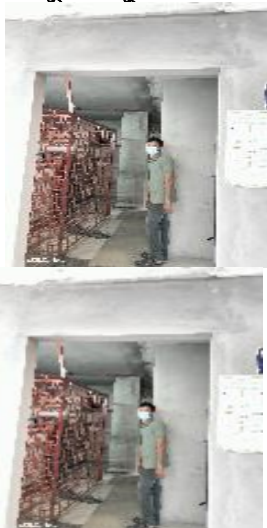
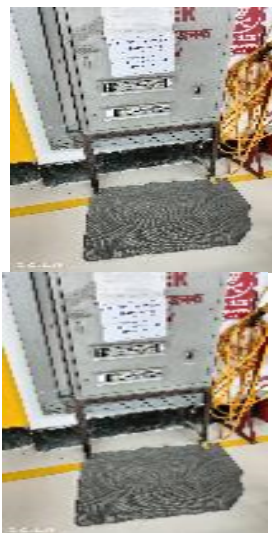
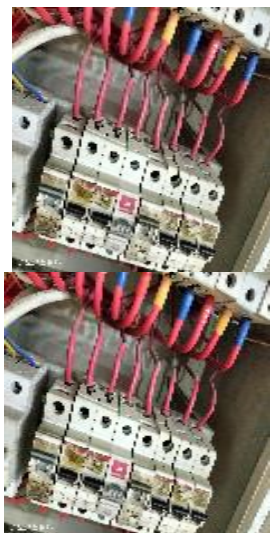
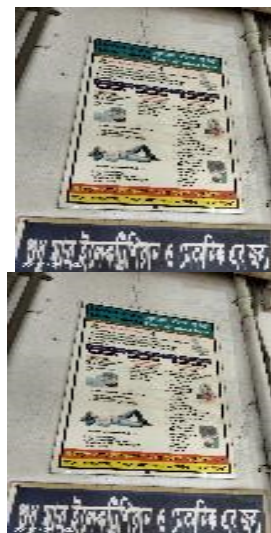
সংযুক্তিসমূহ (৮)

পরিদর্শন পর্যবেক্ষণ	No instruction for first aid to electrical shock and artificial respiration □ Non-conductor mat insufficient □ Electric cables do not pass through insulated conduits □ Connection without lug □ Access obstructed to substation equipment □ No fire rated enclosure from floor to ceiling
ক্যাপ আইটেম ক্যাটাগরি

কার্যক্রম	Provide easy access to the substation panel
সুপারিশের তথ্যসূত্র	
কারখানার কার্যক্রম	We have taken initiative & it will be completed within timeline.
অগ্রাধিকার	৬ মাস
চূড়ান্ত সময়সীমা	-
সংশোধিত সময়সীমা	০১-০১-১৯৭০
অগ্রগতির অবস্থা	চলমান
মন্তব্য	Previous timeline: NA, during cap explanation (CAP01) factory claimed completed Final Timeline: 11/8/2017, Factory has taken action and they have agreed to implement within final timeline. 02-09-2020 Visit Observation: No fire rated enclosure from floor to ceiling. 01.12.2020 (CVV): Easy access to the substation is found. 28-03-2021 Visit Observation: Easy access to the substation is found. 28-08-2021 on visit day Easy access to the substation is found. 23-08-2022 : 1. Instruction for first aid to electrical shock and artificial respiration not found at all required location. 2. Non-conductor mat insufficient. 3. Electric cables pass through insulated conduits. 4. Connection without lug. 5. Access obstructed to substation equipment. 6. No fire rated enclosure from floor to ceiling. 09-04-2023 : 1. Instruction for first aid to electrical shock and artificial respiration was found at all required location. 2. Non-conductor rubber mat was found in front of DB. 3. Electric cables pass through insulated conduits. 4. Connection without lugs was found. 5. Easy access to substation equipment was found. 6. No fire rated enclosure from floor to ceiling was provided for substation room.

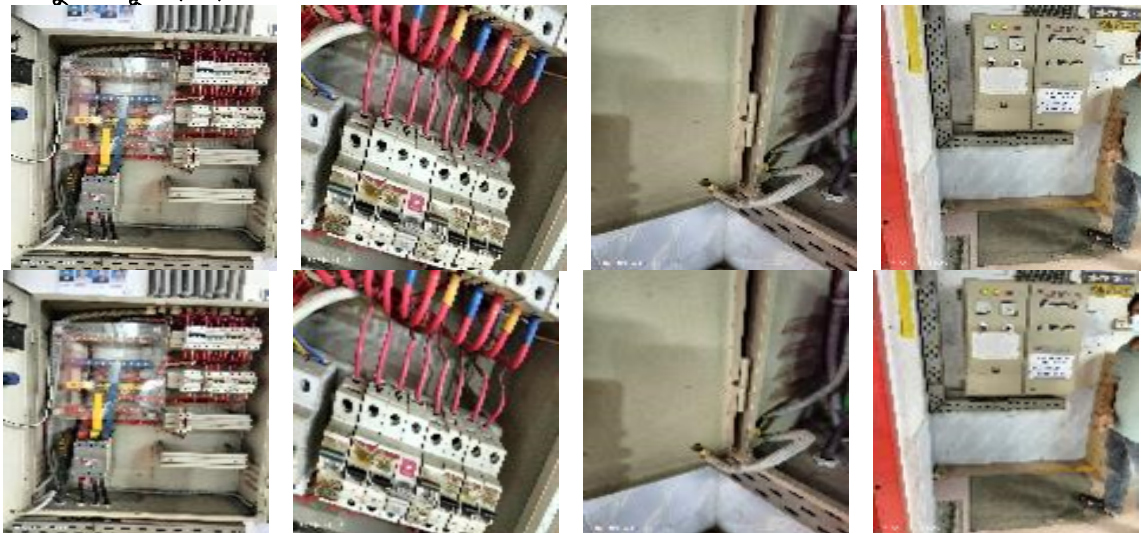
সংযুক্তিসমূহ (৮)

পরিদর্শন পর্যবেক্ষণ	Cable ends not properly or crimped □ Connection without lug □ Undressed messy wire inside □ Door not earthed □ No clear identification mark on distribution board □ Loose Circuit Breaker
ক্যাপ আইটেম ক্যাটাগরি

কার্যক্রম	Repair loose MCB. □ Provide earthing to body & door. □ Provide clear identification mark on distribution board.
সুপারিশের তথ্যসূত্র	
কারখানার কার্যক্রম	We have taken initiative & it will be completed within timeline.
অগ্রাধিকার	৬ সপ্তাহ
চূড়ান্ত সময়সীমা	-
সংশোধিত সময়সীমা	০১-০১-১৯৭০
অগ্রগতির অবস্থা	চলমান
মন্তব্য	Previous timeline: NA, during cap explanation (CAP01) factory claimed completed Final Timeline: 11/8/2017 ,Factory has taken action and they have agreed to implement within final timeline. 02-09-2020 Visit Observation: No clear identification mark on few distribution board. 01.12.2020 (CVV) : 1. Earthing connection is provided in body and door of distribution panels. 2. Distribution boards have clear identification mark. 28-03-2021 Visit Observation: 1. Earthing connection is provided in body and door of distribution panels. 2. Distribution boards have clear identification mark. 28-08-2021: 1. Earthing connection is provided in body and door of distribution panels. 2. Distribution boards have clear identification mark. 23-08-2022 : 1. Cable ends are properly or crimped. 2. Connection without lug. 3. Undressed messy wire inside. 4. Door earthed. 5. No clear identification mark on distribution board. 6. No Loose Circuit Breaker. 09-04-2023 : 1.Connection without lugs was found. 2.No undressed messy wire was found. 3.Door earthed was found. 4.Clear identification mark on distribution board was found. 5. No loose circuit breaker was found.
