গণপ্রজাতন্ত্রী বাংলাদেশ সরকার  
শ্রম ও কর্মসংস্থান মন্ত্রণালয়  
কলকারখানা ও প্রতিষ্ঠান পরিদর্শন অধিদপ্তর

ক্যাপ পর্যবেক্ষণের তথ্য

| কারখানার নাম | মেসার্স এম্বাপোলো ক্যাশনস লিঃ |

| মূল্যায়নের ধরণ: বৈদ্যুতিক মূল্যায়ন | পর্যবেক্ষণের তারিখ: ০২-০৪-২০২৩ |

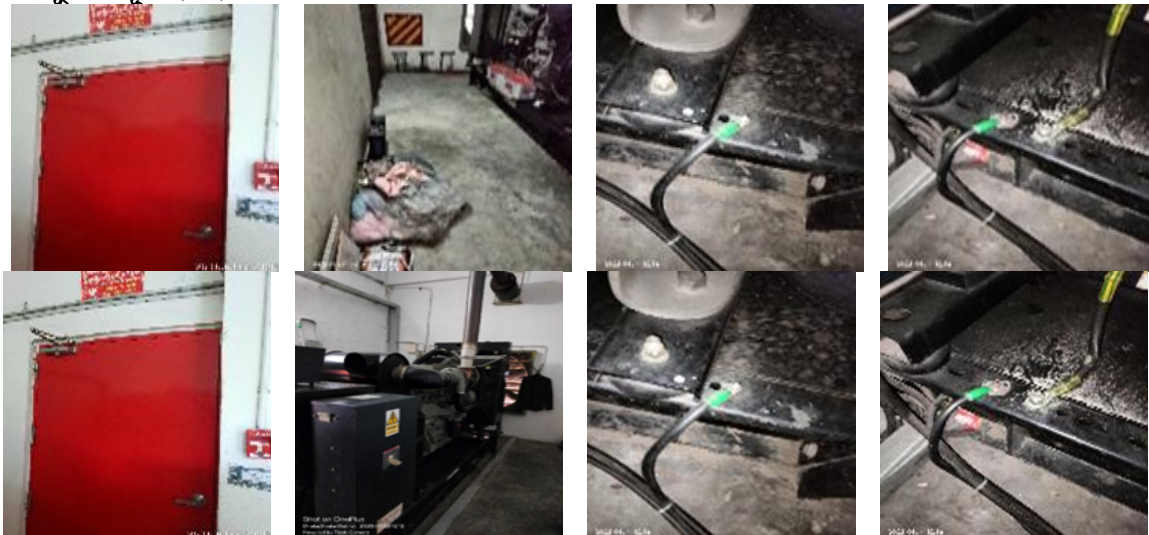
| পরিদর্শন<br>পর্যবেক্ষণ | The generator room is not properly segregated from the rest of the occupancy due to presence of non Fire-rated Door □ No detector in generator room □ No firefighting equipment is present in the generator room □ Combustible materials inside generator room □ No over current or earth fault protection provided □ No cover on the cable trench |

| মন্তব্য | 29-08-2021 (CVV): 1. Generator is located on ground floor building. 2. They has been provide fire separation. 3. They didn't provide first aid box and artificial respiration. 4. Generator is earthed at two point. 5. Illumination is sufficient in generator room. 6. Dust has not been found in generator room. 7. Factory has submitted detection design to DIFE and waiting for approval. 8. Cover on the cable trench. 14-08-2022: 1. They didn't provide first aid box and artificial respiration. 2. Dust has not been found in generator room. 02-04-2023: 1. Factory has been provided proper fire separation for generator room. 2. Fire detector has been provided for generator room. 3. No combustible materials was found inside generator room. 4. Proper cover on the cable trench was found. |

| কার্যক্রম | Produce design drawings to demonstrate the incorporation of fire rated enclosure from floor to ceiling and an approved fire rated self-closing swing door for the Generator room. □ Provide firefighting equipment as required by the Guidelines. □ Provide over current and earth fault protection |

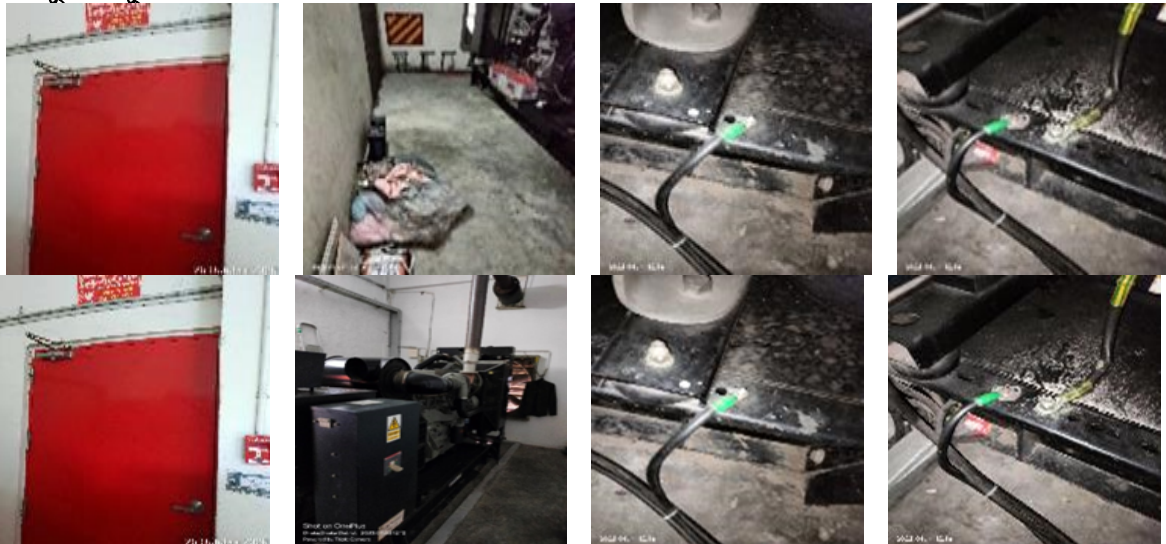
| পরিদর্শন<br>পর্যবেক্ষণ | The generator room is not properly segregated from the rest of the occupancy due to presence of non Fire-rated Door □ No detector in generator room □ No firefighting equipment is present in the generator room □ Combustible materials inside generator room □ No over current or earth fault protection provided □ No cover on the cable trench |

| মন্তব্য | 29-08-2021 (CVV) : 1. Generator is located on ground floor building. 2. They has been provide fire separation. 3. They didn't provide first aid box and artificial respiration. 4. Generator is earthed at two point. 5. Illumination is sufficient in generator room. 6. Dust has not been found in generator room. 7. Factory has submitted detection design to DIFE and waiting for approval. 8. Cover on the cable trench. 14-08-2022 : 1. They didn't provide first aid box and artificial respiration. 2. Dust has not been found in generator room. 02-04-2023: 1. Factory has been provided proper fire separation for generator room. 2. Fire detector has been provided for generator room. 3. No combustible materials was found inside generator room. 4. Proper cover on the cable trench was found. |

| কার্যক্রম | Provide fire rated enclosure from floor to P27.2 ceiling and an approved fire rated selfclosing swing door for the Generator room □ Install appropriate detectors. |

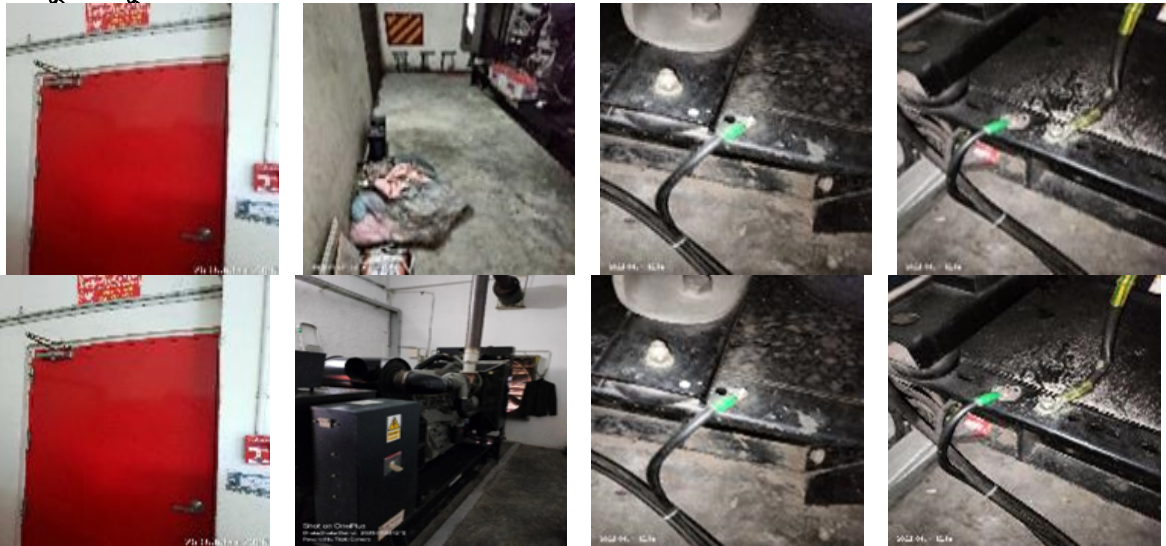
| পরিদর্শন<br>পর্যবেক্ষণ | The generator room is not properly segregated from the rest of the occupancy due to presence of non Fire-rated Door □ No detector in generator room □ No firefighting equipment is present in the generator room □ Combustible materials inside generator room □ No over current or earth fault protection provided □ No cover on the cable trench |

| মন্তব্য | 29-08-2021 (CVV): 1. Generator is located on ground floor building. 2. They has been provide fire separation. 3. They didn't provide first aid box and artificial respiration. 4. Generator is earthed at two point. 5. Illumination is sufficient in generator room. 6. Dust has not been found in generator room. 7. Factory has submitted detection design to DIFE and waiting for approval. 8. Cover on the cable trench. 14-08-2022: 1. They didn't provide first aid box and artificial respiration. 2. Dust has not been found in generator room. 02-04-2023: 1. Factory has been provided proper fire separation for generator room. 2. Fire detector has been provided for generator room. 3. No combustible materials was found inside generator room. 4. Proper cover on the cable trench was found. |

| কার্যক্রম | Remove Combustible materials from generator room. □ Provide cover on the cable trench |
