# Electrical Safety Assessment Report

## TSS-FASHION

Telerchala, Mouchak, Kaliakor, Gazipur, Bangladesh.  
24.0228444 N, 90.3003772 E

Date of Assessment : 14 Oct 2021  
Report Code : 145\_CP\_2021\_1170\_TSS-FASHION\_ESA\_V00  
Report Version : V00\_14 October 2021  
Name of the Assessor : Imtiaz Mahmud  
Assessing Firm :

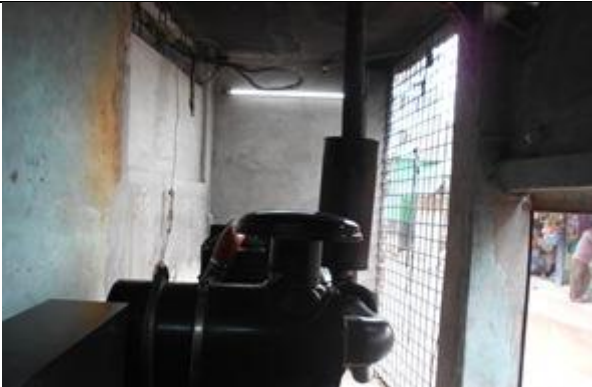
| 13 | Are there any unwanted materials stored inside the transformer / generator room? | Risk Level | High |

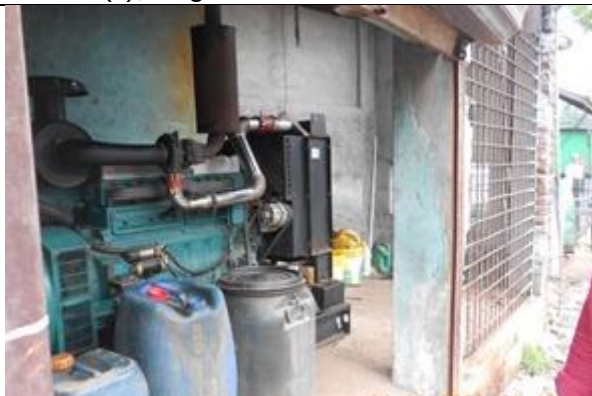
| 14 | Are there rubber mats provided in front of all distribution boards? | Risk Level | High |

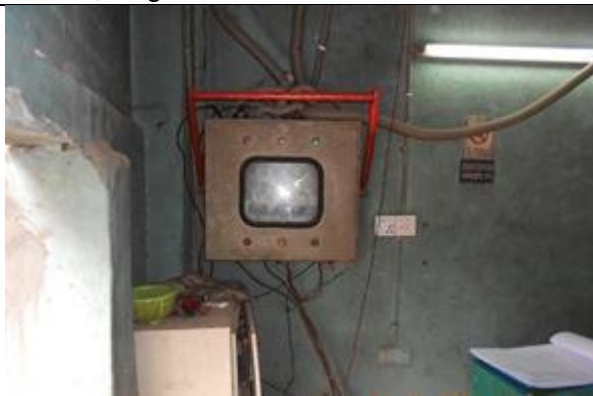
| 18 | Is fire rated wall and fire door available in case of substation / generator room located inside the production building? | Risk Level | High |

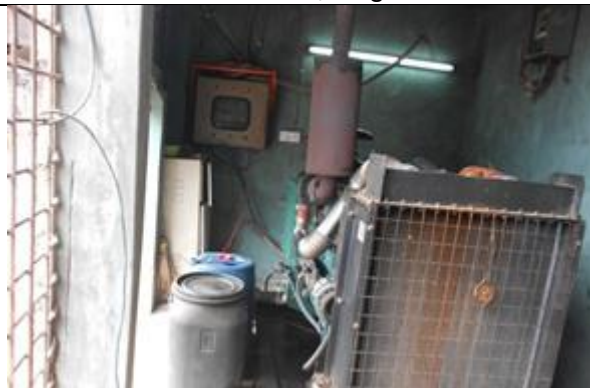
| 24 | Is the generator located in with proper working clearance and easy access for maintenance? | Risk Level | Moderate |

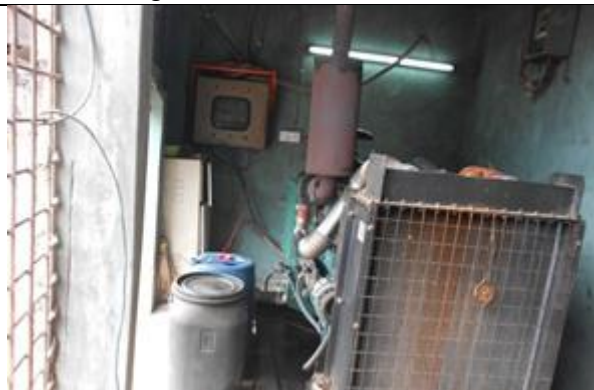
| 25 | Is generator oil stored away from control panels in generator room? | Risk Level | Moderate |

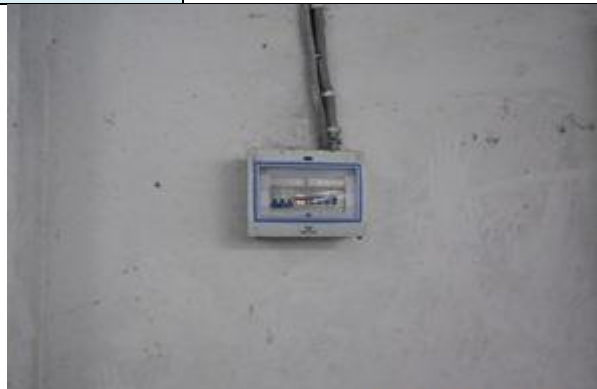
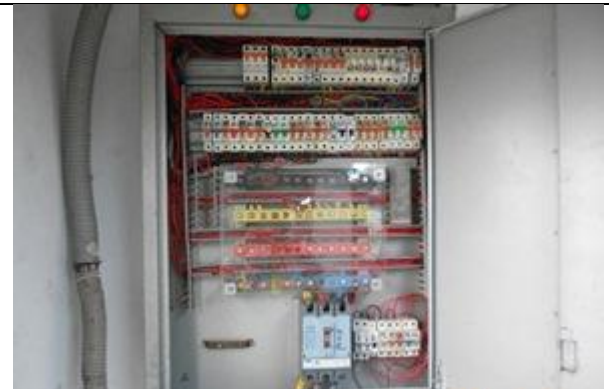
| 28 | Are there adequacies of all type of meters (Ammeter, Voltmeter etc.) at distribution boards (LT/MDB)? | Risk Level | Moderate |

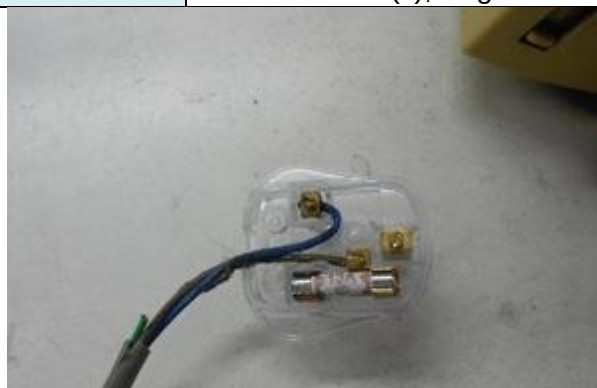
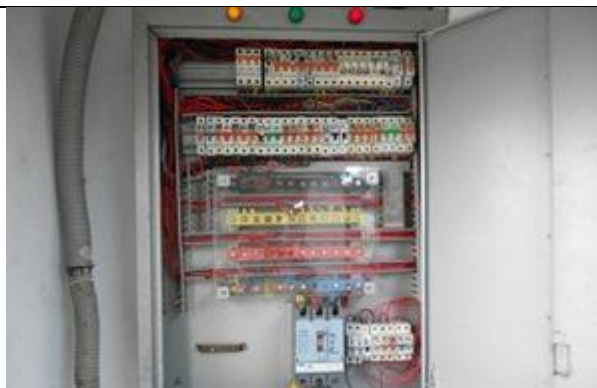
| 30 | Are there cable sockets at cable end provided to stranded cables with cable size area $\geq 6\text{mm}^2$ ? | Risk Level | High |

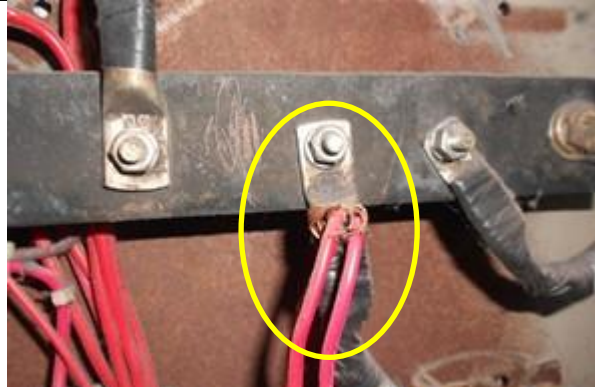
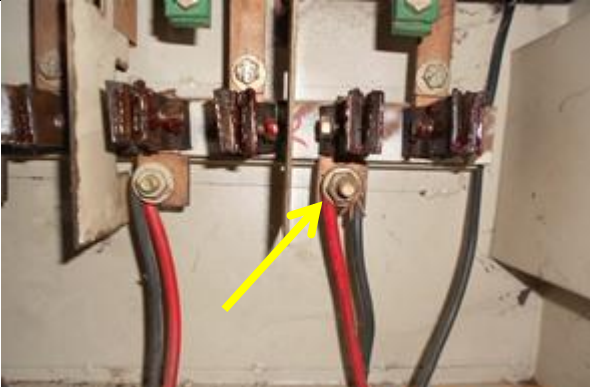
| 31 | Any cable / wire found exposed or open live?<br>Cable ends / sockets have improper connections? | Risk Level | Very High |
| Observation | Exposed / open wires were found. | | |

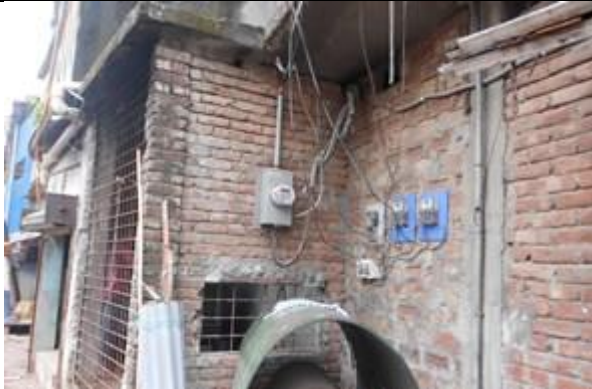
| 36 | Is there adequacy of emergency power capacity essential lighting, one lift, fire pumps etc.? | Risk Level | Moderate |
| Observation | No emergency power backup found for essential lighting. | | |

| 36 | Is there adequacy of emergency power capacity essential lighting, one lift, fire pumps etc.? | Risk Level | Moderate |
|---|---|---|---|
| Corrective Action | Review capacity of standby generator on basis of loads for essential lighting / AC / Equipment / Services. Replace generator with larger capacity or install second generator if review indicates existing unit is too small. | | |

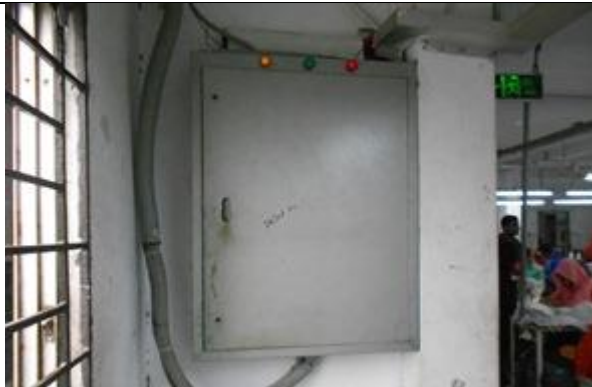
| 46 | Is there installation of switchboards / panel boards is at proper height, easy and accessible location? | Risk Level | High |

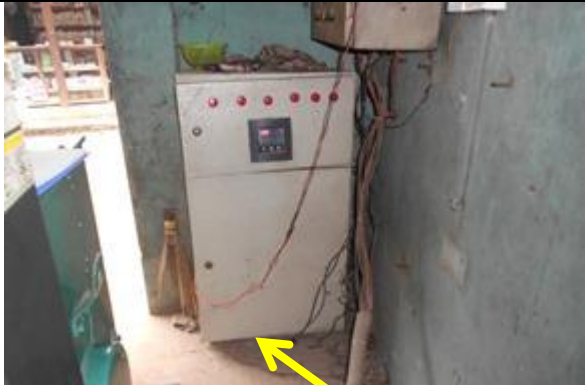
| 47 | Is there over current protection device installed at all distribution panels? | Risk Level | Very High |

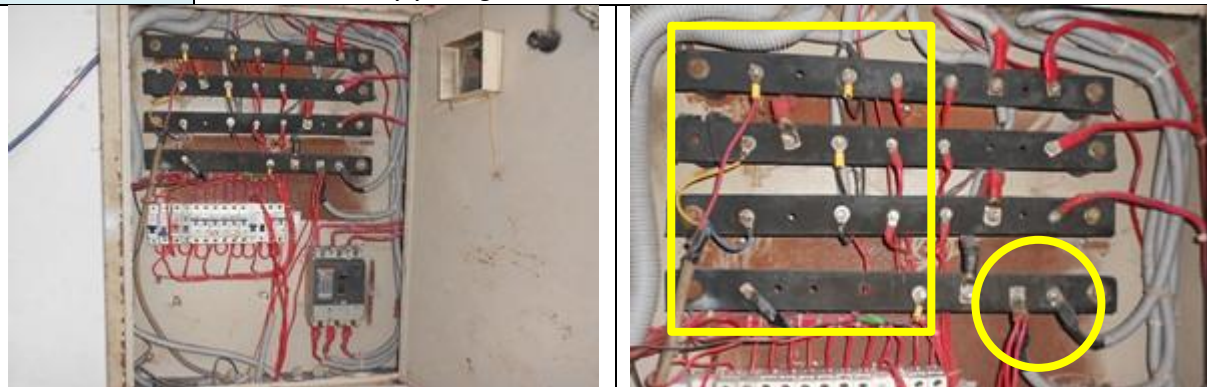
| 48 | Is there proper working clearance provided near distribution panels? | Risk Level | Moderate |

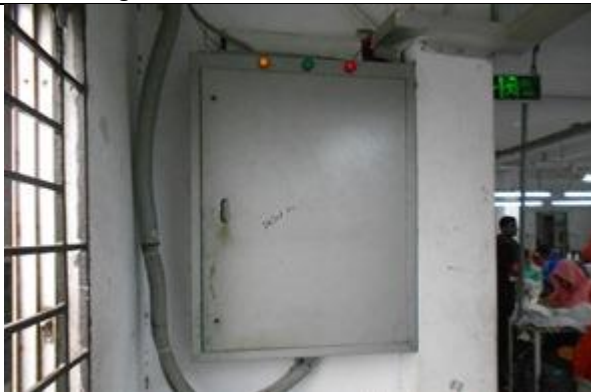
| 50 | Are electrical connections properly secured with lugs and glands? | Risk Level | High |

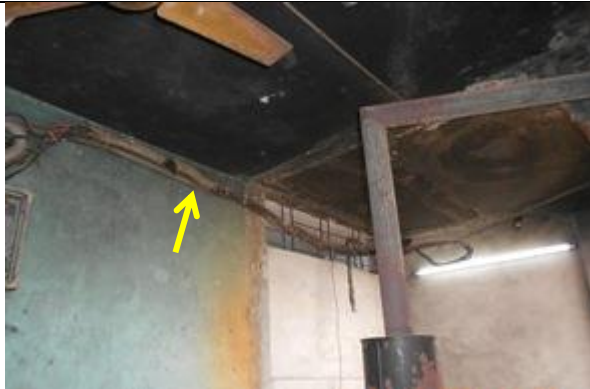
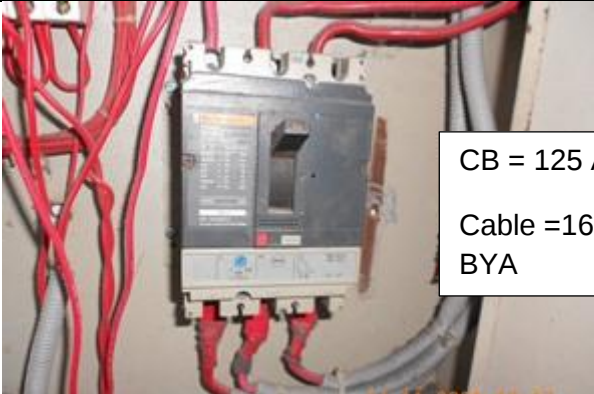
| 53 | Are cables / wires and MCB / MCCB selected with suitable rating for desired application? | Risk Level | Very High |
| <div><div>CB = 125 A<br/><br/>Cable =16 rm<br/>BYA</div></div> | | | |

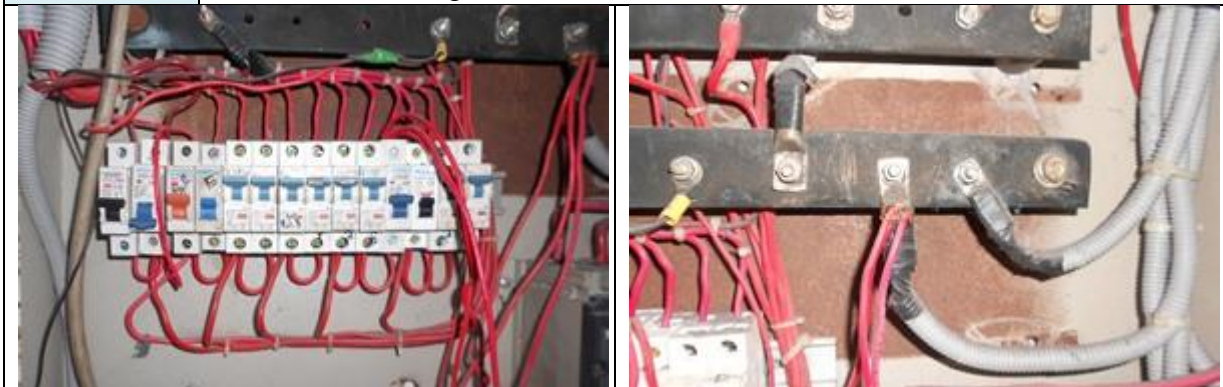
| 54 | Is there Any cross-circuiting (Looping, Bunching at MCCB/MCB or Bus bar terminal) observed in the panels? | Risk Level | Very High |
| Observation | Looping & Bunching at MCCB / MCB or Bus bar terminal was observed.- Multiple cables terminated to a single pole of MCCB, MCB or Bus bar. Loop connection has used powering multiple MCCBs / MCBs. | | |

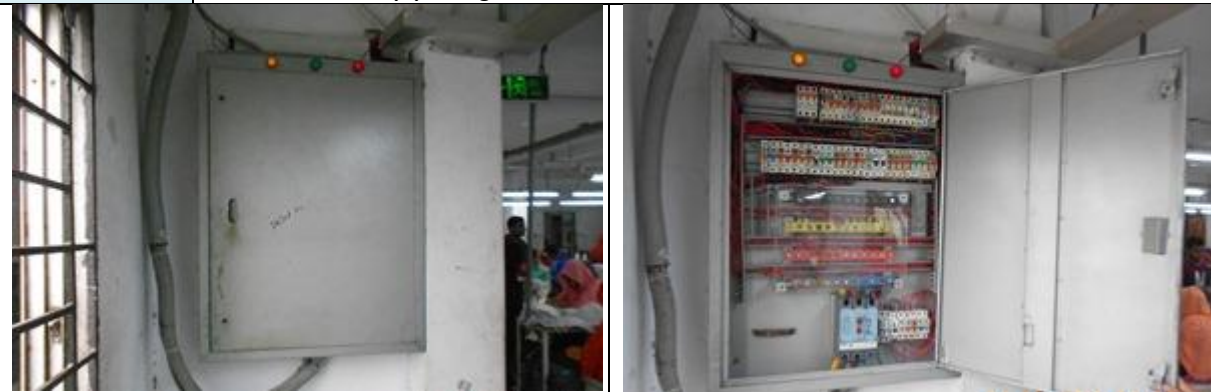
| 55 | Is wiring diagram/ circuit list with proper current ratings are available on every distribution boards? | Risk Level | Low |

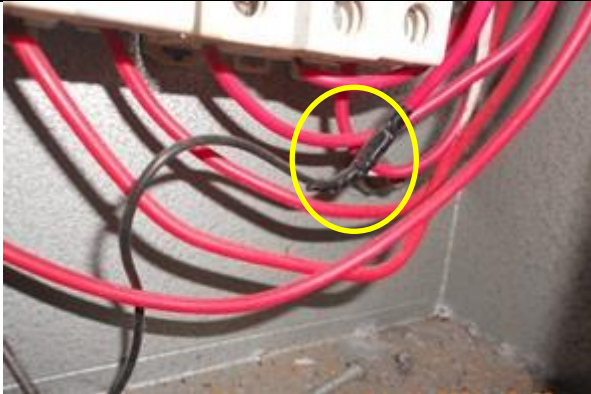
| 56 | Are there non-standard cable joints observed in electrical circuit? | Risk Level | Very High |

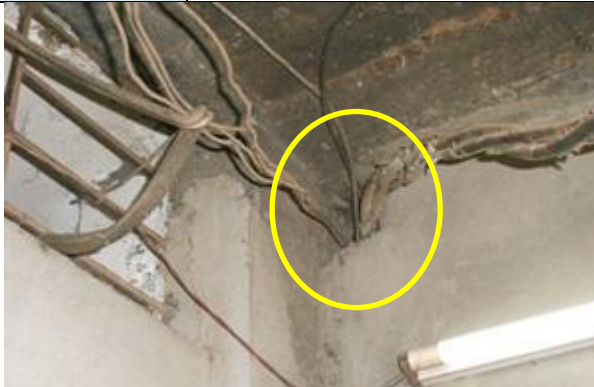
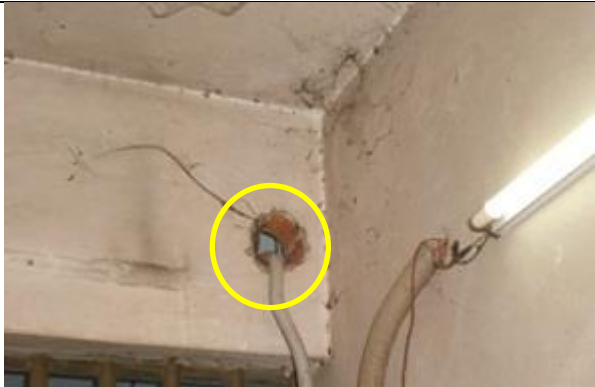
| 57 | Are there cable penetrations from wall adequately covered and sealed? | Risk Level | Moderate |

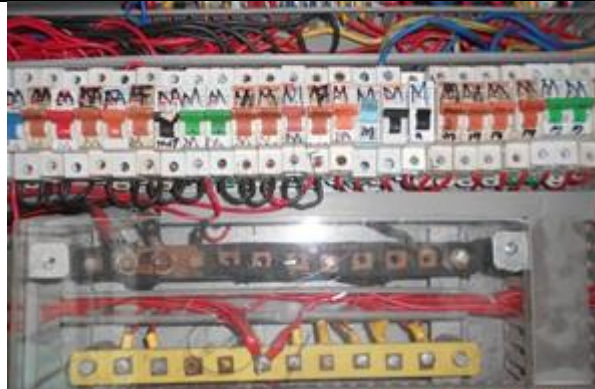
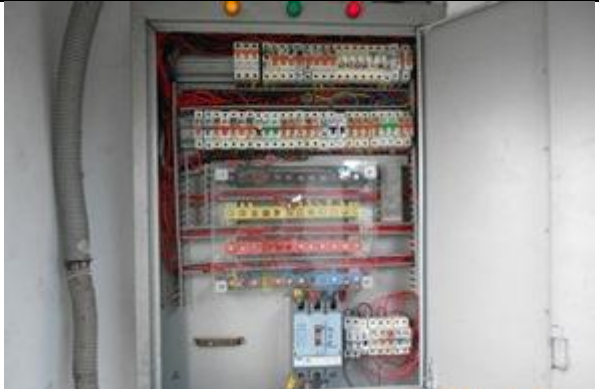
| 58 | Are there common neutrals observed for more than one circuits? | Risk Level | High |

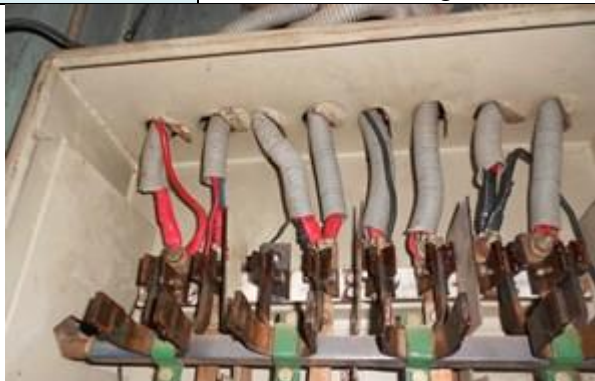
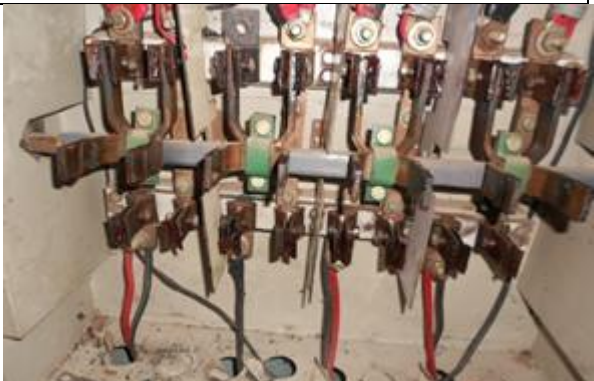
| 62 | Is cable entry-exit point to the panel properly sealed? | Risk Level | Very High |

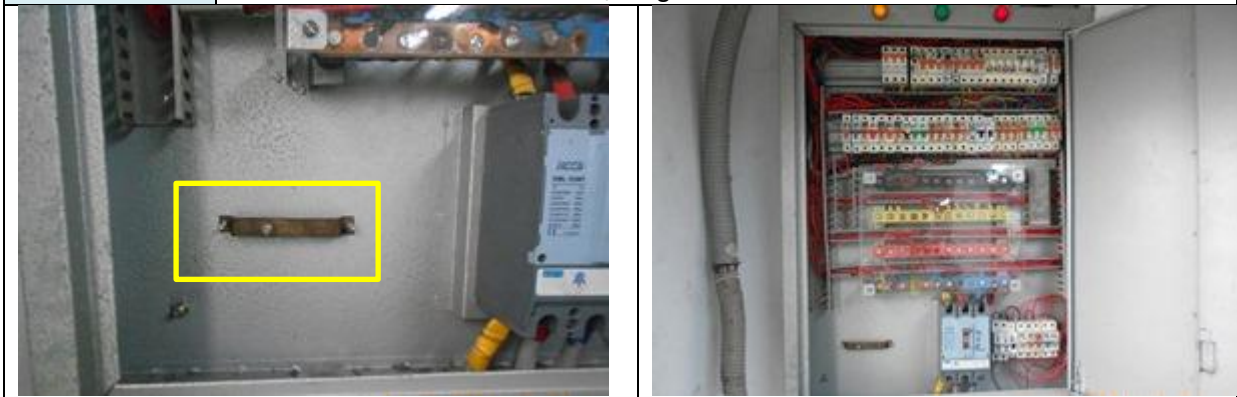
| 68 | Is there separate earthing provided on all electrical equipment? | Risk Level | High |
