Fire and Electrical Safety Assessment of Existing RMG Factory Buildings in Bangladesh

Kojima Lyric Garments Ltd.
(BGMEA Ref. # 407)
Chandna-Naljani, Joydebpur Road, Gazipur

Bureau of Research Testing and Consultancy (BRTC)
Bangladesh University of Engineering & Technology (BUET), Dhaka – 1000

April 2014

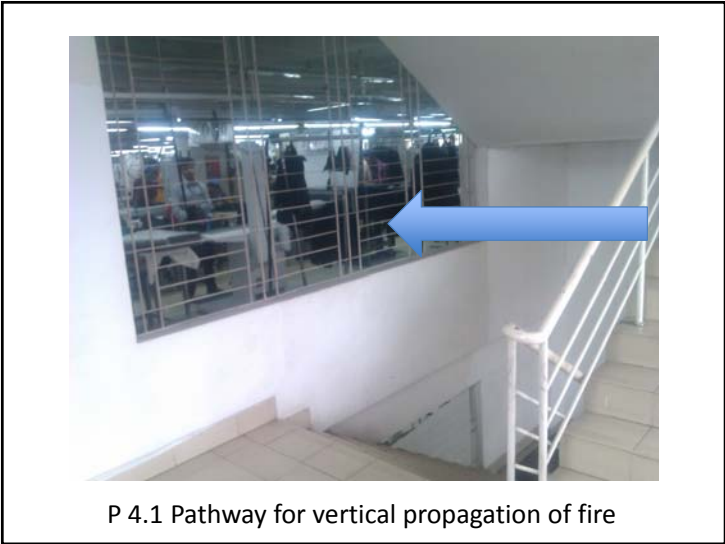
P 4.1 Pathway for vertical propagation of fire

Sl #	Item	BNBC2006 Reference	Guidelines Reference	Type of Non-Conformities	Actions	Time frame	Photo
4	Vertical Propagation of Fire	• § 3.1.7 Page 10326		<ul style="list-style-type: none"> • Protection against propagation of fire through voids in interior and exterior walls not equivalent to the fire resistance rating of the wall 	<ul style="list-style-type: none"> • Provide fire-rated separation to prevent smoke and fire propagation through staircases and grills on the interior walls 	6 months	P4.1 P4.2

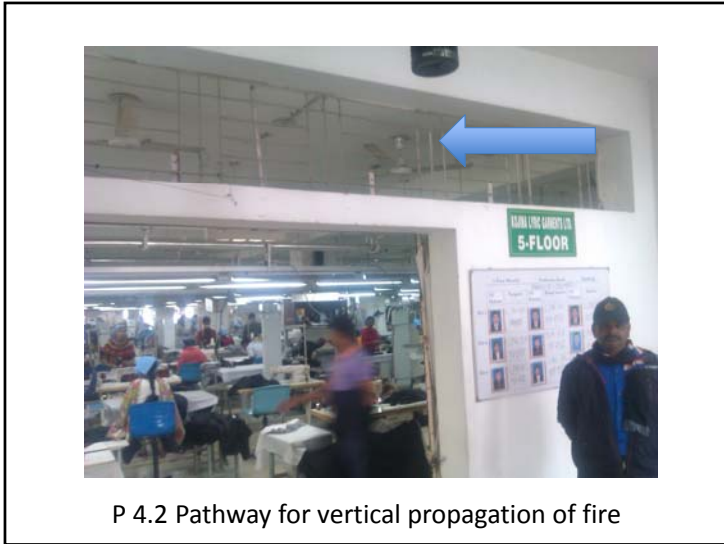
P 4.2 Pathway for vertical propagation of fire

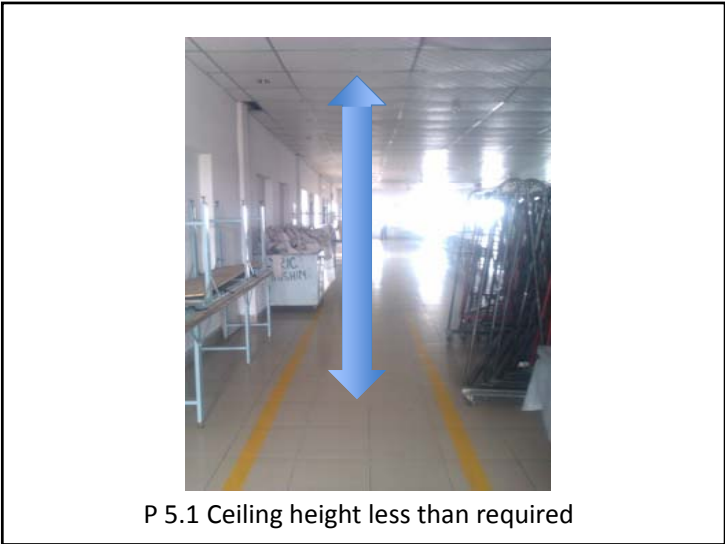
• Sec. 2.3.5	<ul style="list-style-type: none"> • Same as above 			
5	Ceiling Height	• §1.12.2.1 Page 10327		<ul style="list-style-type: none"> • Ceiling height less than specified for Industrial building 	<ul style="list-style-type: none"> • No action needed at present 		P5.1

P 5.1 Ceiling height less than required

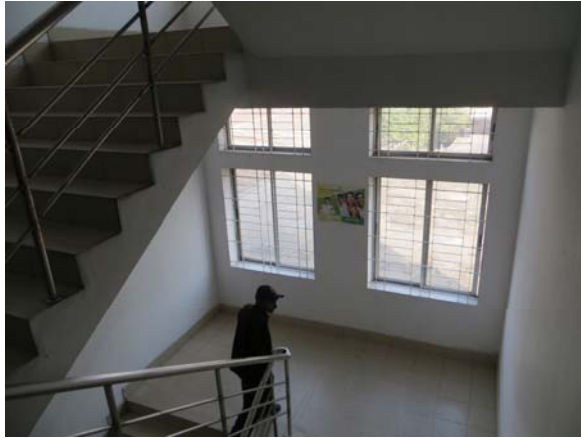
P 11.2 Stairway not in smoke-proof enclosure

<ul style="list-style-type: none"> • Sec. 2.5.2 • Sec. 2.9.5 • Sec. 2.9.7 • Sec. 2.9.12 	<ul style="list-style-type: none"> • Same as above 	<ul style="list-style-type: none"> • Convert all stairways into smoke-proof enclosures equipped with Fire-rated side swinging doors opening in the direction of travel at each floor. • The ground floor exits should be enclosed so as to ensure safe pathway for escape from the premises. • Remove all collapsible security gates and roller shutters from all exit stairway access doors Provide continuous smoke-proof fire protected pathway along all the 	6 months

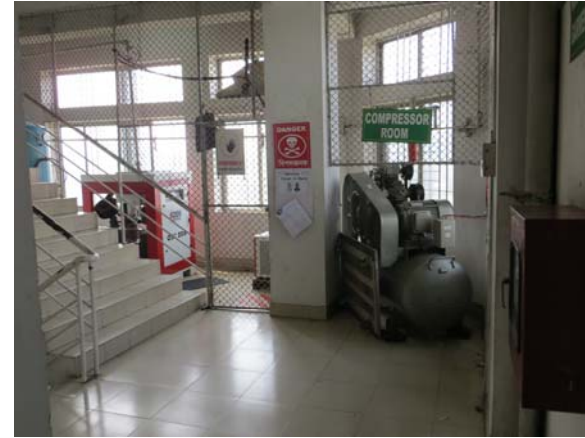
P 11.3 Obstacle in Stairway

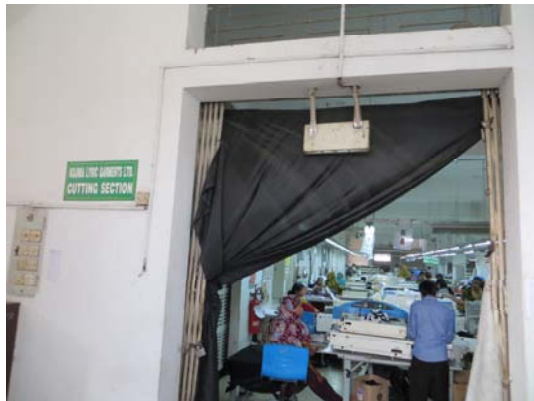
P 11.4 No Fire door

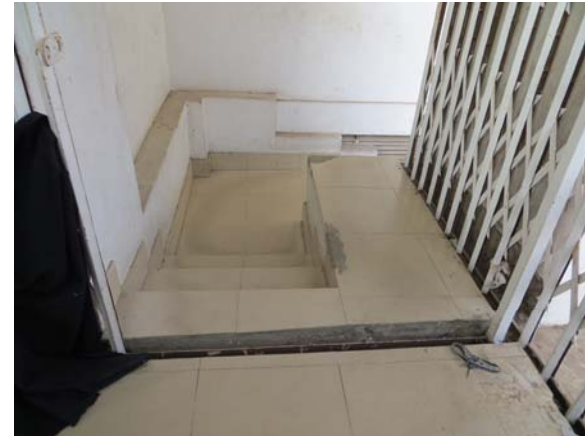
P 11.4 Improperly constructed stairway

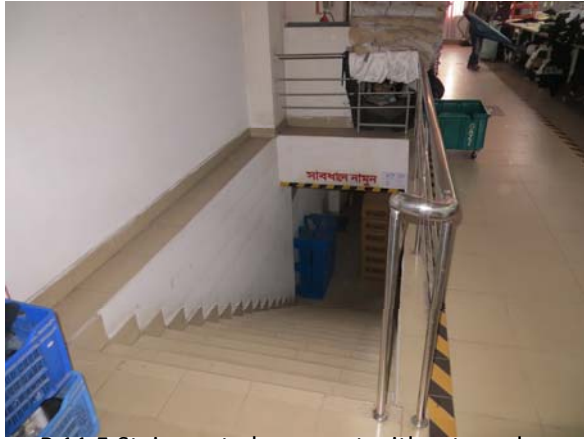
P 11.5 Stairway to basement without smoke-proof enclosure

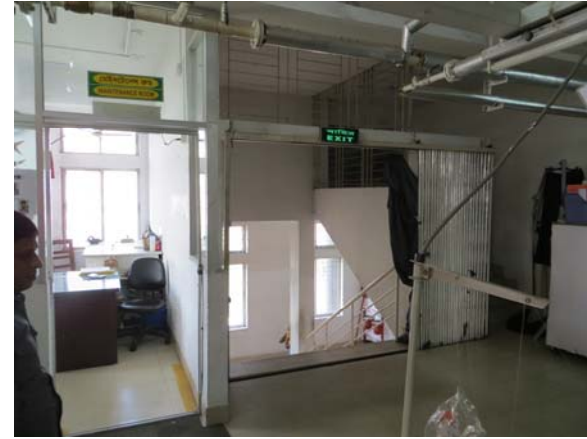
2. The stairway on the North-West corner does not extend from the roof to the ground level. It ends at 2nd floor and continues anew laterally about 10m away forcing the workers to travel through the 2nd floor work area. Thus, appropriate planning is required to make the entire stairway smoke-proof and fire proof.

P 11.6 Discontinuous stairway

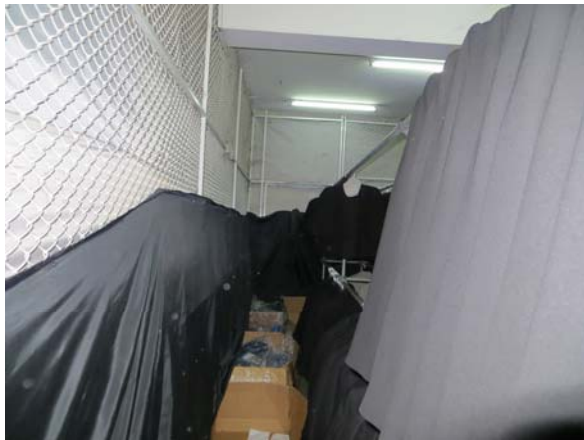
P 12.1 Blocked passageway

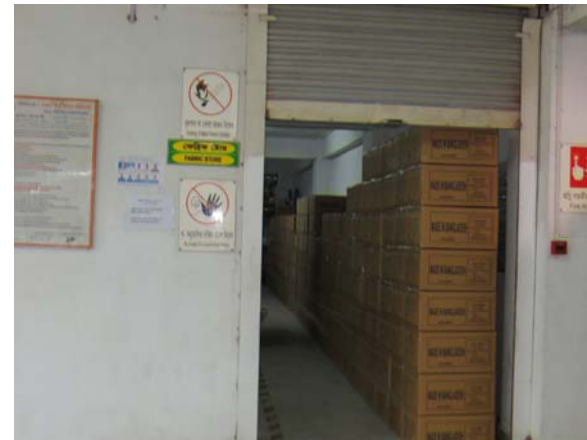
P 12.2 No fire door

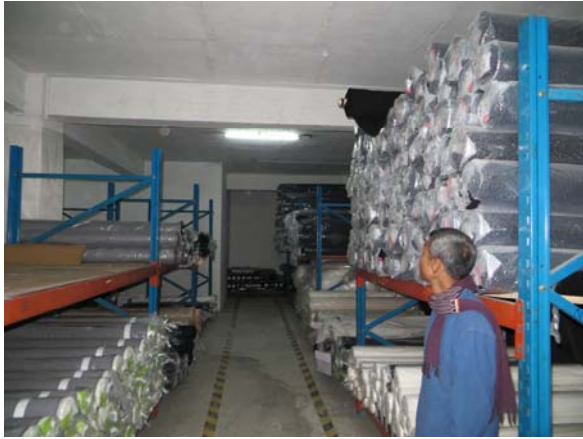
P 12.3 Inadequate clearance from ceiling

<ul style="list-style-type: none"> Rearrange storage items to ensure proper clearance from ceiling. 	On-going

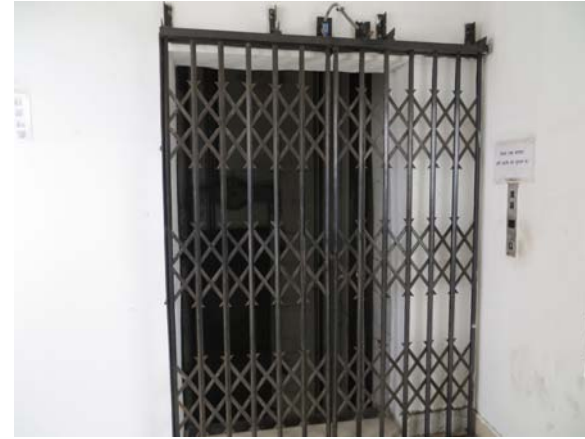
P 14.1 Collapsible gate for door

SI #	Item	BNBC2006 Reference	Guidelines Reference	Type of Non-Conformities	Actions	Time frame	Photo
13	Smoke and Heat Vents	<ul style="list-style-type: none"> • §2.6 Page 10411 • §B 2 Page 10469 		<ul style="list-style-type: none"> • No Smoke and Heat Vents 	<ul style="list-style-type: none"> • Provide smoke and heat vents as required (e.g. Storage, etc.) 		
			<ul style="list-style-type: none"> • Sec. 2.7.2 	<ul style="list-style-type: none"> • Same as above 			
14	Lift & Enclosures	<ul style="list-style-type: none"> • §D 3 Page 10481 • § 3.7 Page 10424 		<ul style="list-style-type: none"> • Lift lobby not enclosed and without Fire door • No Fire switch • Inappropriate Fire rated Lift car door • Collapsible gate on lift door • No rules posted for use during Fire 	<ul style="list-style-type: none"> • Provide enclosed Lift lobby with Fire door as part of the stair enclosure as specified in the Guidelines. • Remove collapsible gate on lift door at all levels. • Post emergency procedure notices in lift lobbies. 	6 months	P14.1

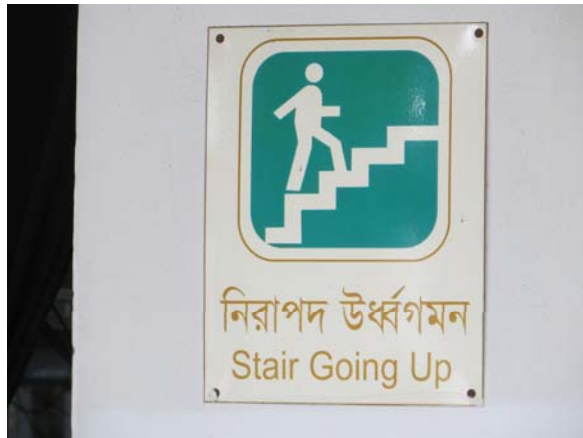
P 16.1 Wrong directional sign

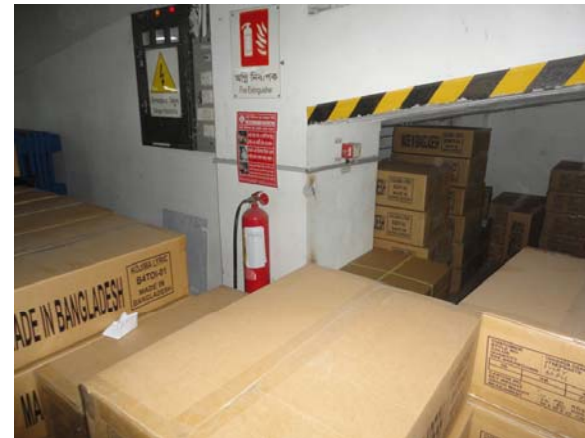
P 19.1 Inaccessible fire extinguisher

<ul style="list-style-type: none"> • Sec. 3.8 				
19	Portable Fire Extinguishers	<ul style="list-style-type: none"> • § 4.10 Page 10451 • BDS 825 : 91 		<ul style="list-style-type: none"> • Non-standard Cylinder color • Validation certificate not monitored regularly • Cylinders not accessible 	<ul style="list-style-type: none"> • Provide fire extinguishers that meet the requirements of the Guidelines. 	6 weeks	P19.1 P19.2
			<ul style="list-style-type: none"> • Sec. 3.5 • Sec. 3.10 • FACTORY RULES 1979 	<ul style="list-style-type: none"> • Same as above 	<ul style="list-style-type: none"> • Ensure regular monitoring and maintenance of extinguishers, including inspection and expiry/re-service labels. • Ensure easy accessibility to fire extinguishers. 	On-going

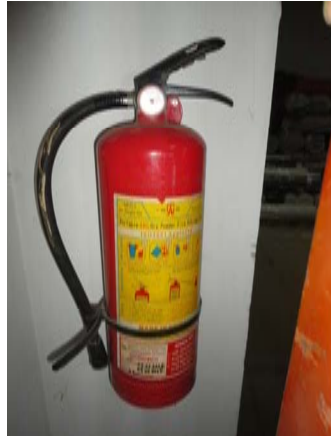
P 19.2 No validation certificate

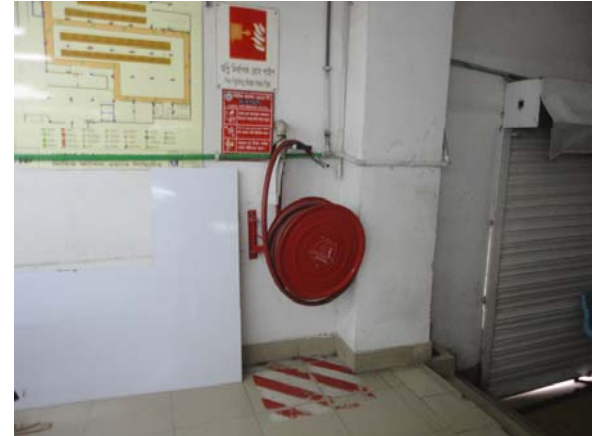
P20.1 Non-standard hose system

SI #	Item	BNBC2006 Reference	Guidelines Reference	Type of Non-Conformities	Actions	Time frame	Photo
20	Standpipe and Hose system	<ul style="list-style-type: none"> • §2.11 Page10368 • Table 3.2.6 Page 10371 • §4.2.1 Page10435 • §4.2.2 Page10435 • Table 4.4.1 Page 10436 • §4.2.2.4 Page10439 • §4.2.3 Page10439 • Table 4.4.2 Page 10442 		<ul style="list-style-type: none"> • Non standard Standpipe & Hose system • Supply of water required for interior fire protection is not adequate • Pressure in the standpipe is less than required • The size (diameter) of the standpipe is less than the prescribed value. • No Siamese connection available. 	<ul style="list-style-type: none"> • Provide standard Standpipe& Hose system that complies with the Guidelines requirements for supply of water, minimum pressure in the standpipe and size (diameter) of the standpipe. • Ensure that Siamese connections are available as specified by the Guidelines. 		P20.1 P20.2

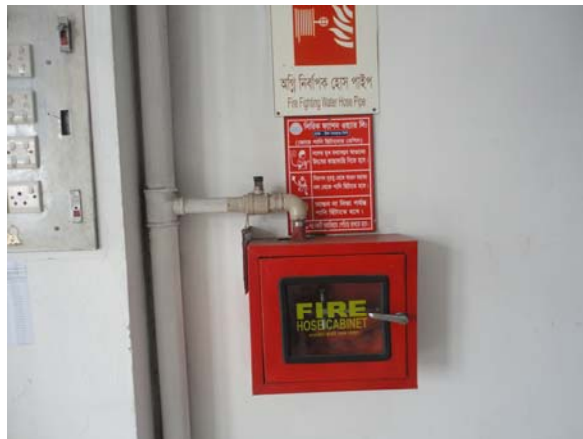
P20.2 Non-standard hose system

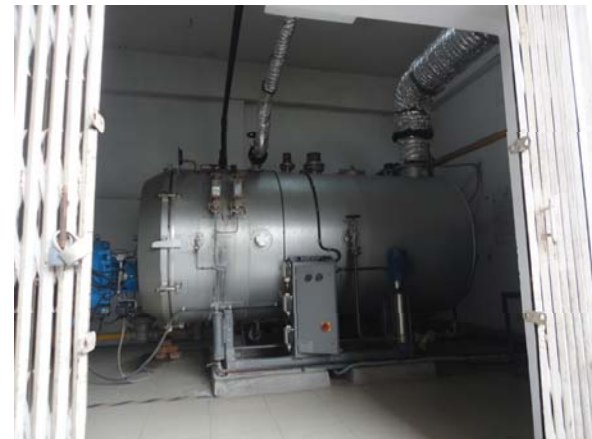
P 23.1 Boiler room is not properly segregated

SI #	Item	BNBC2006 Reference	Guidelines Reference	Type of Non-Conformities	Actions	Time frame	Photo
	Fire Fighting Provisions		• Appendix-II: FACTORY RULES 1979				
23	Boiler Room	<ul style="list-style-type: none"> • § C 4 Page 10477 • § D 11 Page10486 • § 2.12.8 Page 10419 		<ul style="list-style-type: none"> • Boiler room is not properly segregated from the rest of the occupancy • No smoke detectors in boiler room 	<ul style="list-style-type: none"> • Produce design drawings to demonstrate the incorporation of fire rated enclosure from floor to ceiling and an approved fire rated self-closing swing door for the boiler room. • Provide firefighting equipment as required by the Guidelines. 	6 weeks	P23.1
			<ul style="list-style-type: none"> • Sec. 2.8.2 • Sec. 3.4.2 • Sec. 3.7.6 	<ul style="list-style-type: none"> • Same as above 	<ul style="list-style-type: none"> • Provide fire rated enclosure from floor to ceiling and an approved fire rated self-closing swing door for the boiler room. • Install appropriate detectors. 	6 months

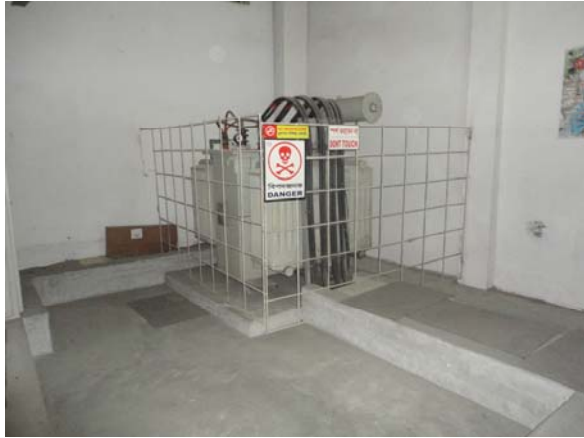
P24.1 No separating wall for transformer

24	Transformer Room	<ul style="list-style-type: none"> • § D 15 Page10487 • Electricity Rule 1937 § 49 		<ul style="list-style-type: none"> • No separating wall in Transformer room 	<ul style="list-style-type: none"> • Produce design drawings to demonstrate the incorporation of fire rated enclosure from floor to ceiling and an approved fire rated self-closing swing door for the Transformer room. • Provide firefighting equipment as required by the Guidelines. 	6 weeks	P24.1
			<ul style="list-style-type: none"> • Sec. 3.7.10 • Electricity Rule 1937 § 49 	<ul style="list-style-type: none"> • Same as above 	<ul style="list-style-type: none"> • Provide fire rated enclosure from floor to ceiling and an approved fire rated self-closing swing door for the Transformer room. • Install appropriate detectors. 	6 months

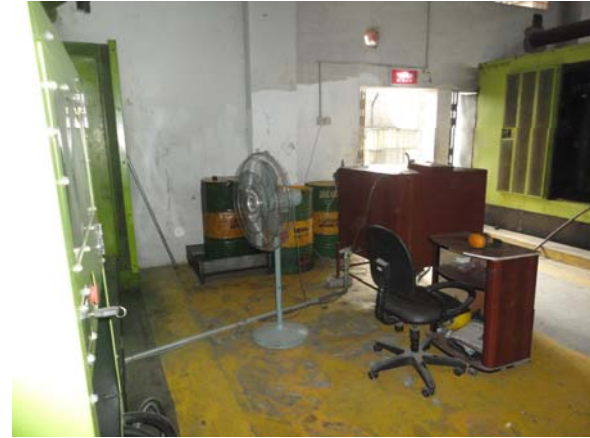
P25.1 Combustible material in generator room

Sl #	Item	BNBC2006 Reference	Guidelines Reference	Type of Non-Conformities	Actions	Time frame	Photo
25	Generator Room	<ul style="list-style-type: none"> • § D 14 Page 10487 • Table 3.2.7 Page 10377 • § 2.6 Page 11248-11250 • § 2.7.4 Page 11253 • Electricity Rule 1937 § 49 		<ul style="list-style-type: none"> • The generator room is not properly segregated from the rest of the occupancy due to presence of non Fire-rated Door • No detector in generator room • No firefighting equipment is present in the generator room • Combustible materials inside generator room • One point frame earthing of generator instead of two • No earth fault protection provided 	<ul style="list-style-type: none"> • Produce design drawings to demonstrate the incorporation of fire rated enclosure from floor to ceiling and an approved fire rated self-closing swing door for the Generator room. • Provide firefighting equipment as required by the Guidelines. • Provide earth fault protection as required by Guidelines. 	6 weeks	P25.1 P25.2

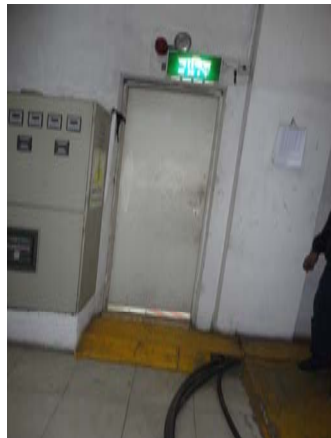
P25.2 Wooden door in generator room

<ul style="list-style-type: none"> • Provide fire rated enclosure from floor to ceiling and an approved fire rated self-closing swing door for the Generator room Install appropriate detectors. 	6 months	
			<ul style="list-style-type: none"> • Sec. 4.9.3 • Electricity Rule 1937 § 49 	<ul style="list-style-type: none"> • Same as above 	<ul style="list-style-type: none"> • Remove Combustible materials from generator room. 	On-going	
26	Basement	<ul style="list-style-type: none"> • § D 8 Page 10483 • § 3.13 Page 10428 		<ul style="list-style-type: none"> • Basement staircase is not enclosed with materials of 2 hours fire resistance. 	<ul style="list-style-type: none"> • Produce design drawings to demonstrate the incorporation of a fire-rated construction with smoke proof enclosure from roof to ceiling with vestibule separation from basement or by other provisions provided in the Guidelines. 	6 weeks

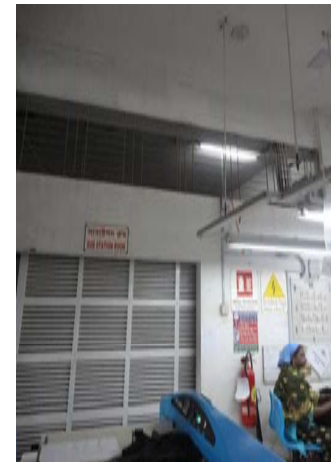
P28.1 Improper separation in substation room

<ul style="list-style-type: none"> • Provide fire rated enclosure from floor to ceiling and an approved fire rated self-closing swing door for the Substation room. • Install appropriate detectors 	6 months		
		<ul style="list-style-type: none"> • Sec. 4.6 • Electricity Rule 1937 § 46, 47, 50, 60 	<ul style="list-style-type: none"> • Same as above 	<ul style="list-style-type: none"> • Provide instructions for first aid from exposure to electrical shock. 	On-going

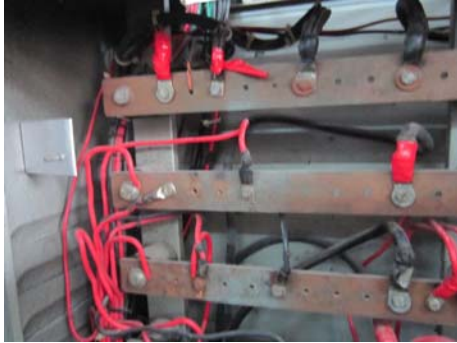
P 29.1 Wiring without lug
