গণপ্রজাতন্ত্রী বাংলাদেশ সরকার  
শ্রম ও কর্মসংস্থান মন্ত্রণালয়  
কলকারখানা ও প্রতিষ্ঠান পরিদর্শন অধিদপ্তর

ক্যাপ পর্যবেক্ষণের তথ্য

কারখানার নাম	কতুল্লা এম্পাওয়ারেলস লিমিটেড
ঠিকানা	B-68/1 Wapda Road, Jalkuri, Siddirganj, Narayanganj
কারখানার কোড	NRY087
কালার কোড	
মূল্যায়নের ধরণ: <a href="#">কাঠামোগত মূল্যায়ন</a>	পর্যবেক্ষণের তারিখ: ০১-০২-২০২৩
১. পর্যবেক্ষণ

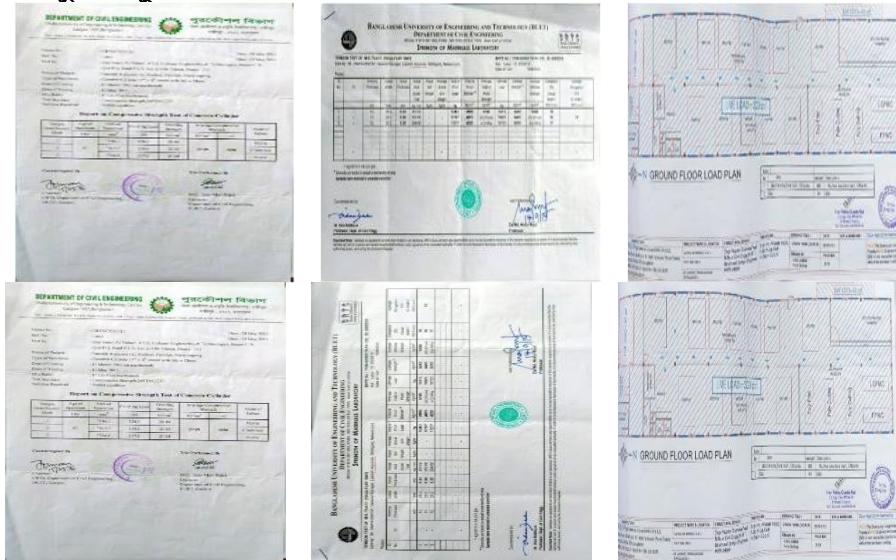
সংযুক্তিসমূহ ( ৬ )

পরিদর্শন পর্যবেক্ষণ	During document review floor load plan and material test report were not found.
ক্যাপ আইটেম ক্যাটাগরি

কার্যক্রম	Develop full set of floor load plan showing loading details, and conduct materials test.
সুপারিশের তথ্যসূত্র	
কারখানার কার্যক্রম	We have already developed floor load plan by DEA and done material test report from BUET
অগ্রাধিকার	৬ মাস
চূড়ান্ত সমন্বয়সীমা	-
সংশোধিত সমন্বয়সীমা	০১-০১-১৯৭০
অগ্রগতির অবস্থা	চলমান
মন্তব্য	27-10-2020, They have all kind test reports & we found all kinds report at factory. 13.01.2021: No floor load plan has been found during inspection but as built drawing material test report was found. 03-06-2021 ( CVV4 ): No floor load plan has been found during inspection but as built drawing material test report was found. 24-Aug-2021 ( CVV5 ): Floor load plan has not found during inspection , materials test report is available at factory. 28-Aug-2022: Materials test report & floor load plan drawing is available at factory during visit. but floor load plan are not posted on floor because they are waiting for approved floor load plan. 01.Feb.2023: Materials test report & floor load plan drawing is available at factory during visit. but floor load plan are not posted on floor because they are waiting for approved floor load plan.
